Assessment and Retrofitting of an Existing Steel Structure subjected to Wind-Induced Failure Analysis

C. Maraveas^{1,2*} and K.D. Tsavdaridis³

¹C. MARAVEAS & ASSOCIATES P.C. - Consulting Engineers, Greece

Abstract

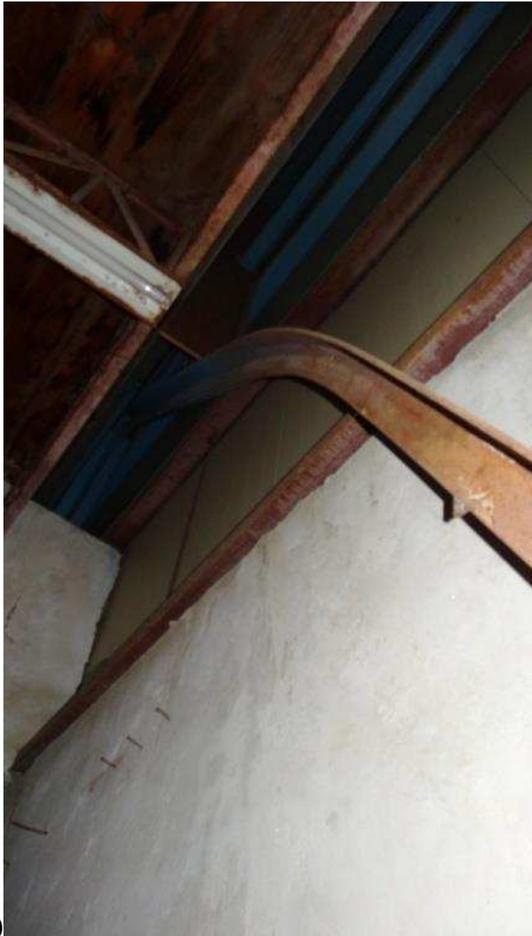
a) Extended buckling deformation of the corroded Λ -type vertical bracings to the south (Fig. 4a) as well as of the connecting beams between the IPE360 columns at +8.70 m (Fig. 5).

a) b)
Fig. 4. Vertical Λ -type bracing on the southern section of the building: a) the corroded portion with major second-order deformation and b) the undamaged portion.

- c) Replacement of insufficient vertical bracings using the same or different configurations (examples from the south and north sides of the building as well as Section 1-1 can be observed in Fig. 16, Fig. 17).

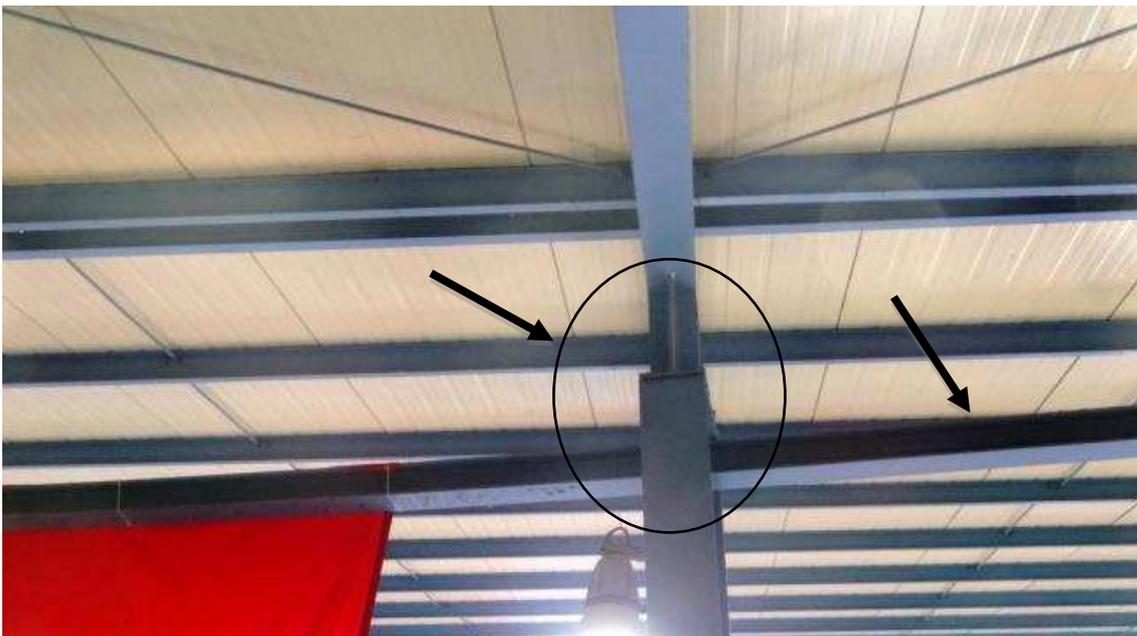
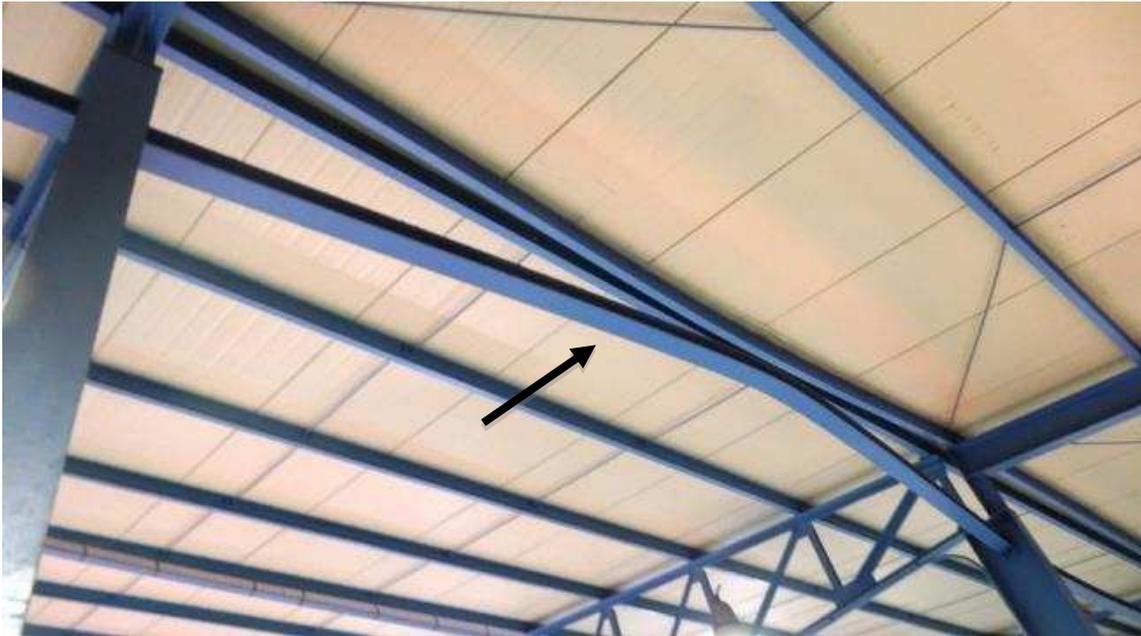
Fig. 5. Steel elements with major second-order deformations.

- d) Replacement of distorted members such as H-type connecting beams in Section 1-1 of Fig. 16, Fig. 17.
- e) Replacement of vertical elements at the end of the IPE360 column (Fig. 17), which is predicted to provide a stiffer beam-column connection.

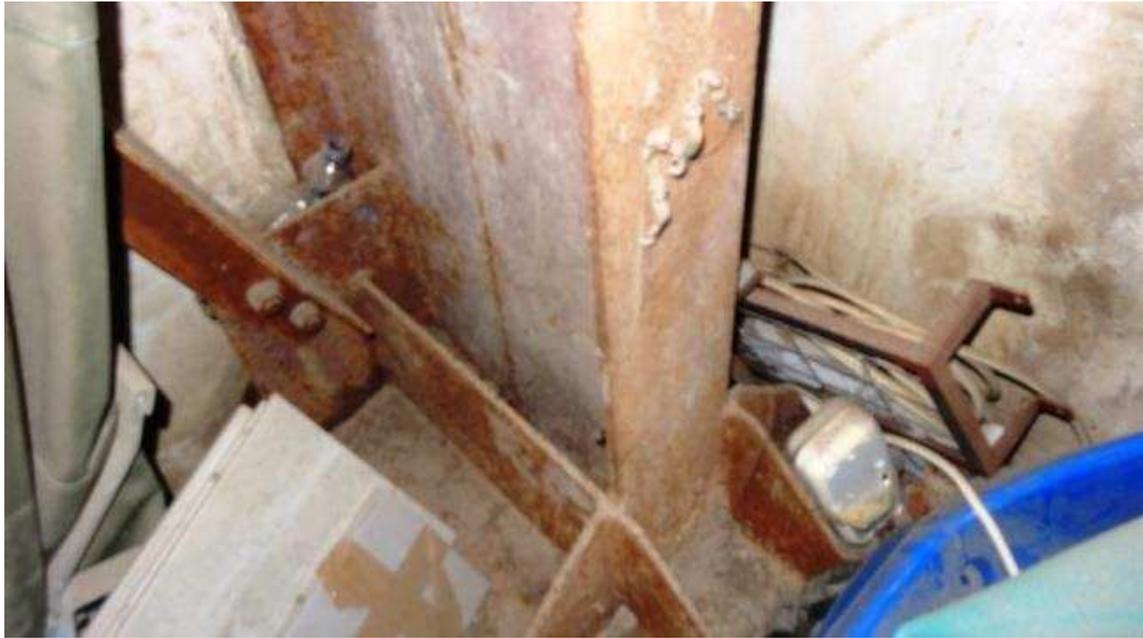
- b) Column-baseplate connections with major corrosion effects and insufficient stiffener thicknesses (Fig. 6a).
- c) Significant cracking effects at various locations along the perimeter of the brick wall. In particular, shear cracking expands to the concrete foundation wall on the north-east corner (Fig. 6b).
- d) Relaxed bolted connections at elements of major importance (i.e., vertical bracings) as well as relaxed anti-sag bars at the roof (Fig. 7).
- e) Major torsional deformation of vertical primary elements with insignificant torsional stiffness (Fig. 8).
- f) Almost non-existing column foundation under the first and last truss. They were connected to a slim (~20cm) layer of plain concrete without any reinforcement.

Fig. 6. Bad condition of the existing structure a) Column base with significant corrosion and b) brick wall with a large crack.

Minor but important restoration techniques should be implemented. They include tightening of bolts and anti-sag bars, surface treatment for corroded members that are not to be replaced (e.g., surfaces of columns near the base). Special treatment for foundation inadequacies is required as well. In particular, portions of the foundation beneath the gable columns (at both the east and west parts of the building) should be strengthened so that they can receive bending moments. The latter recommendation is illustrated in Fig. 18(a), where H-type steel beams are used as provisional column supports for an adequate length in both directions.

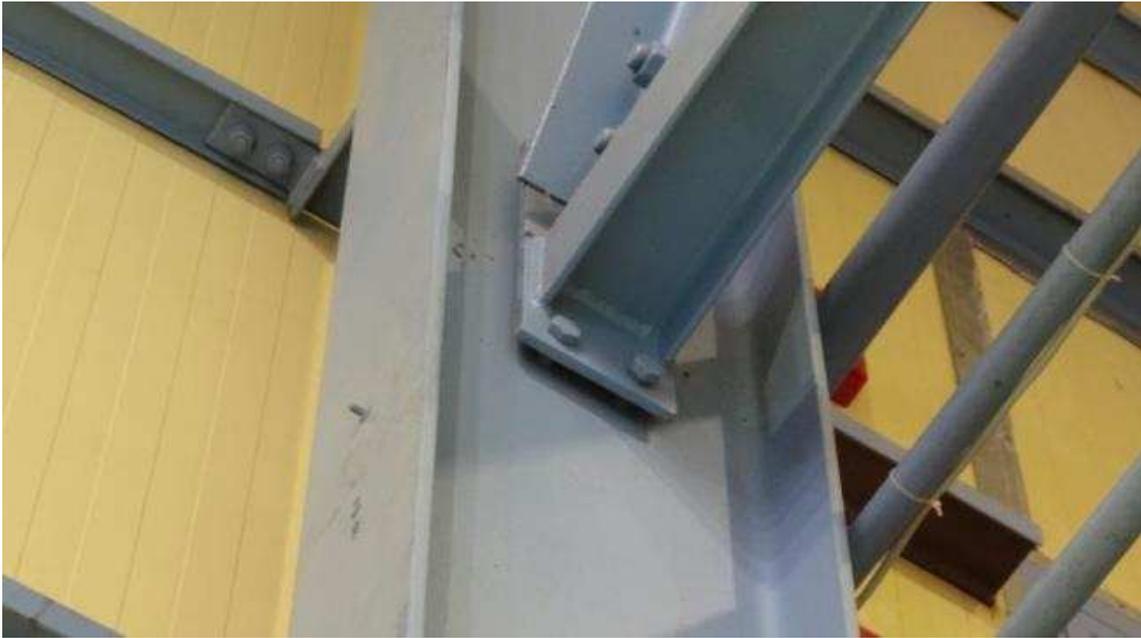
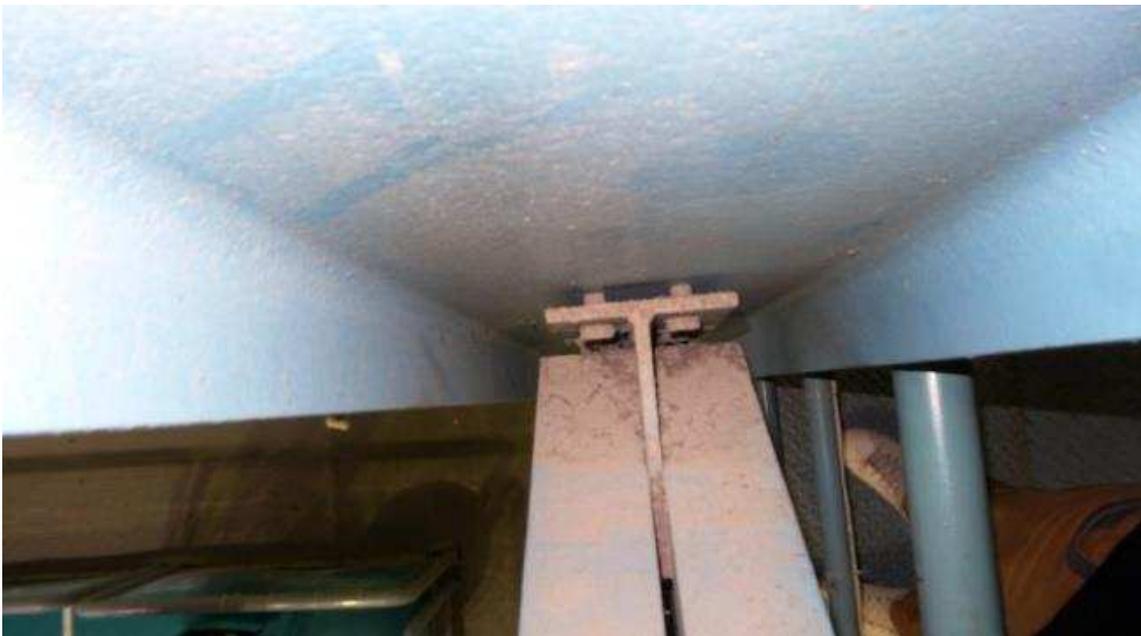
Fig. 7. Relaxed bolted connection.

In summary, this investigation indicated that corrosion (Fig. 4) and construction (Fig. 7 to 9) defects as well as accumulated damage (Fig. 4) from past events and further deterioration combined to produce the present structural condition. It is likely that failures of different structural elements (i.e., brick walls, bracings, etc.) resulted from different events that took place in an unknown sequence. Nevertheless, it is vitally important to examine the most likely sequences that could lead to failure before proposing strengthening measures. Since the most severe main steel structure failures are caused by the wind, more detailed numerical simulations are conducted in section 2.3.

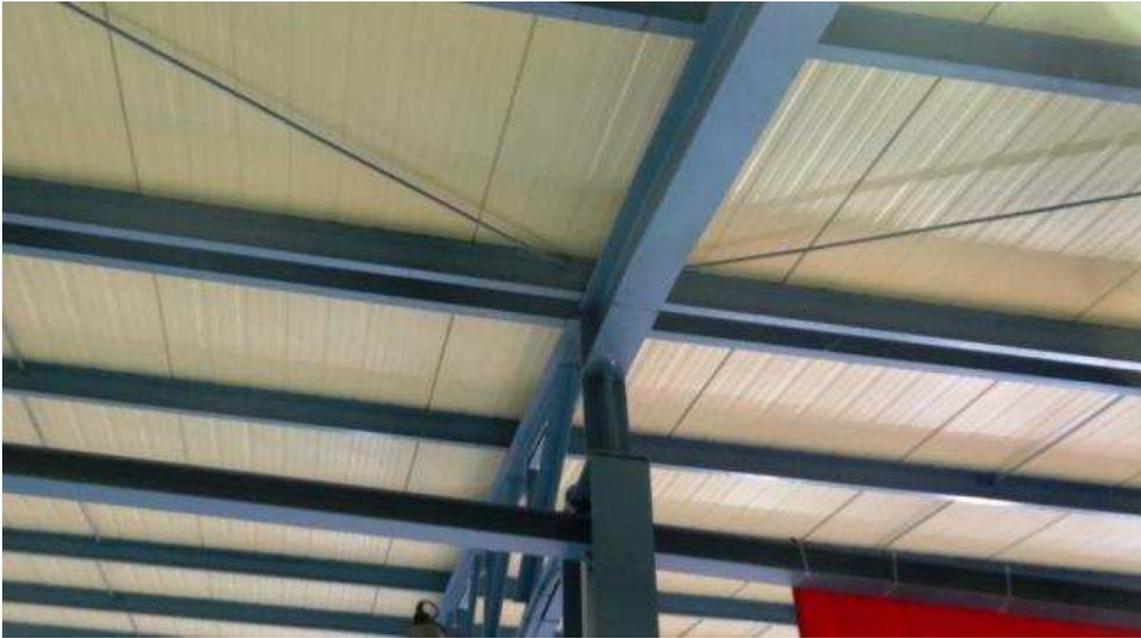
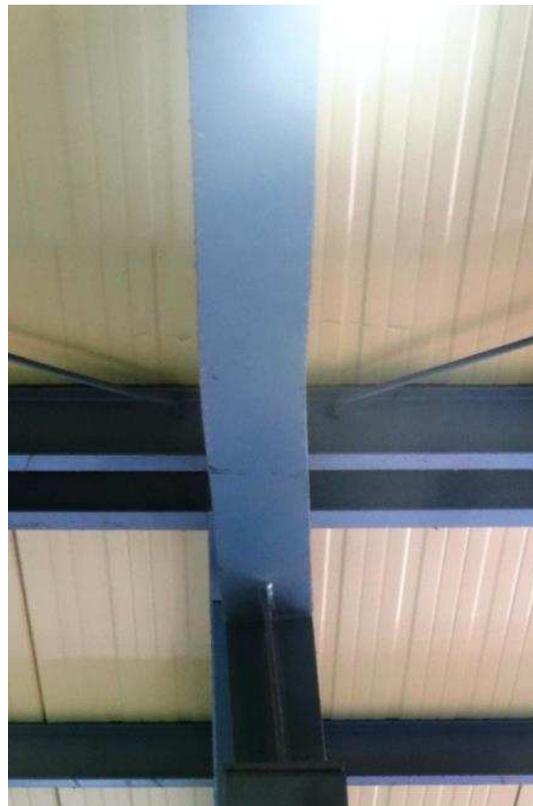
Fig. 8. Insufficient beam-column connection.
