Citation: Surre, F., Sun, T. & Grattan, K. T. V. (2013). Fiber Optic Strain Monitoring for Long-Term Evaluation of a Concrete Footbridge Under Extended Test Conditions. *IEEE Sensors Journal*, 13(3), pp. 1036-1043. doi: 10.1109/jsen.2012.2234736

Fiber Optic Strain Monitoring for Long-Term Evaluation of a Concrete Footbridge under Extended Test Conditions

Abstract—An optical fiber sensor system that can be installed and used to give reliable and informative data has been developed, tested and evaluated, over an extended period of two years, on a redundant 50 year-old concrete foot bridge whose conditions of use were well known. The bridge now serves as an operational test-bed as it has been taken out of service, and recently has been subjected to different known environmental and loading conditions. Thus in this work, specific and controlled damage has been induced, the effects monitored and thus the changes induced to the bridge have been recorded, using the optical fiber sensor system over the test period. During this two year survey, issues relating to the installation, use, data capture and evaluation of performance not available in the present literature have been identified

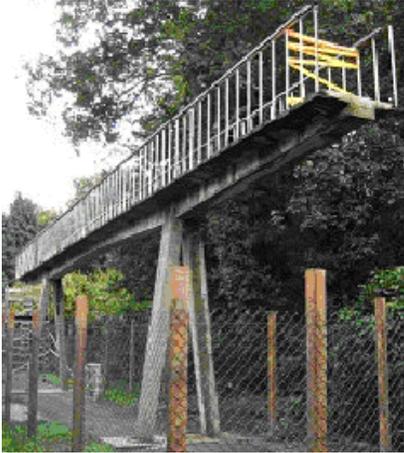
Fig. 1. Concrete footbridge at the National Physical Laboratory (© NPL).

A concrete footbridge on the premises of the National Physical Laboratory (NPL), Teddington, UK, was the ‘test-bed’ for this work. The bridge, shown in fig. 1, was built in the early 1960s and is built from reinforced concrete. The deck is 20m long; the piers are 5m high and the total weight of the bridge is 15tonnes. It had been in use for more than 40 years before it had been moved to its present location after its decommission to allow the test work to be done. Prior to that, new purpose-built concrete foundations had been created to support the bridge. As it is no longer in active use, it could be used as a test specimen, allowing loading at levels beyond what would be permissible with a ‘working bridge’ and allowing for accelerated damage situations to be created with it.
