Citation: Miah, S., Kaparias, I., Ayub, N., Milonidis, E. & Holmes, W. (2019). Measuring cycle riding comfort in Southampton using an instrumented bicycle. In: 6th International Conference on Models and Technologies for Intelligent Transportation Systems (MT-ITS). . IEEE. ISBN 9781538694848 doi: 10.1109/MTITS.2019.8883328

Measuring cycle riding comfort in Southampton using an instrumented bicycle

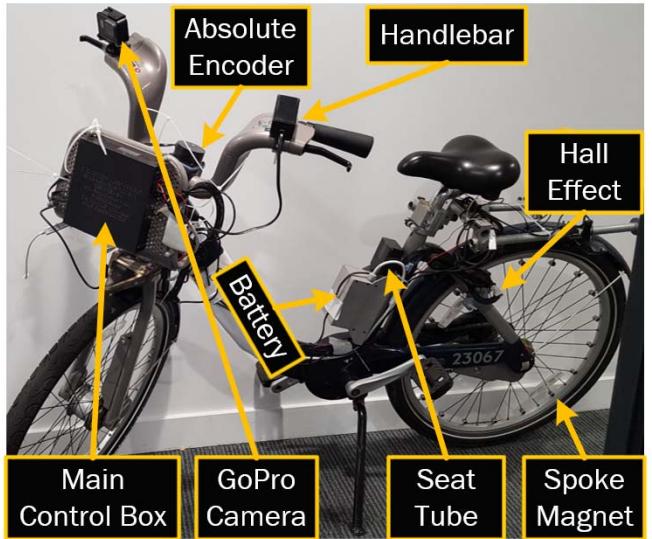
Fig. 1. The instrumented bicycle (iBike)

The iBike is an instrumented bicycle capable of monitoring several key variables related to cycling, such as speed, steering and acceleration, through an on-board bespoke measuring and logging system. Although the iBike was originally developed to enhance the positioning accuracy of cyclists (related studies can be found in [8]), the measurement from the iBike can also be employed to monitor the road pavement surface quality. For instance, the acceleration data can be related to surface quality and can be mapped with the positioning data from the iBike. Fig. 1 illustrates the actual instrumented bicycle with its sensor configuration.

The housing of the handlebar sensors includes a GY80 Inertial Measurement Unit (IMU), which incorporates a three-axis accelerometer, three-axis gyroscope, three-axis magnetometer, temperature and pressure sensors. The housing also includes a light-emitting diode (LED) and a push button. The LED is used to indicate the status of measurement and logging system and the push button is used to start and stop the data acquisition, as well as to place a real-time flag (marker) on the data. This function of the iBike is employed to record the rider’s perceptions in this study. For example, the cyclist can press the push button while the bicycle is being ridden to indicate the location of a pothole or a surface defect, and the iBike system will record this data along with the measurements from the sensors with a

The seat tube enclosure houses another set of accelerometer and gyroscope configuration, and these are used to monitor the rear frame acceleration and angular rate respectively. The Hall Effect and the absolute encoder sensors are used to measure the revolutions of the rear wheel and the steering angle respectively, while the main control box incorporates an Arduino Mega 2560 board along with various electronic components and micro SD memory card. In addition, a GoPro camera is installed on the bicycle for the purpose of visual validation of the journeys. The iBike's full system architecture is shown in Fig. 2.

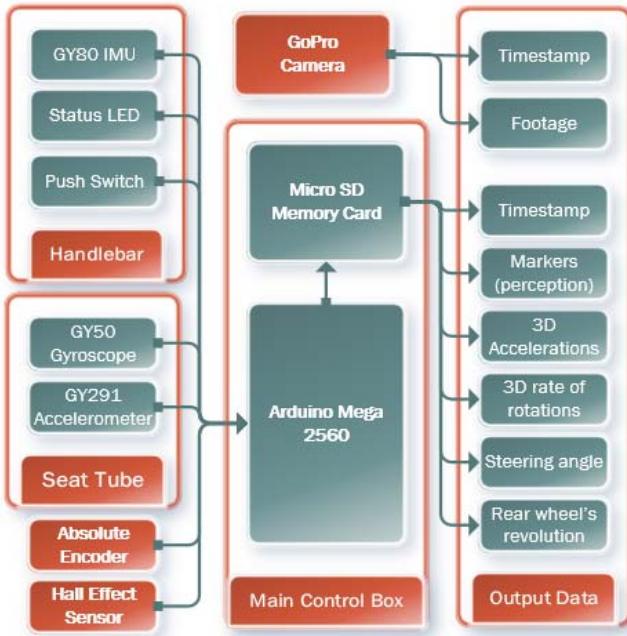
Fig. 2. iBike measurement system architecture and output data

In order to establish riding comfort and demonstrate the iBike's capability in this respect, only the timestamp, markers and vertical acceleration data are analyzed in this study. The authors believe that cycle riding comfort is very likely also influenced by the rider's behavior, and this could include a variation of speeds and steering angles in order to avoid a pothole or surface defect. However, this is beyond the scope of the present study and the authors envisage analyzing these other parameters in a subsequent publication.

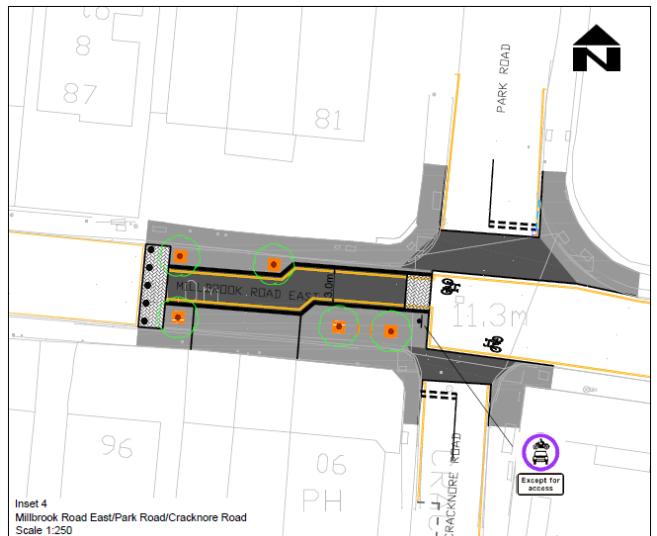
Fig. 4. Modal filter and short one-way conversion along MRE
(Source: Southampton City Council)

As a result of the feedback, Southampton City Council decided to redevelop the MRE site to a "Low Traffic Neighborhood Scheme". In essence, the redevelopment scheme was to proceed in two phases, with the first phase concentrating on resurfacing the road to eliminate potholes and other surface defects, and the second one entailing the introduction of a wide range of traffic management measures to restrict vehicle traffic and facilitate cyclists (and by extension also pedestrians). These include: introduction of a modal filter, which would only allow pedestrians and bicycles to pass through; implementation of a short one-way restriction; provision of enhanced landscaping and seating; changing of junction priority rules to give cyclists along MRE right of way; and widening of the cycle paths (Fig. 4).

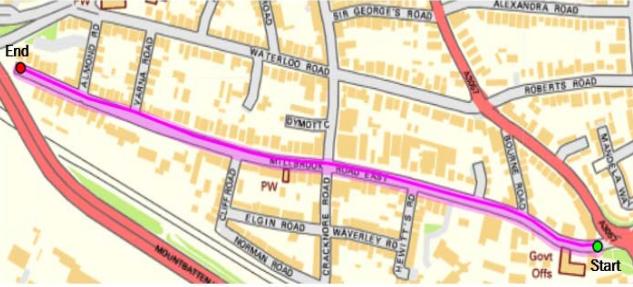
Fig. 5. Survey route: MRE, Southampton, UK

The present study focuses on the first phase of the MRE redevelopment scheme, i.e. the resurfacing. The data collection involves a single cyclist riding the iBike on MRE, first before the start of the resurfacing works, and then after their completion. This results in two sets of mapped sensor, data corresponding to a total of 21 runs for each of the before-and after-case. Each run is considered either from start to end

or vice-versa, such that a completed round trip along MRE, highlighted in pink in Fig. 5, is considered as two runs.

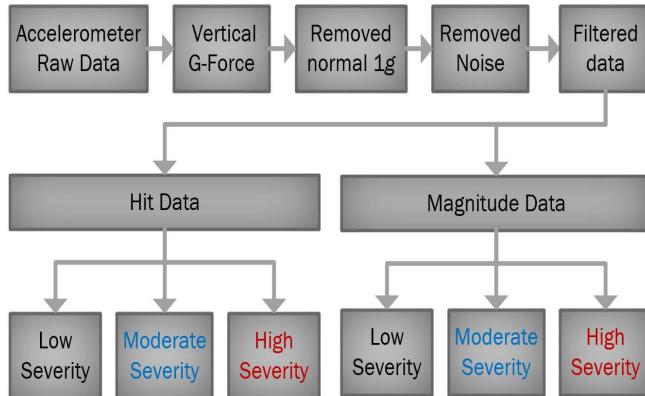
Fig. 6. Extraction of vibration values from the accelerometer's raw data

In this study, the longitudinal roughness of the surface is measured using the vertical acceleration data from the iBike's accelerometer. Several steps are required to convert the raw measurement data into acceleration values, and these are demonstrated in Fig. 6. As can be seen, the raw data from the accelerometer is first converted into a vertical g-force, and since the data already includes the normal gravitational force ($1g = 9.81 \text{ ms}^{-2}$), it needs to be removed here by reducing the g-force by $1g$.

Furthermore, accelerometers are susceptible to noise and in this case, some of the noise is associated with the riding and mechanical noise from the bike, such as noise from pedaling. In order to remove this noise, an experiment has been conducted on a smooth surface and it has been found that approximately $0.2g$ is generated under the normal conditions of riding the iBike even on a smooth surface, i.e. regardless of the surface roughness. This can also be observed from Fig. 7, where all the hits below the black line are considered to be noise.

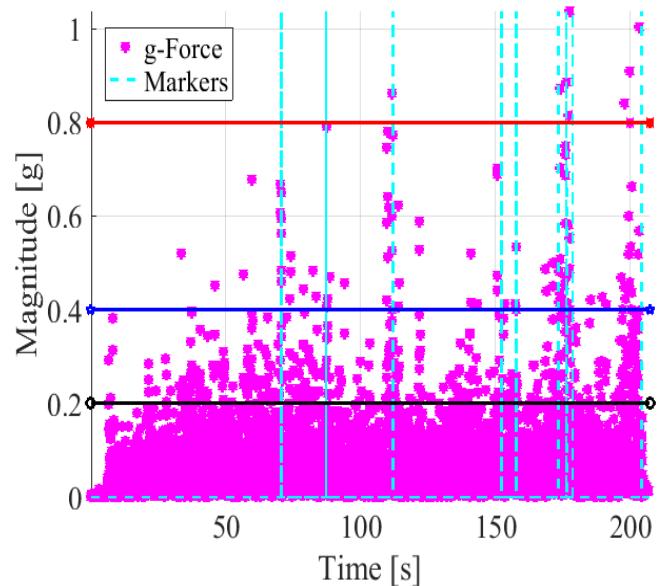
Fig. 7. Pre-resurfacing accelerometer data with markers and thresholds

magnitude values. Fig. 7 presents the vertical acceleration data from a single run conducted at the survey location and after taking the absolute value and removing the normal $1g$ from them. Each pink solid dot represents a vibration hit and it is also associated with a magnitude value, which is used to categorize it into either "low", "moderate" or "high" severity. In the present study, the threshold ranges shown in Table I are adopted based on a fine-tuning exercise carried out by analyzing the GoPro camera's footage, the data from the accelerometer and the markers denoting cyclist perceptions. A more elaborate study seeking to establish the threshold values for these categories in a systematic way is currently under way; however, this is beyond the scope of this paper.

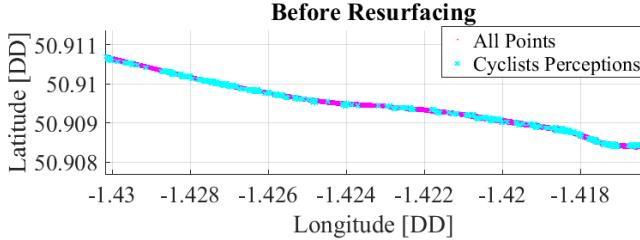
Fig. 8. Pre-resurfacing: perceived cyclist comfort along MRE

Fig. 8 and Fig. 9 show "heatmaps" of the real-time perceived cycling comfort before and after resurfacing of the MRE for all runs carried out. The pink dots represent the longitude and latitude coordinate data established using the iBike localization system (i.e. the trajectory), whereas the cyan blue crosses denote occurrences of uncomfortable vibration, as identified by the rider in real-time. As can be observed from the mapped data, instances of perceived uncomfortable vibrations have greatly reduced post-resurfacing, so cycling comfort has overall improved considerably. Nevertheless, Fig. 9 also shows that there are still certain locations along the road where cycling comfort has not changed even after resurfacing. This could be due to the fact that certain parts of the road have either not been resurfaced or modified, possibly in preparation for the

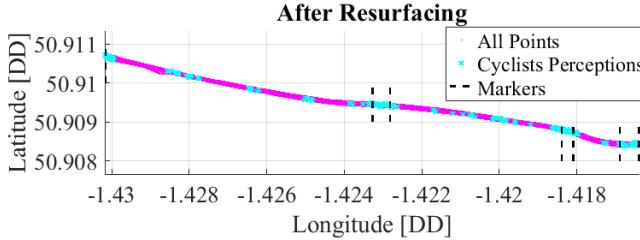
Fig. 9. Post resurfacing: perceived cyclist comfort along MRE

defects have been repaired through the resurfacing of MRE. However, instances of finishing "snags" in some parts of the surface appear to introduce new minor defects (*g*, *h* and *i*) that are not visible to the naked eye, and these still have some negative effect on the riding experience, as demonstrated both by the rider themselves and the analysis of the sensor data presented in Fig. 9 and Fig. 10 (after case).

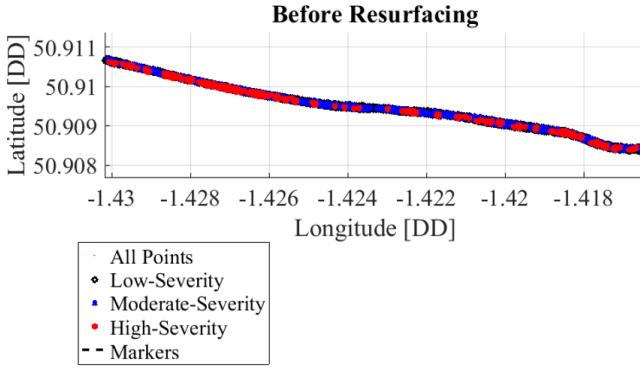
Fig. 10. Hit severity pre- and post-resurfacing along MRE

Subsequently, the vibration hit data with their magnitude and position values found through the analysis of the accelerometer data for all runs of the before- and after-resurfacing cases are depicted in Fig. 10, grouped by severity category. The locations of Markers A and C in the figure have been identified as parts of the road that have not been resurfaced, whereas the location of Marker B represents a speed hump. It is apparent that the number of high severity hits has considerably decreased in the after case, and visual examination of the data shows that it matches cyclist's perception depicted in Fig. 8 and Fig. 9.

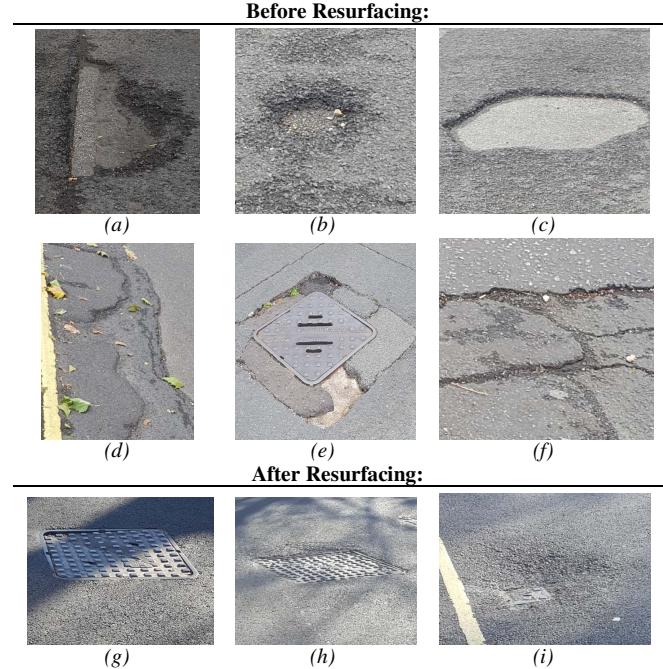
TABLE II. IMAGES OF DEFECTS ALONG MRE PRE AND POST RESURFACING

Examples of road pavement defects on MRE causing low, moderate and high severity hits before and after resurfacing are given in Table II. In the before case, some of the main discomfort instances were linked to pavement edge cracking (*a* and *d*), potholes of low, moderate and high severities (*b* and *c*), manholes (*e*) and longitudinal joint and alligator cracking of high severity (*f*). In the after case, most of these

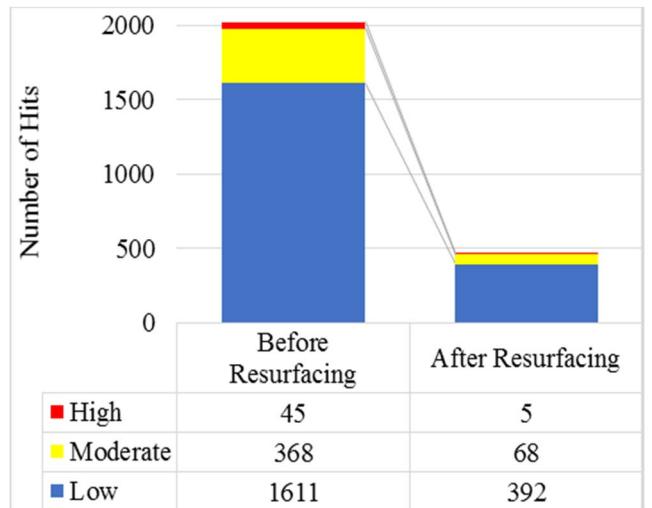
Fig. 11. Average number of vibration hits for pre-and-post-resurfacing

Fig. 11 shows the average number of hits for each severity category on MRE before and after resurfacing. Confirming the results of the previous sub-sections, it can be clearly seen that high-severity hits have on average reduced to single digits per run, while medium- and low-severity hit occurrences have reduced to a fifth and a quarter of their pre-resurfacing values respectively.

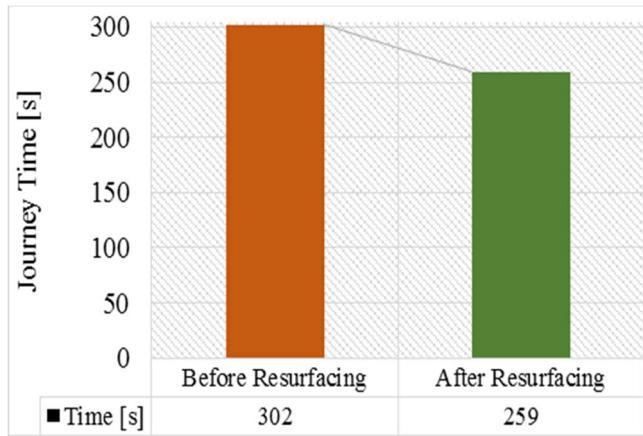
Fig. 12. Average journey time along MRE pre-and-post-resurfacing

Furthermore, it is also clear from Fig. 12 that on average the journey time for the after-case has reduced by 9 seconds along the 1 km surveyed route. This suggests that in the after-case the cyclist has been able to ride faster along the route because of the reduction of the discomfort caused by surface defects.

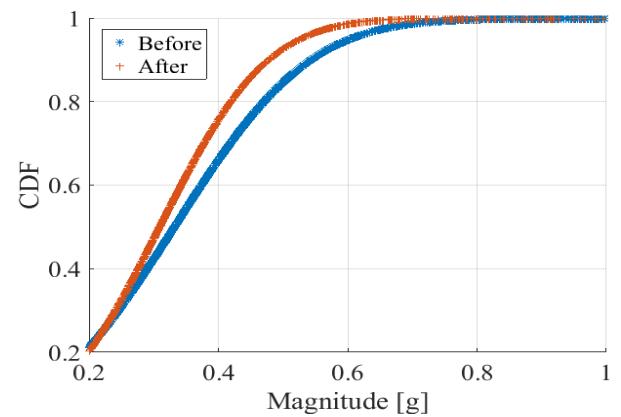
Fig. 13. Cumulative distribution function of all hits before and after

as a whole are computed for each run separately, and the mean values of all these are presented in Table IV. The results suggest that on average the magnitude has decreased by $0.023g$ across all hit severity levels, and this finding is statistically significant to the 0.05 level ($p = 0.000$). This represents a 7% reduction, and it can be clearly observed when plotting the cumulative distribution function (CDF) of the magnitude in Fig. 13, as the curve corresponding to the post-resurfacing case is shifted to the left compared to the pre-resurfacing one.

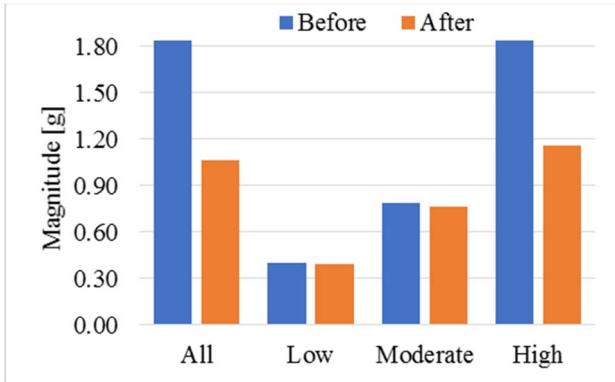
Fig. 14. Average maximum magnitude pre-and-post-resurfacing

The analysis of the average maximum and average standard deviation of the magnitude also delivers some interesting conclusions. In the case of the maximum values, as can be observed in Fig. 14, there appears to be a reduction in the average maximum hit magnitude per run, and this can be attributed to a clear reduction in the maximum magnitude of the high-severity hits. A similar pattern is also observed in the case of the average standard deviation (Fig. 15), where it appears that a slight decrease in overall hit magnitude variability is attributed to a clear reduction in the variability of the high-severity hits.

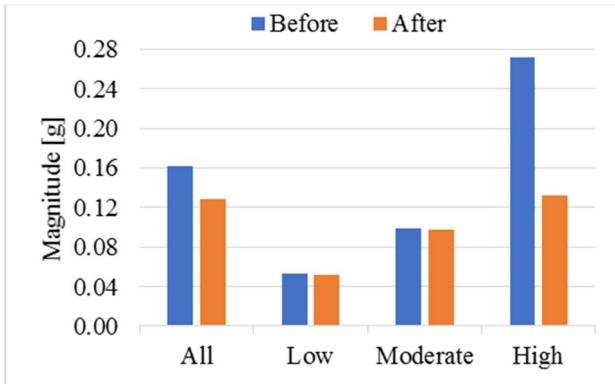
Fig. 15. Average standard deviation of magnitude pre-and-post-resurfacing

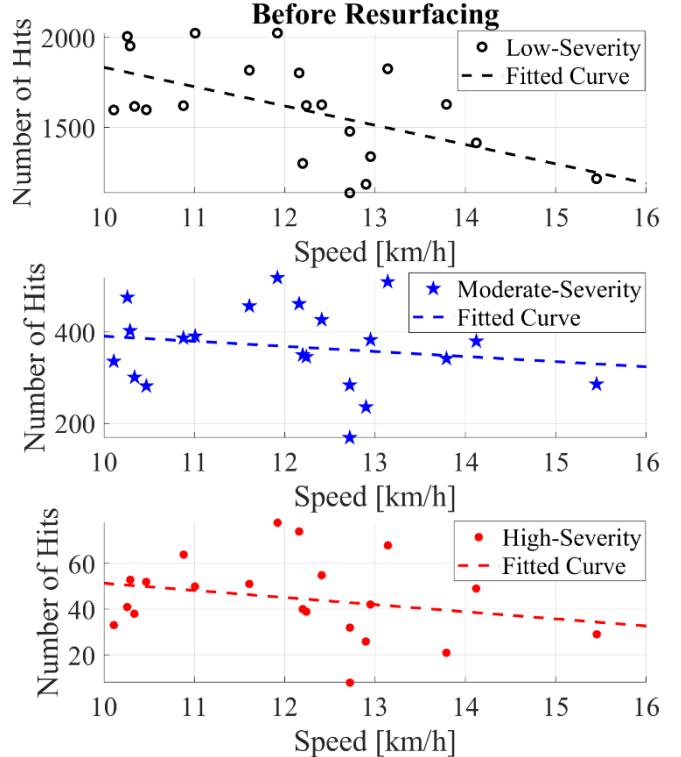
Fig. 16. Pre-resurfacing: cycling speed and number of hits

Fig. 16 presents the relation between cycling speed and number of hits before resurfacing for the three-hit severity categories; each data point on the three graphs represents one experiment run on MRE. As can be observed, there appear to be more low-severity hits when the cycling speed is low, but as the speed increases, the number of low-severity hits reduces; this is an unexpected finding. A possible explanation could lie in the fact that, previously low-severity, hits may be becoming moderate- or even high-severity ones, because many of the existing widespread potholes, humps and other defects are hit at higher speed. A similar, yet considerably weaker, association appears to exist between the number of moderate- and high-severity hits and the cycling speed. This suggests that the widespread and largely unavoidable pavement defects on the pre-resurfacing MRE pavement result in the number of moderate- and high-severity hits being unaffected by the cycling speed.

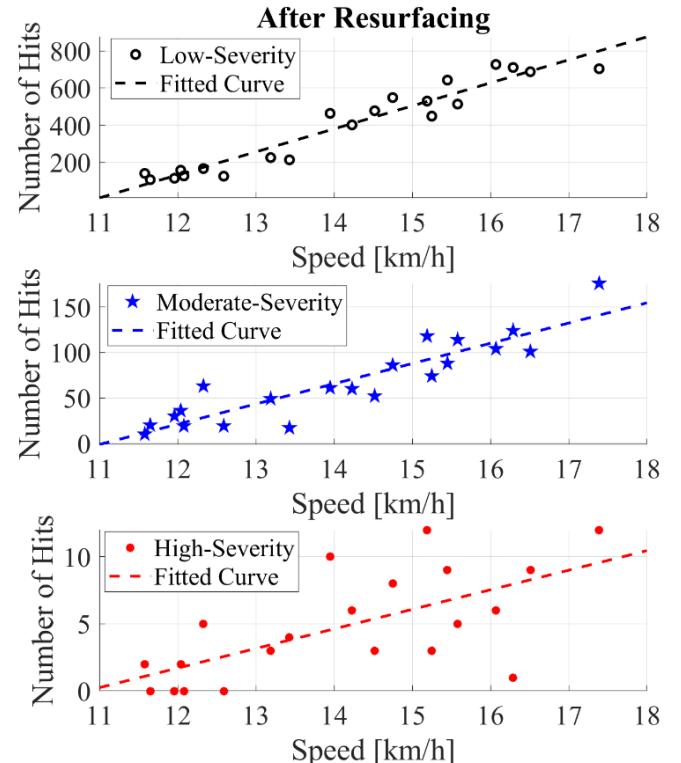
Fig. 17. Post-resurfacing: cycling speed and number of hits

Considering the post-resurfacing case of MRE, the relation between speed and number of hits is depicted in Fig. 17. As can be observed, there appears to be an opposite relation between the two parameters compared to the before-case, as higher travel speed is associated with a higher number of hits across all three severity categories. This can be attributed to the fact that most pre-resurfacing defects on MRE have been repaired/removed, and the selected few ones

remaining are avoidable by swerving. As such, when riding slowly, it is possible to swerve around the defects, which results in lower numbers of hits, but when riding faster, it is more difficult to avoid the defects, so a higher number of hits occurs. Thus, post-resurfacing cycling comfort appears to be more strongly dependent on cycling speed than in the before-case, where speed plays a less important part.
