2 **Retrofitting Seismically Damaged Steel sections encased Concrete Composite**

3 **Walls using Externally Bonded CFRP Strips**

4 Fang-Jin Sun¹, Shao-Hua Pang², Zhong-Wen Zhang², Feng Fu³, and Kai Qian^{1*}

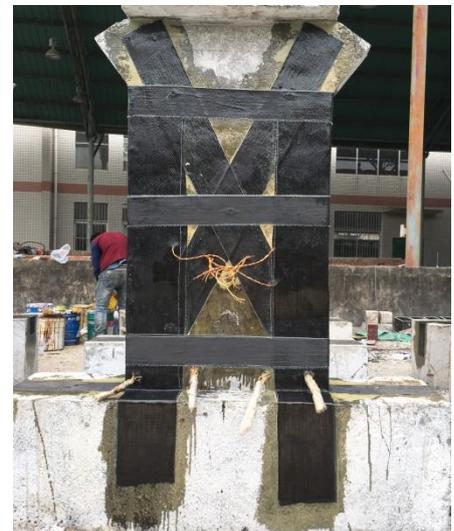
Fig. 8 Strengthening Scheme 1: (a) drawing, (b) photo

133 The repairing scheme was designed based on the failure mode of the control specimens. As
134 shown in **Fig. 8a**, for Specimens RW2 and RW3, repairing scheme 1 was adopted. Firstly, two layers
135 of diagonal strips with width of 150 mm were attached to both face of the wall to restoring the shear
136 strength (the diagonal cracks were just injected by mortar). Secondly, two layers of C-shaped CFRP
137 sheet were attached at both flange of the wall as the fracture of channel steel was not repaired. The
138 layer of C-shaped CFRP sheet was determined using Eq. 1. As shown in the figure, to fully develop
139 the strength of C-shaped CFRP sheet, the sheets were extended enough length in three directions.

144 Finally, CFRP strips with width of 100 mm was wrapped the wall with spacing of 500 mm to
145 delay the debonding of the CFRP strips or sheets. Specimen RW4 was repaired by CFRP scheme 2.
146 Different to RW2 and RW3, the diagonal strips were replaced by vertical strips with width of 100
147 mm, distributed with spacing of 360 mm. Regarding the C-shaped CFRP sheets and horizontal
148 wrapped CFRP strips, identical to that of scheme 1.

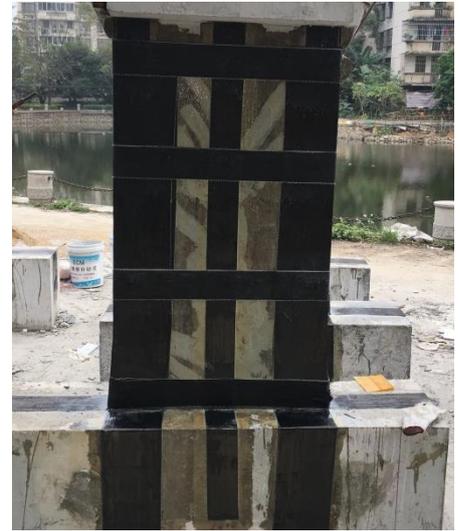
Fig. 9 Strengthening Scheme 2: (a) drawing, (b) photo

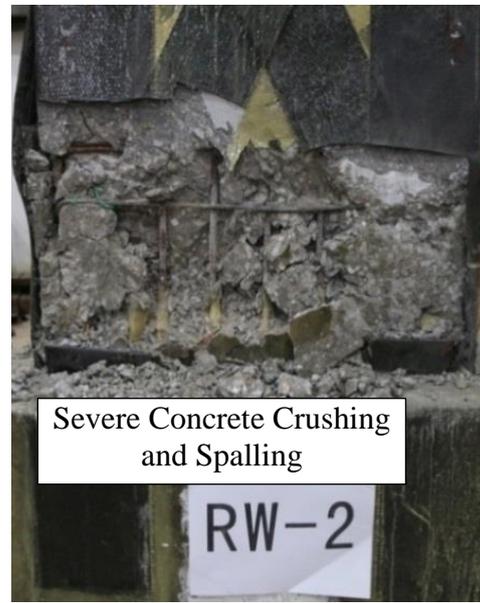
Fig. 11 Failure mode of repaired specimen RW2: (a) before cutting FRP strips, (b) after removal of partial of CFRP strips

166 Similar to RW1, before reaching DR of 0.75 %, no crack and CFRP debonding occurred. At DR of
167 0.75 %, the lower part of the diagonal strip began to debond slightly and sound due to debonding was
168 heard. At DR of 1.0 %, the lowest horizontal wrapping began to debond. Further increase of the DR
169 to 1.5 %, C-shaped CFRP sheets at the corner of the wall began to form bulk, which means severe
170 concrete crushing at there. At DR of 1.75 %, the lowest horizontal wrapping strips and diagonal sheet
171 debonded severely and the debonding zones were connected. Further increase the DR to 2.25 %, the
172 middle part of the horizontal wrapping delaminated completely, and severe concrete crushing
173 occurred at the corner of the wall. **Fig. 11** shows the failure mode of Specimen RW2. In general, it
174 was very similar to that of RW1. Severe concrete spalling and crushing were observed at the lower

175 part of the wall. Completely delaminating was observed at lower part of the diagonal strips. CFRP
176 bulk and rebar buckling was observed at both corner of the wall after severe concrete crushing.

278 As shown in **Figs. 10** and **11**, replacing the buckled rebar and applied CFRP scheme 1 resulted in
279 severe concrete crushing at the bottom corner of the walls as well as severe tearing of CFRP sheet at
280 both sides. However, as shown in **Fig. 12**, if we did not replace the buckled rebar but only applied
281 CFRP scheme 1, the concrete crushing and tearing of CFRP was less severe which was mainly due
282 to less compressive stress required. However, comparison of **Figs. 12** and **13**, RW4, which was
283 retrofitted by CFRP scheme 2 but without replacing buckled rebar, has more severe debonding of
284 CFRP strips and more severe of concrete crushing and tearing of CFRP sheet at bottom corner of the
285 wall.

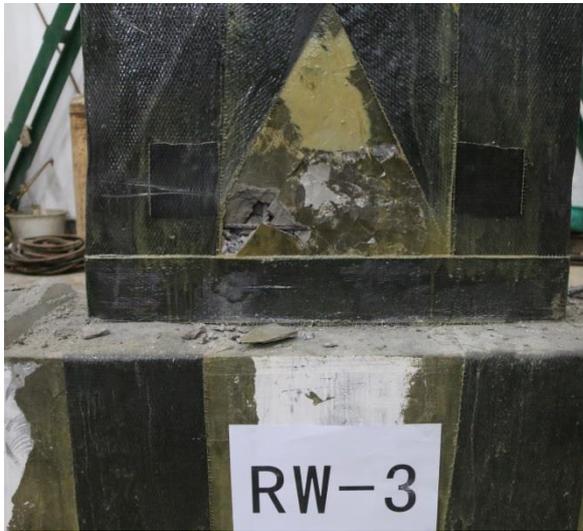
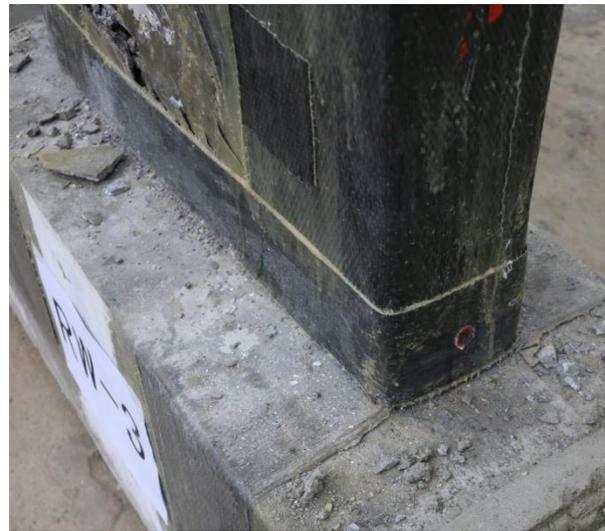
Fig. 12 Failure mode of repaired specimen RW3: (a) front view, (b) side view

178 Similar to RW1 and RW2, the debonding was first observed at the diagonal strip at a DR of 0.75 %.
179 At a DR of 1.0 %, debonding was also occurred at the lowest horizontal wrapping. Slight debonding
180 was observed at C-shaped sheet at DR of 1.25 %. Concrete crushing at the corner of the wall was
181 observed at DR of 1.5 %. Further increase of DR, more concrete crushing and debonding was
182 observed. The failure mode of Specimen RW3 is shown in **Fig. 12**. As shown in the figure, the
183 concrete spalling at the front face of the wall was also milder. Moreover, the debonding of C-shaped
184 sheets and concrete crushing at the wall corner was much milder. This could be explained by the
185 fractured or buckling rebar was not replaced. There was the demand of compressive force from
186 concrete was less when flexure strength was considered.

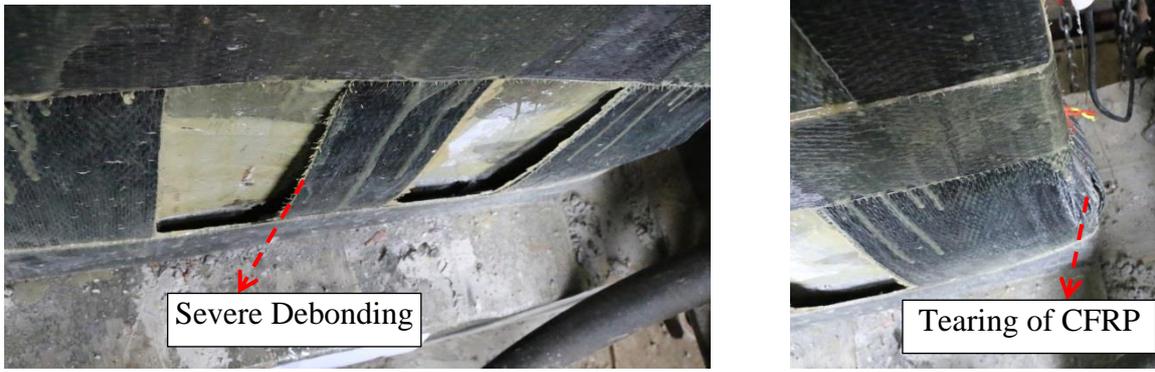
Fig. 13 Failure mode of repaired specimen RW4: (a) front view, (b) side view

188 Different to above three specimens, RW4 was repaired by CFRP rehabilitation scheme 2. Debonding
189 of CFRP was observed at the right vertical strip at DR of 0.5 %, which was earlier than above three
190 specimens. Tearing was observed at the right vertical strip at DR of 0.75 %. At DR of 1.0 %,
191 debonding was also observed at the lowest horizontal wrapping strips. At DR of 1.25 %, middle
192 vertical strips began to debond and the debonding of the lowest horizontal wrapping strip becomes
193 more severe. Further increase the DR to 1.5 %, CFRP bulk becomes more obvious at the corner of
194 the wall, which means concrete crushing becomes more severe. Further increasing DR to 2.0 %, the
195 debonding zone at the lower part of the wall connected and CFRP strips at the lower part of the wall
196 quit work. **Fig. 13** shows the failure mode of Specimen RW4. As shown in the figure, severe
197 delaminating was observed at the lower part of the wall. Similar to RW3, concrete crushing was

198 much milder than that of RW1 and RW2.
