**Citation:** Cai, B., Wu, A. & Fu, F. (2020). Bond behavior of PP fiber-reinforced cinder concrete after fire exposure. *Computers and Concrete, An International Journal*, 26(2), pp. 115-125. doi: 10.12989/cac.2020.26.2.115

# Bond behavior of PP fiber-reinforced cinder concrete after fire exposure

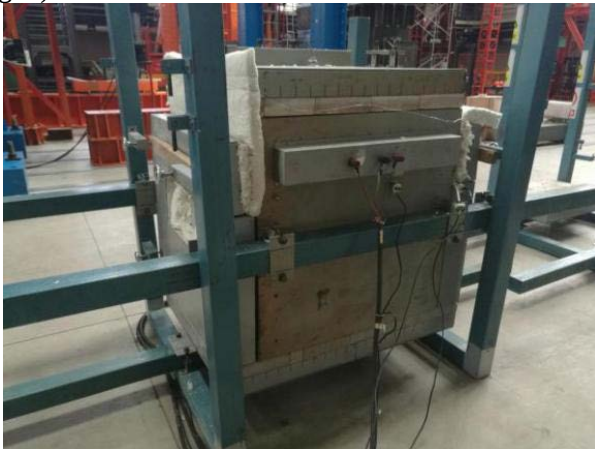
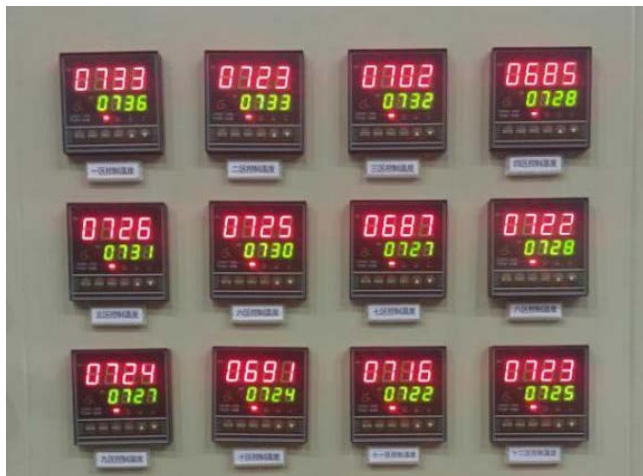
Fig. 3 Electric oven for heating

divided into 5 groups (each 10 specimens) according to heating temperature, including room temperature (RT), 200, 400, 600 and 800 °C. Firstly, the specimens were dried in oven at 100 °C for 24 h, and then heated in a computer-controlled electric oven at the rate of 10 °C/min until reaching the target temperature (Fig. 3).

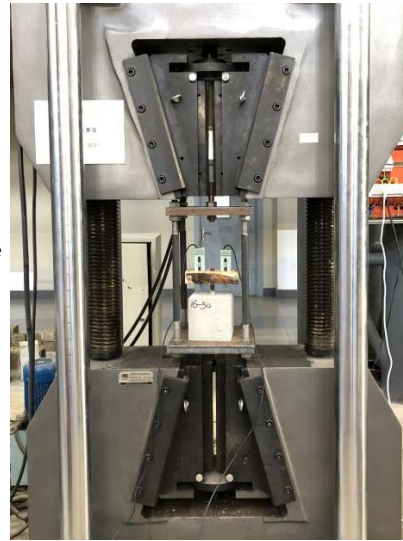
Fig. 7 Pull-out experimental installation

The similar instrumentation of the tests (Fu,2010, Gao,2017, Qian 2020 and Wen 2020,Deng,2020,Guo,2019) was adopted. The pull-out tester was illustrated in Fig. 7. Each specimen was restrained by a steel frame, which consisted of two 30-mm-thick rebar plates and five 25-mm-diameter rebar bars. The frame was clamped by an MTS (Maximum test force: 2000KN, indication accuracy: <1%, motor power: 0.75kW, operating voltage: 380V/220V) loading frame. The rebars of a specimen passed through the reserved hole on the lower plate and was clamped by the lower clamping device. Lubricating oil was

painted in between each specimen and the bottom plate, so as to reduce the specimen-rebar friction during the pull-out tests. Two displacement meters were installed on the top of each specimen to measure the relative slip of the rebar to the specimen, and the pull force was recorded by the force meter of the loading frame. The bond strength of PP fiber-reinforced cinder concrete was calculated as follows:
