‘Measuring the Monument’ – Fibre Optic Sensor Systems show why Hooke’s and Wren’s plans for a Giant Telescope within the Monument in London failed

Matthias Fabian^{a,b,c}, Joanna M. Coote^a, Philip J. Thomas^c, Michael Mainelli^d, Tong Sun^{a,b}, Kenneth T. V. Grattan^{a,b,c}

ABSTRACT

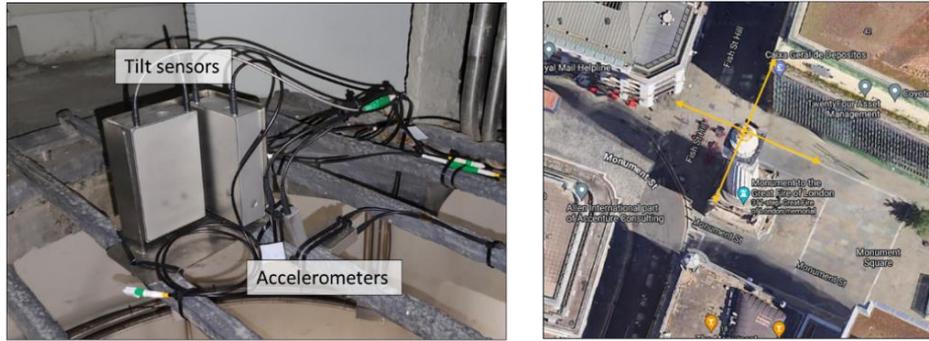
Figure 3. Sensors installed in the flame room of the monument (left). Orientation of the tilt sensors (right) with respect to the surrounding buildings.

In light of the constraints, a careful design of the sensor system was undertaken, in which two tilt sensors were securely fixed to a mounting bracket and oriented perpendicular to one another. To meet the constraints, the bracket was then fixed in the centre of a metal grille that spanned the cross-section of the Monument, near the top of the staircase in the Flame Room above the visitor gallery (as shown in Figure 3). A compass was used to align the tilt sensor axes with the adjoining Fish Street Hill, which runs approximately north to south, and along the line from Monument Street to Monument Square, running approximately east to west. In this way, two fibre optic based accelerometers were also fixed to the grille, oriented horizontally and vertically, i.e. perpendicular and parallel to the central axis of the Monument itself.
