# **CAVITATION EROSION OF ENGINEERING MATERIALS**

**THESIS PRESENTED FOR THE  
DEGREE OF DOCTOR OF  
PHILOSOPHY**

**DEPARTMENT OF MECHANICAL  
ENGINEERING AND AERONAUTICS  
THE CITY UNIVERSITY  
LONDON**

**AUGUST 1993**

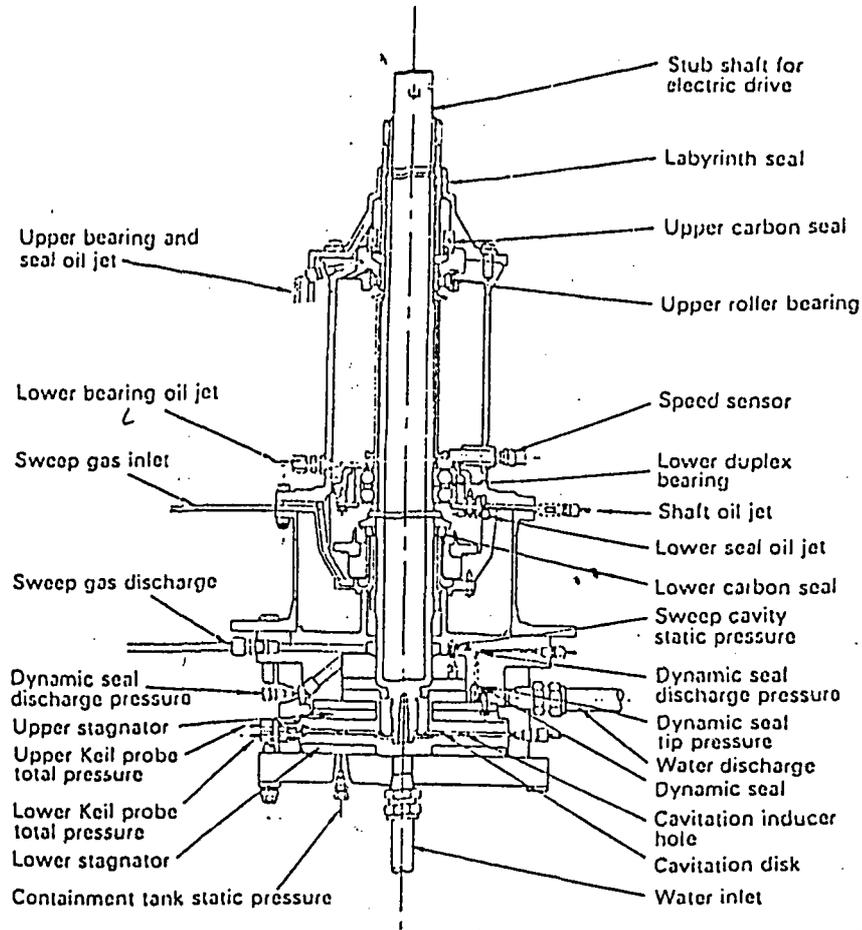
Fig.3a Cross section of a vertically mounted disc

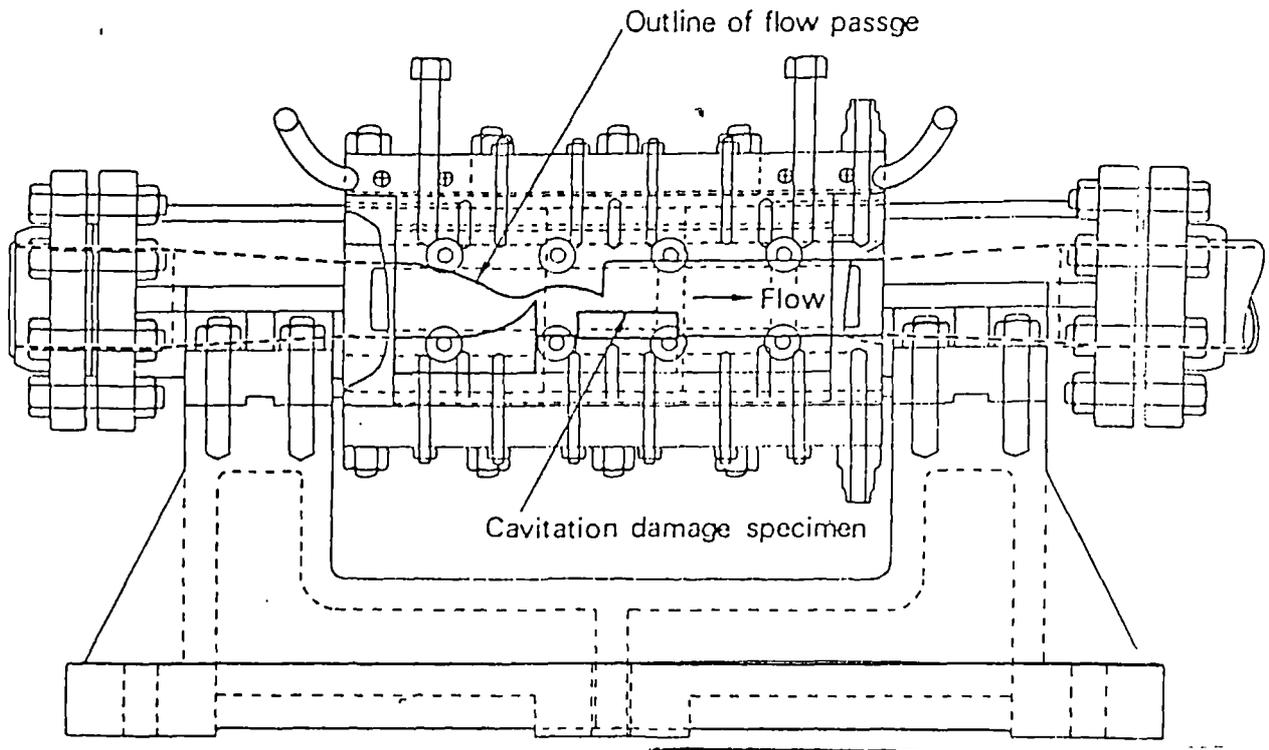
Fig.7 Holtwood Laboratory cavitation-damage test section (Mousson 1937)

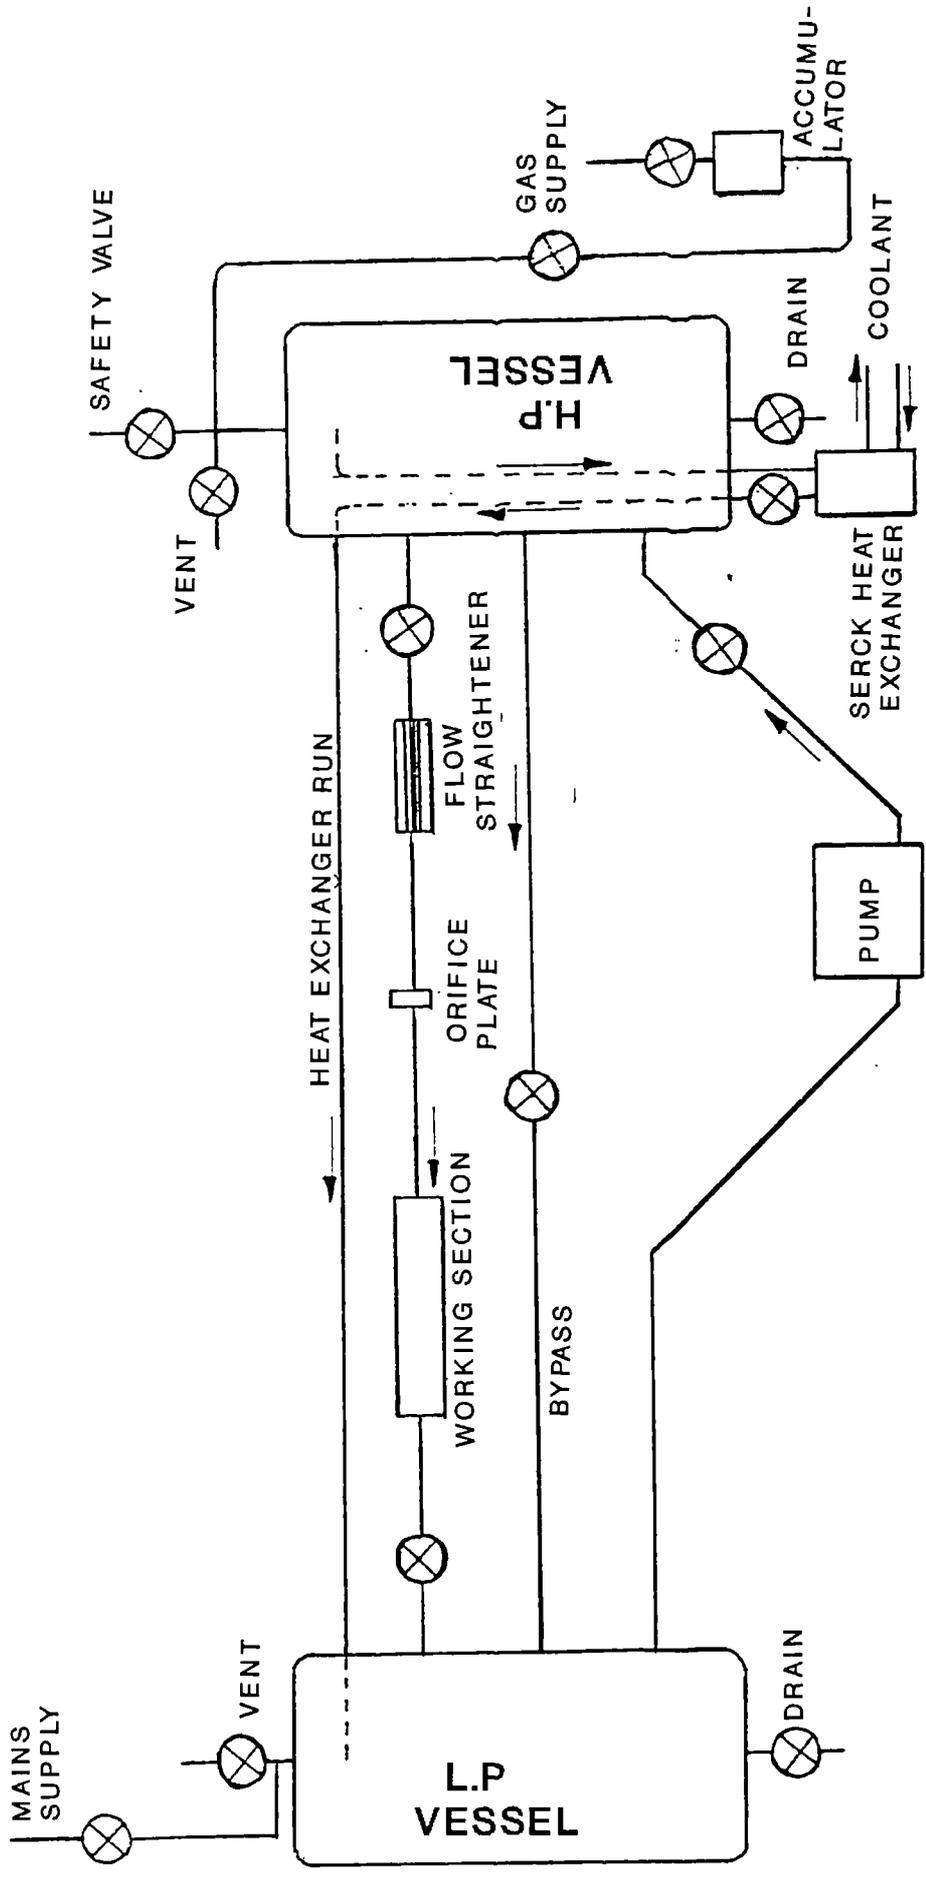
Fig.20 CAVITATION EROSION TEXT FACILITY

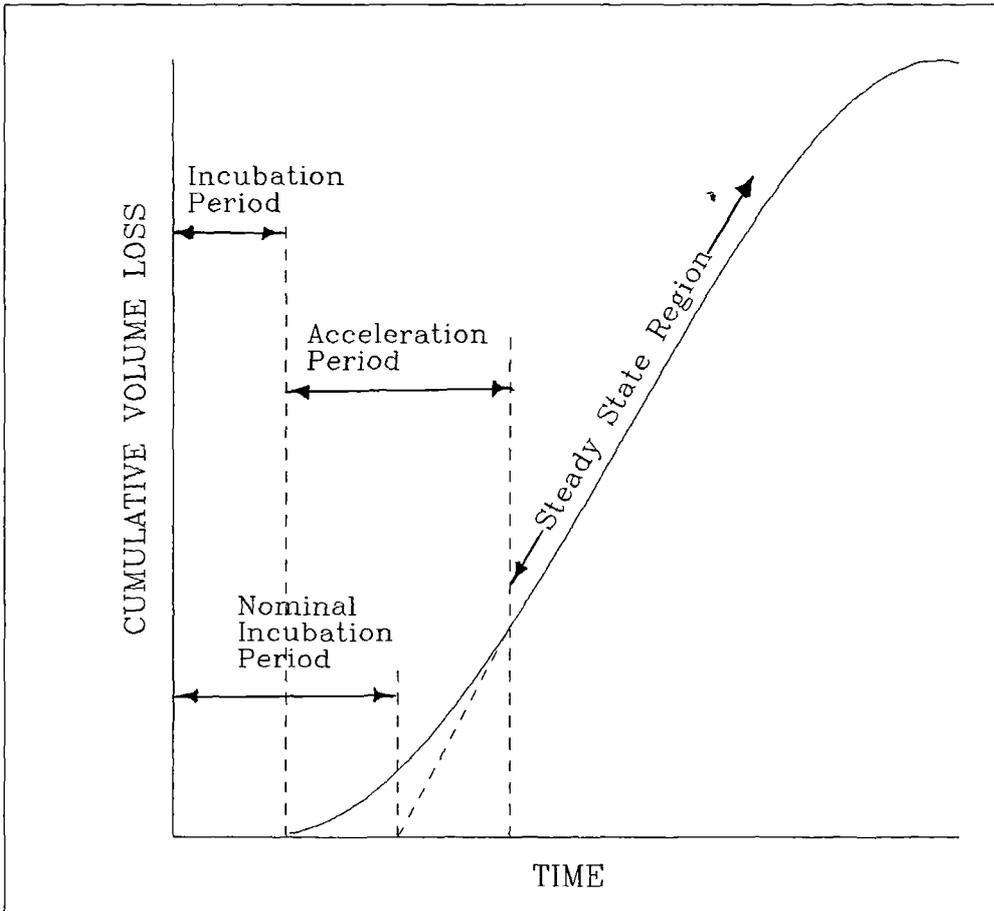
Fig26A. Typical Cumulative Volume loss Versus Time Behaviour

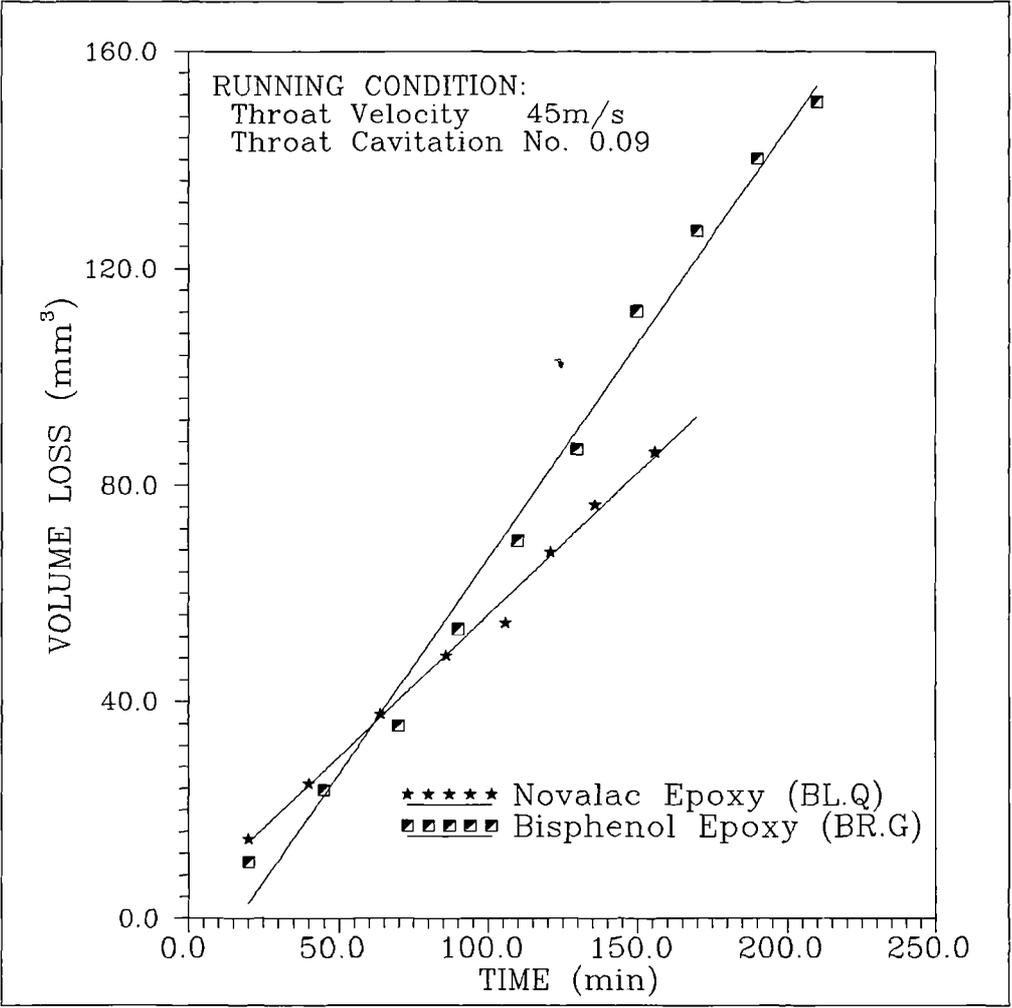
Fig.41 COMPARISON BETWEEN EPOXY RESIN SYSTEMS  
 IN THE MACHINED CONDITION AT 45 m/s

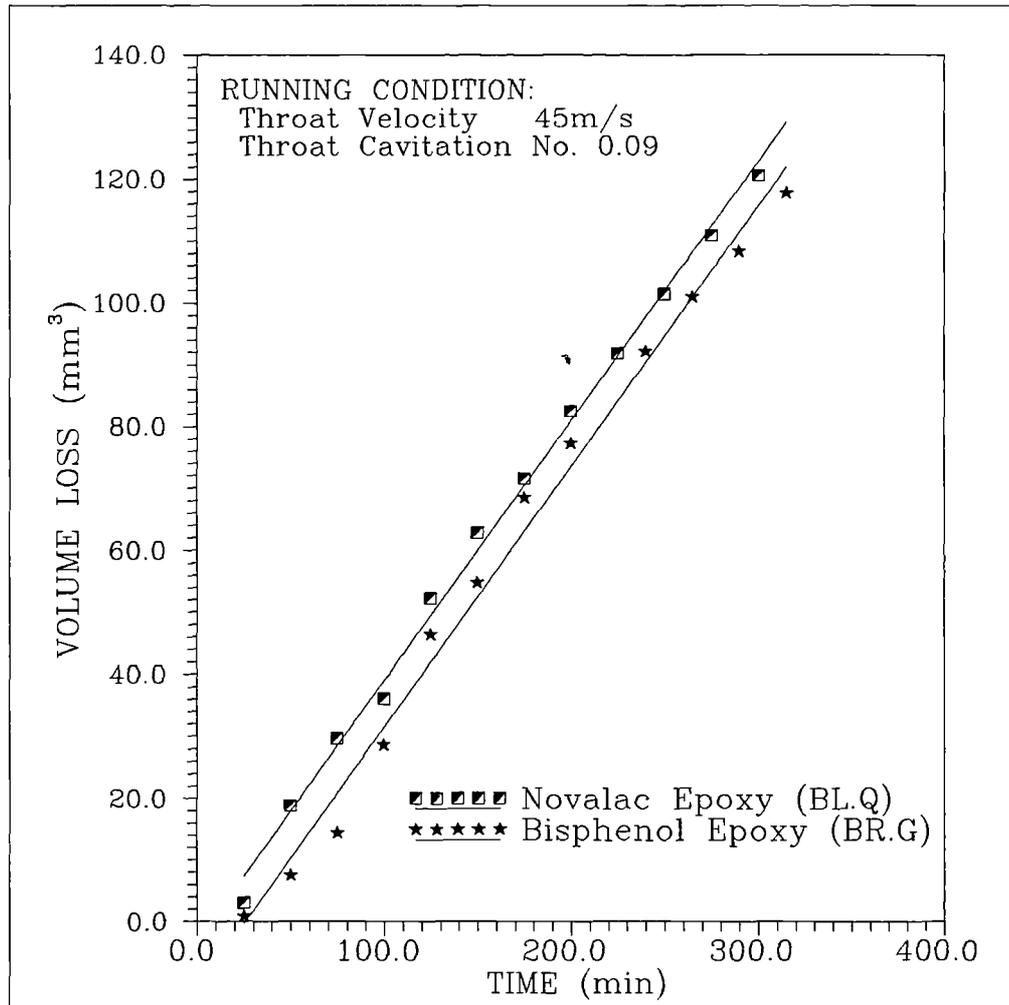
Fig.42 COMPARISON BETWEEN EPOXY RESIN SYSTEMS  
 IN THE AS CAST CONDITION AT 45 m/s

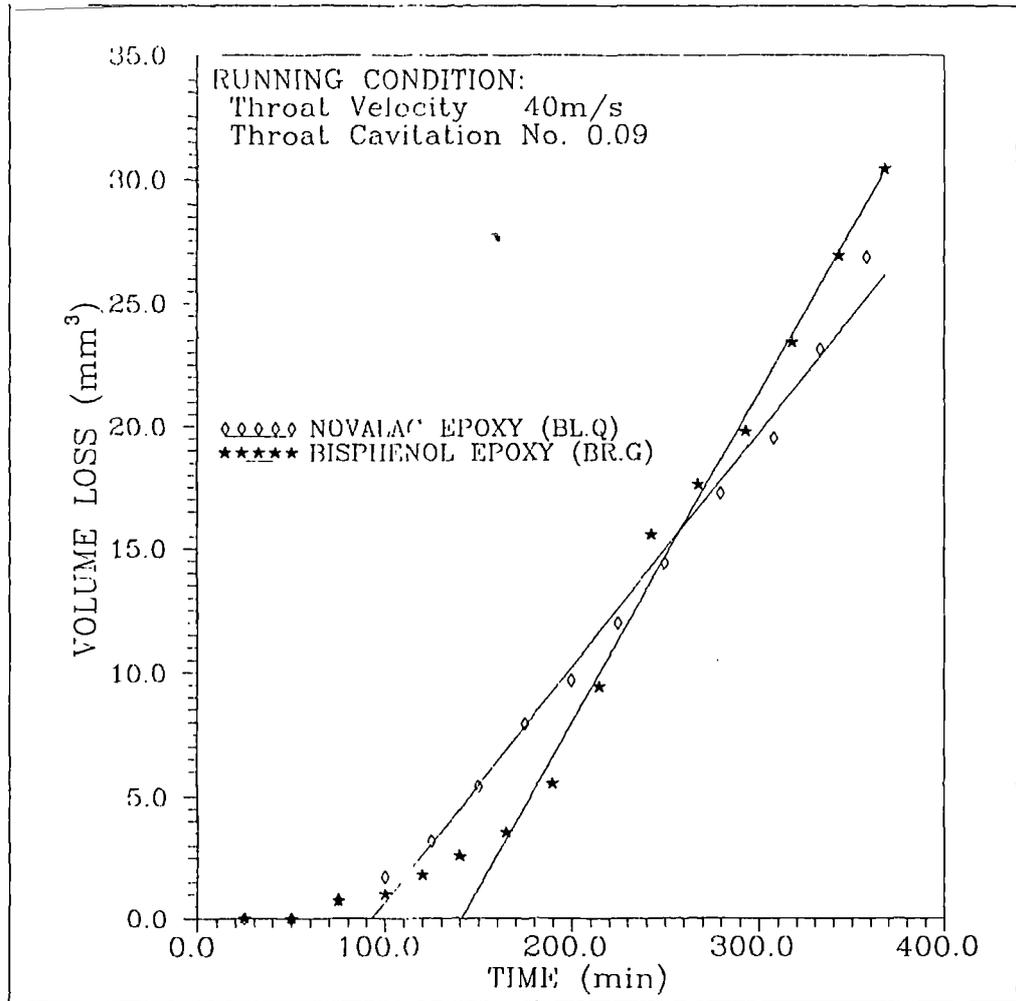
Fig.43 COMPARISON BETWEEN EPOXY RESIN SYSTEMS  
IN THE AS CAST CONDITION

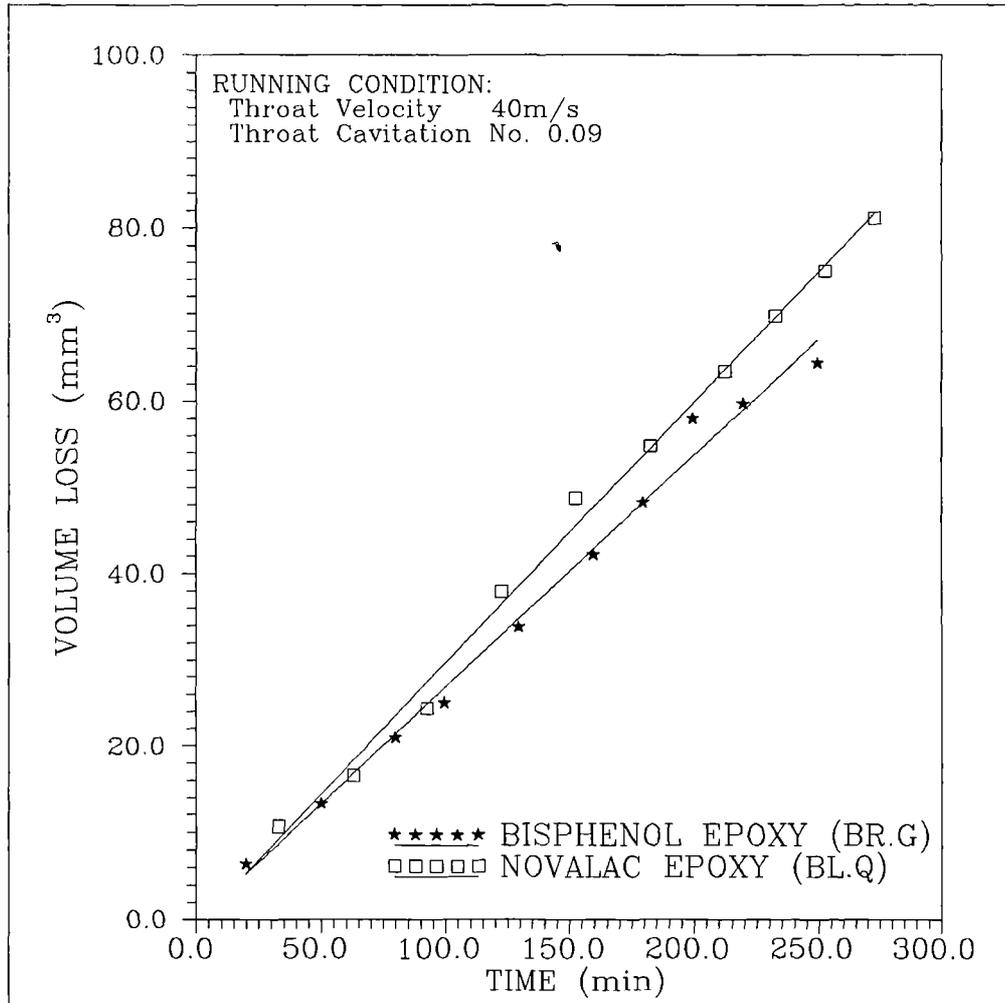
Fig.44 COMPARISON BETWEEN EPOXY RESIN SYSTEMS  
IN THE MACHINED CONDITION

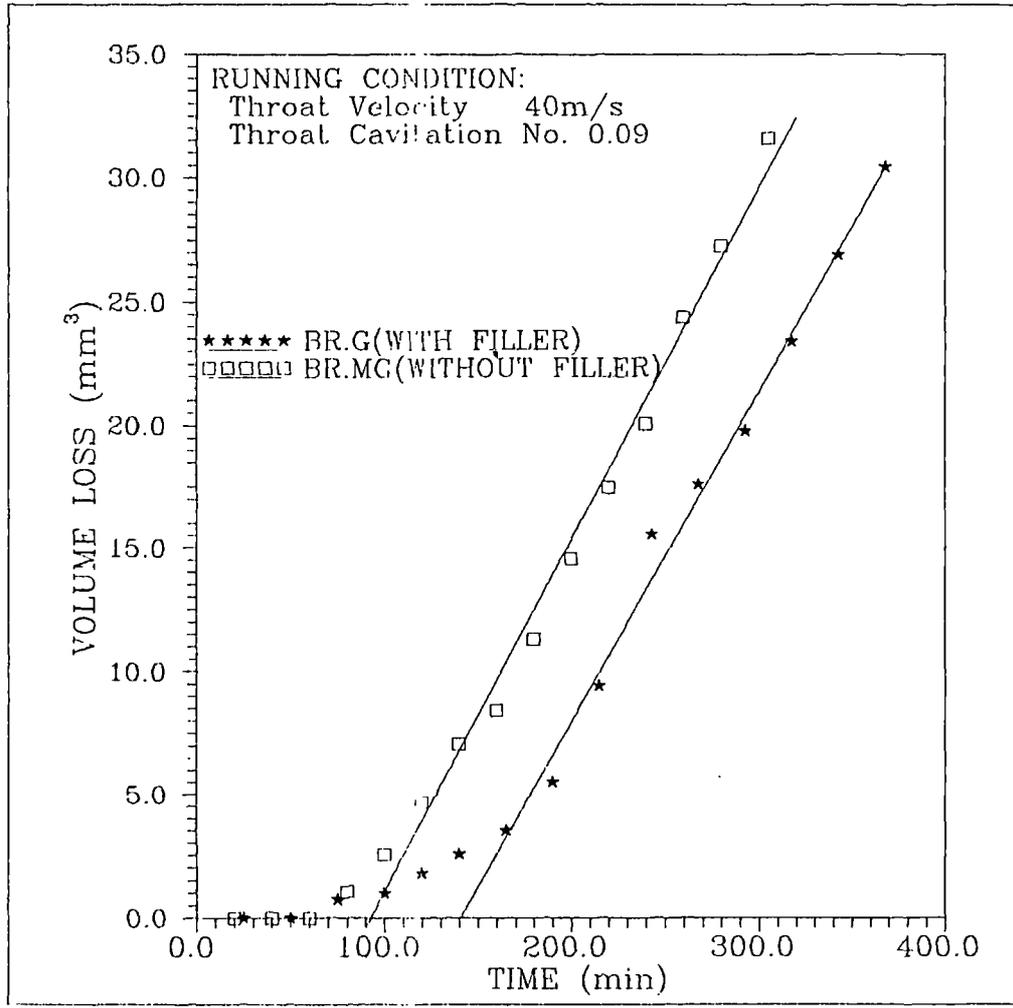
Fig.45 COMPARISON GRAPH OF BISPHENOL EPOXY RESIN WITH AND WITHOUT PARTICULATE FILLER IN AS CAST

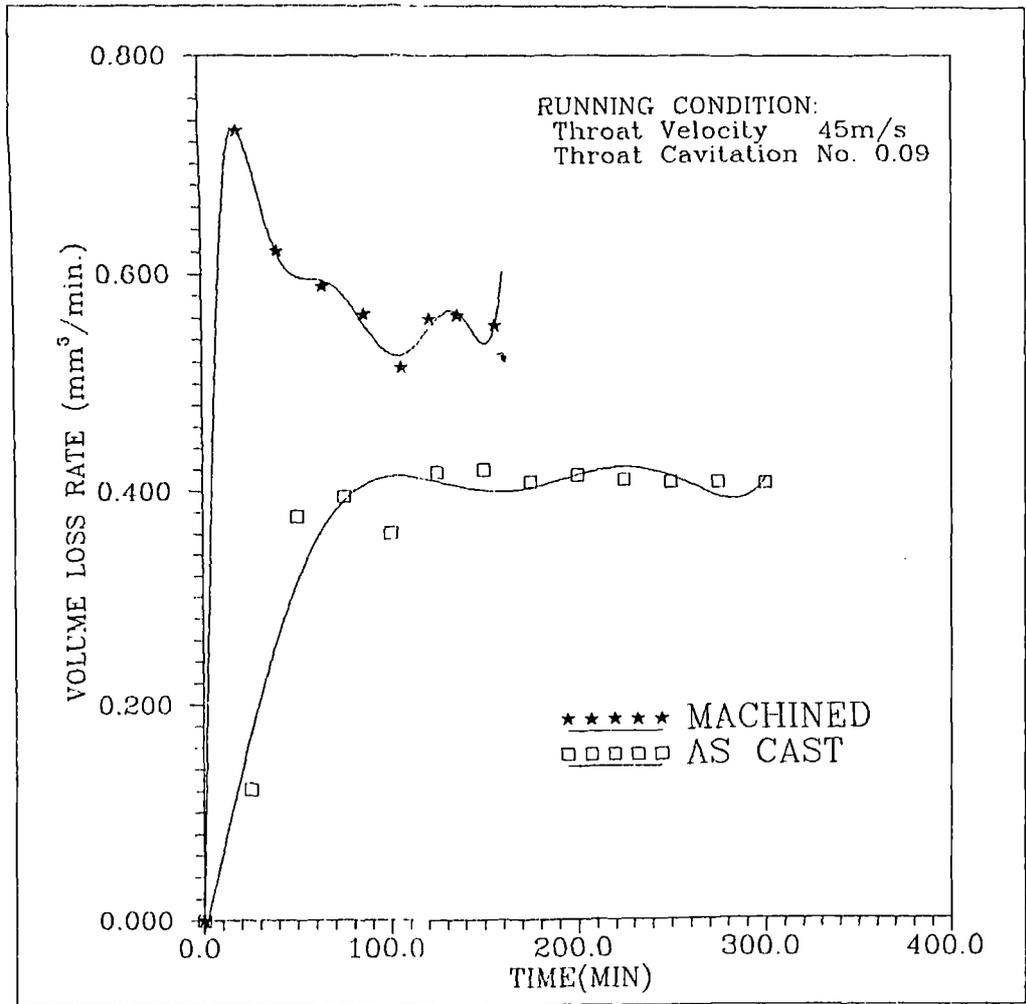
Fig.47 EROSION RATE-TIME CURVES FOR NOVALAC EPOXY RESIN (BL.Q) IN AS CAST AND MACHINED CONDITIONS

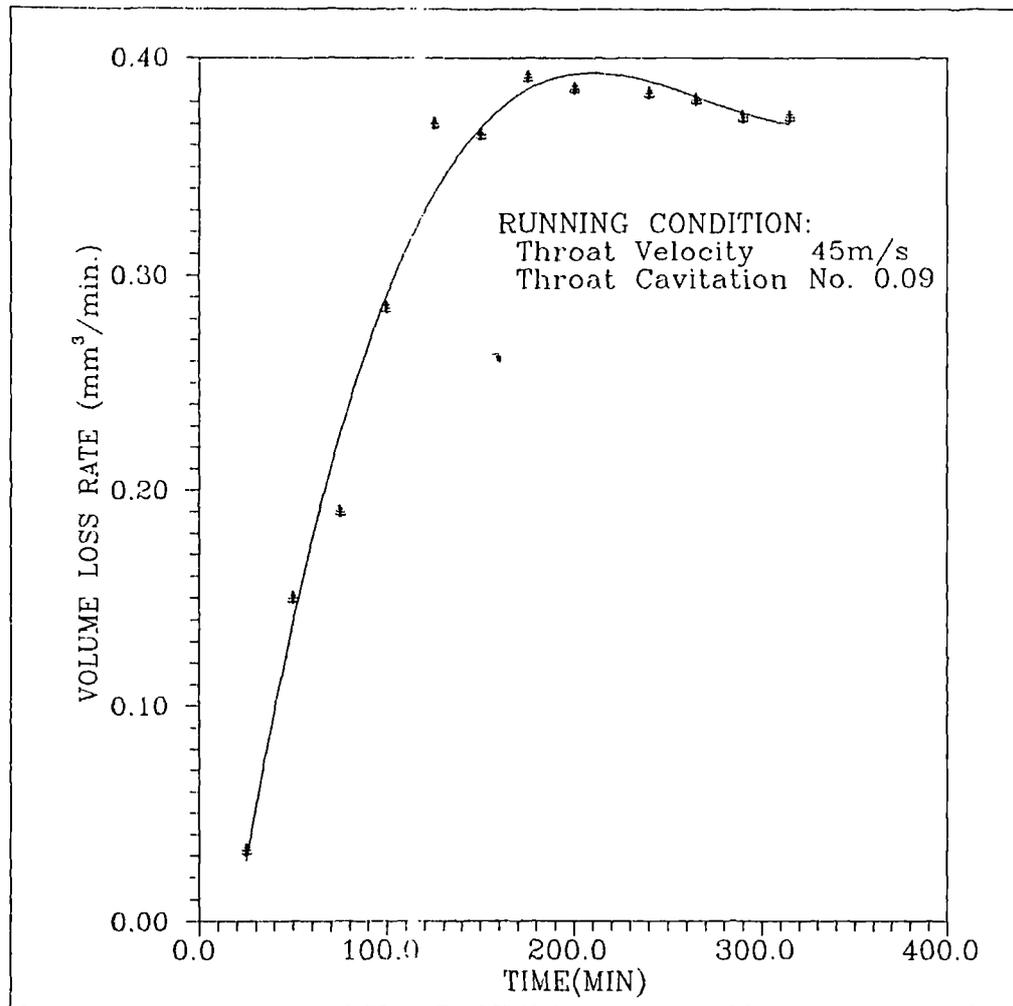
Fig.48 EROSION RATE-TIME CURVE FOR BISPHENOL EPOXY RESIN SYSTEM (BR.G)IN AS CAST

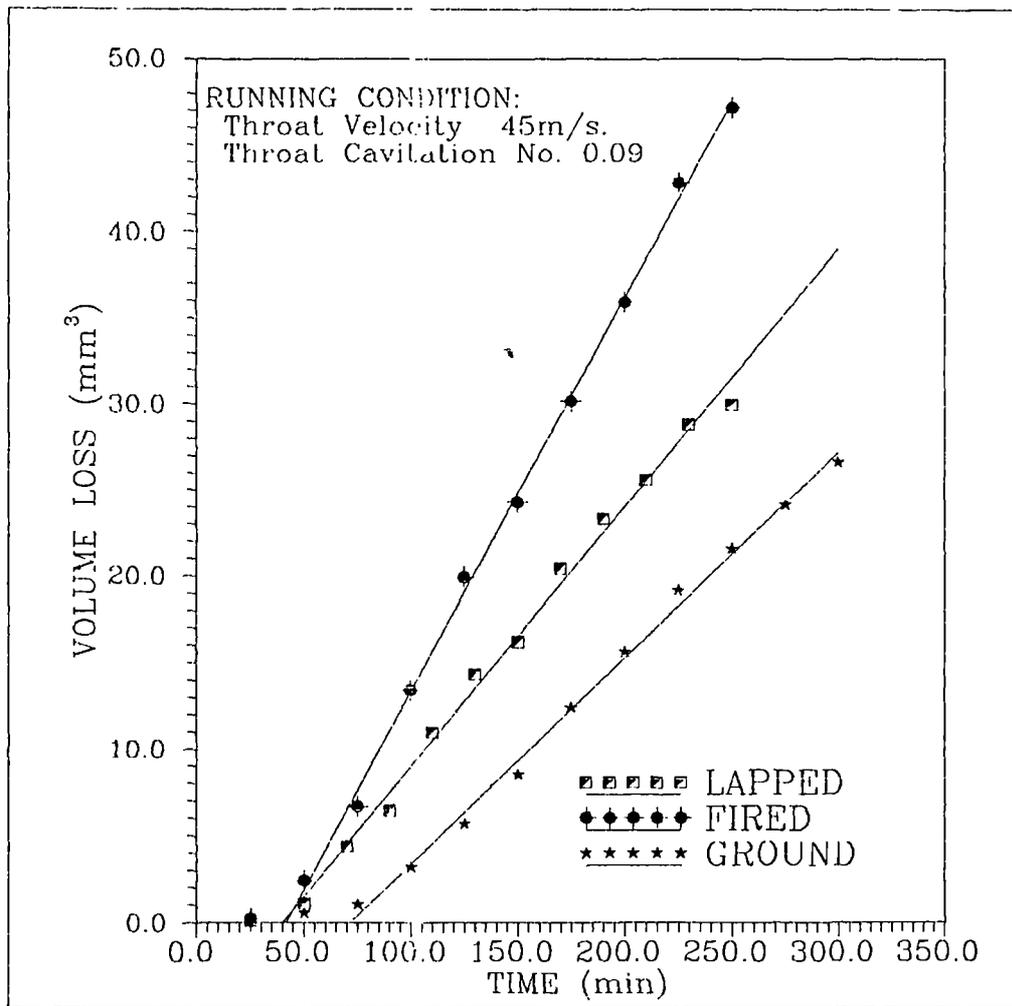
Fig.56 COMPARISON OF SILICON CARBIDE IN AS LAPPED,  
GROUND AND FIRED CONDITIONS

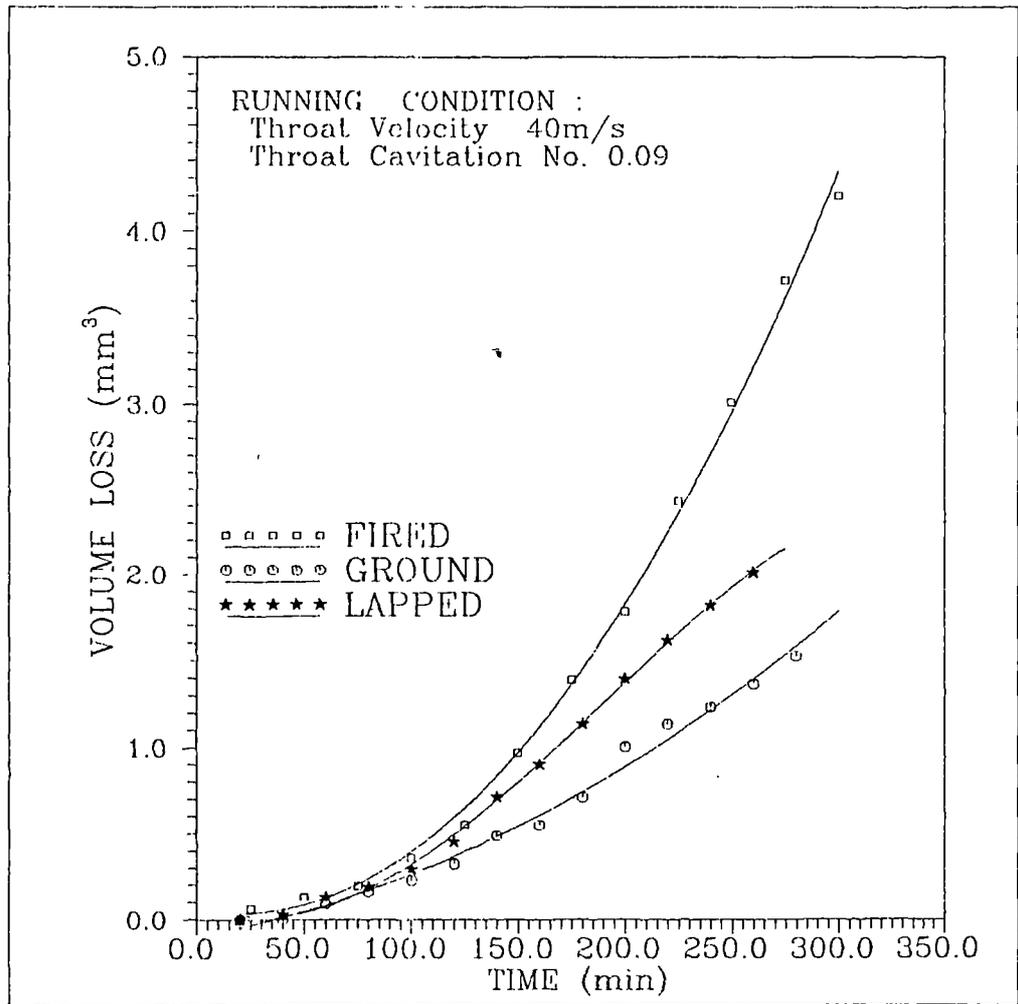
Fig.57 COMPARISON OF SILICON CARBIDE IN AS LAPPED,  
GROUND AND FIRED CONDITIONS

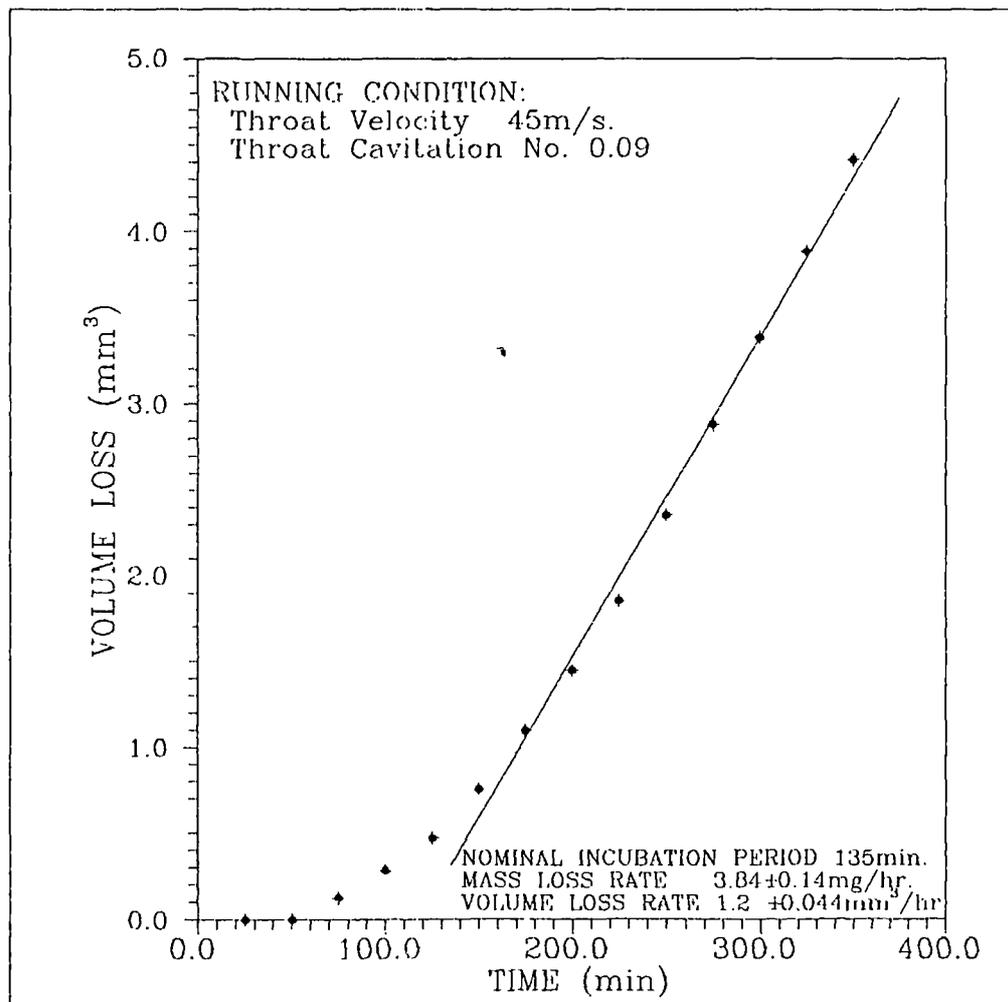
Fig.58 CUMULATIVE VOLUME LOSS AGAINST TIME  
FOR SILICON NITRIDE AS GROUND

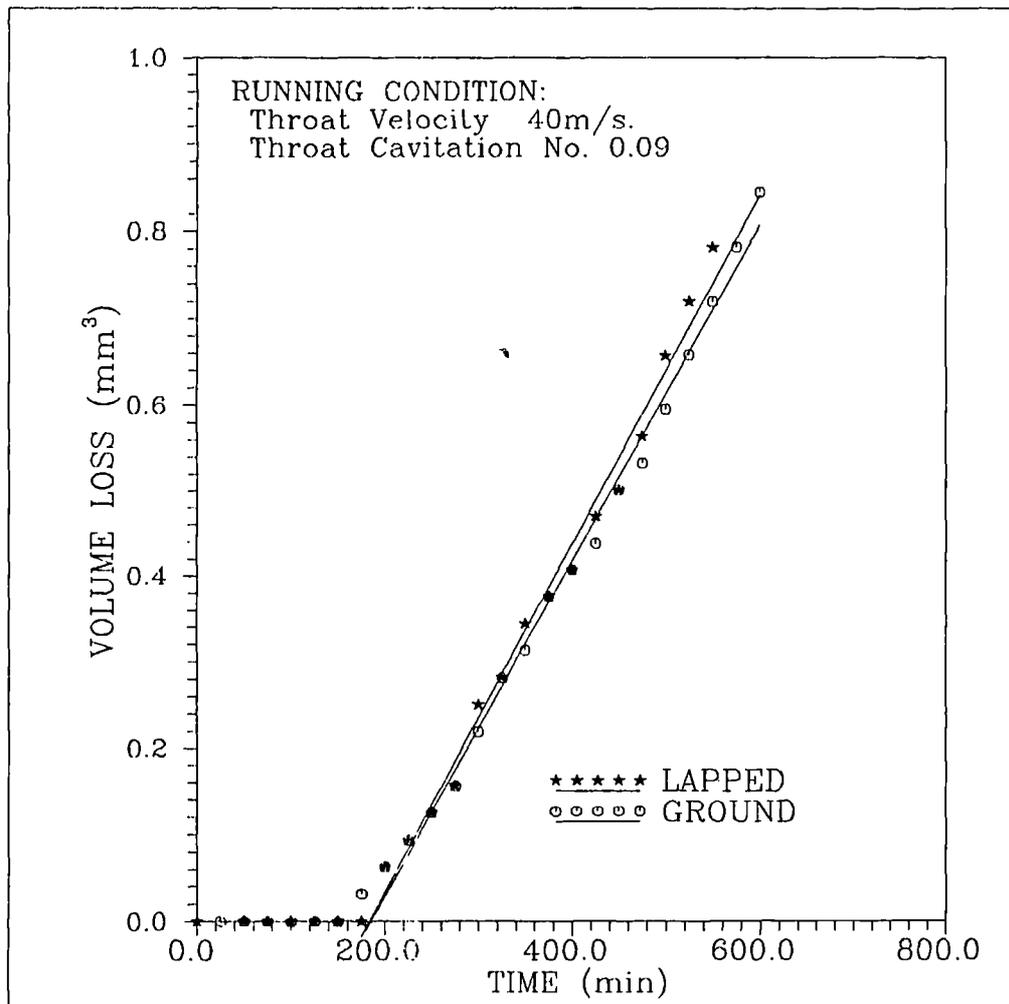
Fig.61 COMPARISON OF SILICON NITRIDE IN AS  
LAPPED AND GROUND CONDITIONS

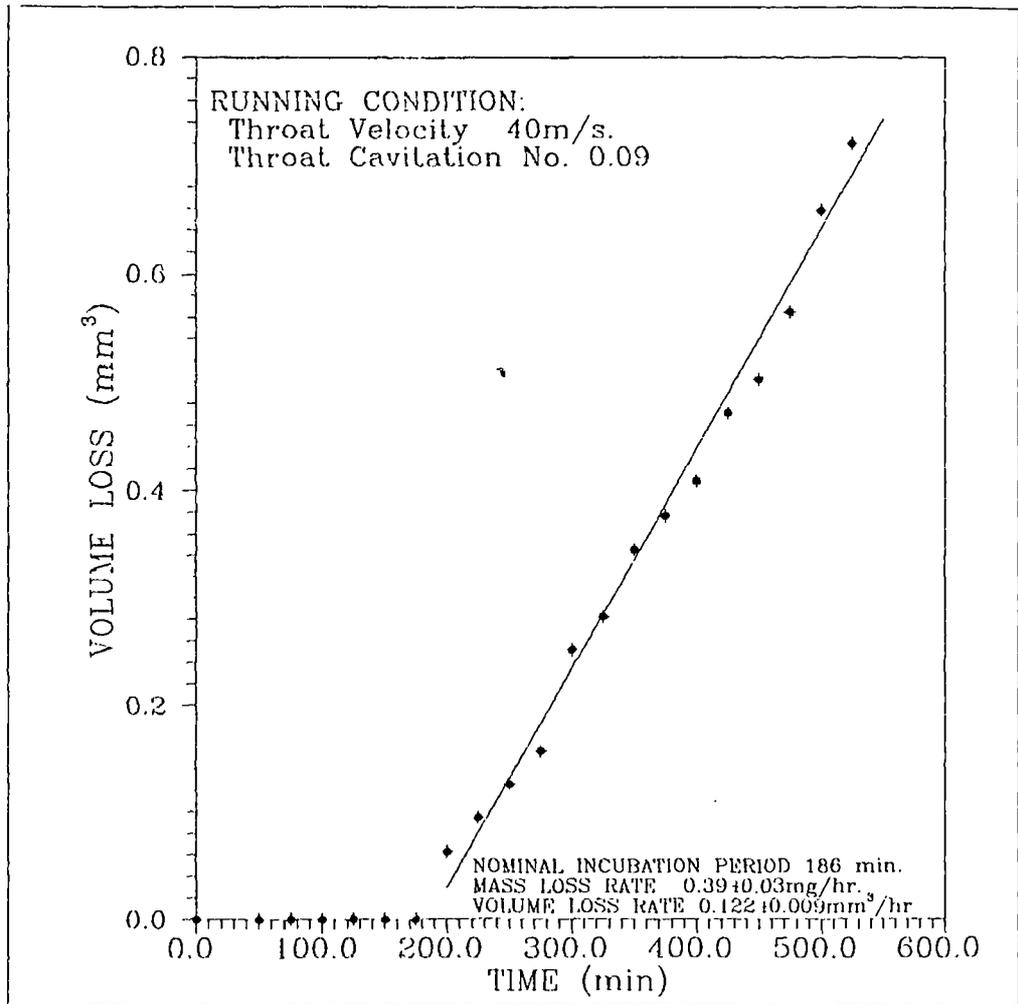
Fig.62 CUMUIATIVE VOLUME LOSS AGAINST TIME  
 FOR SILICON NITRIDE AS LAPPED

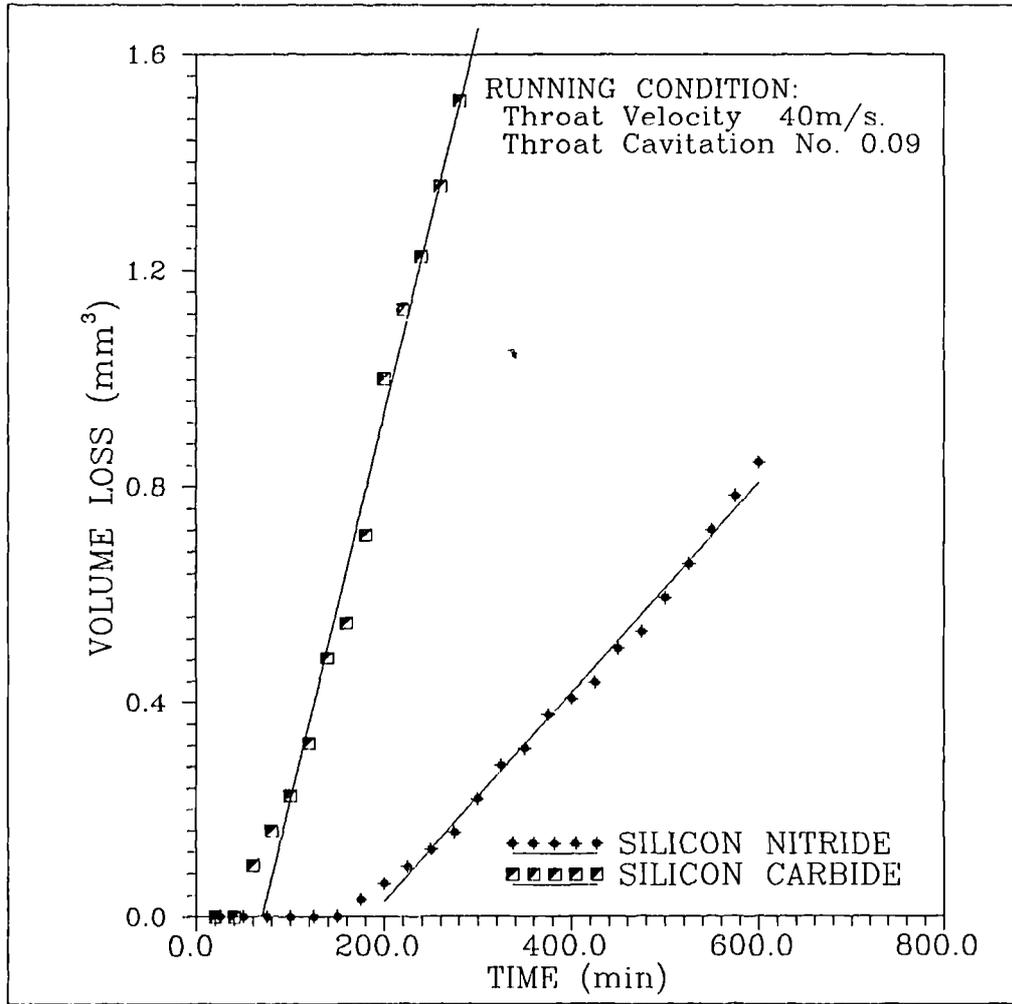
Fig.66 COMPARISON BETWEEN SILICON CARBIDE AND  
SILICON NITRIDE IN THE GROUND CONDITION

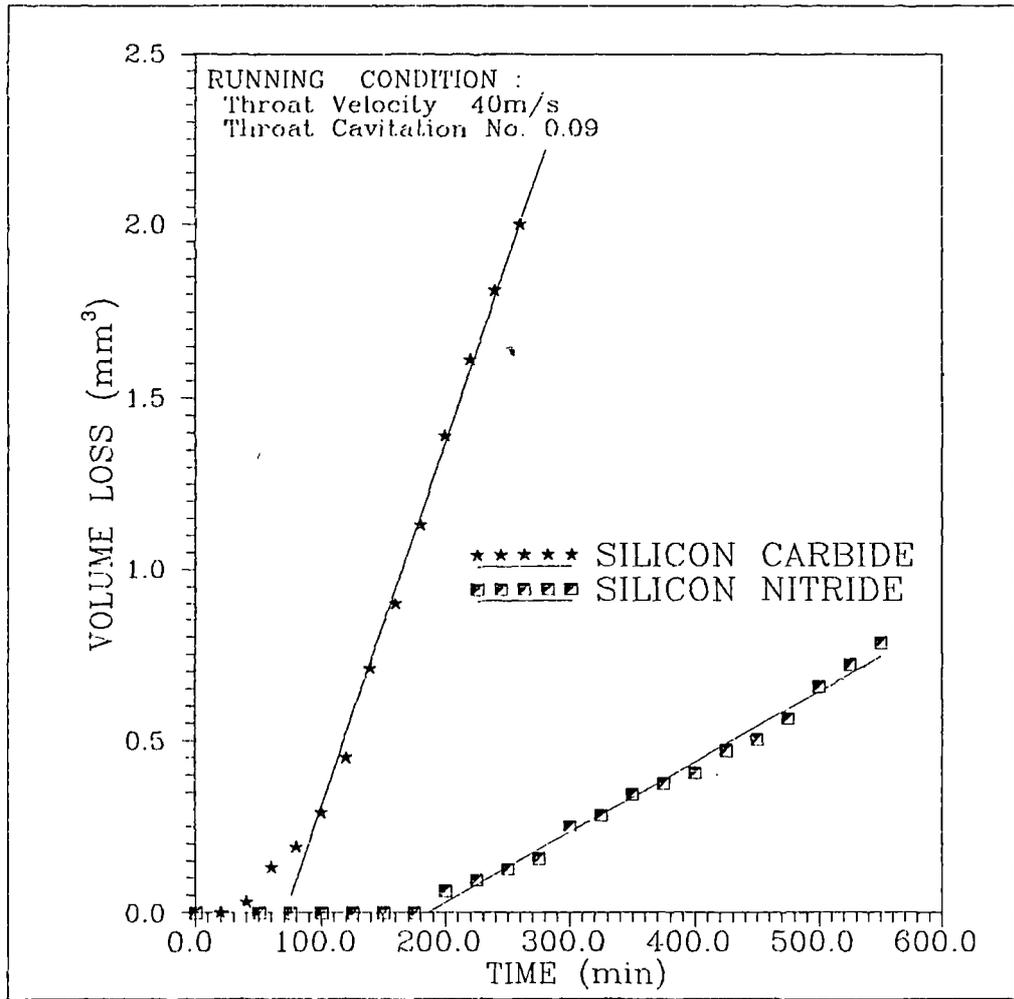
Fig.67 COMPARISON BETWEEN SILICON CARBIDE AND SILICON NITRIDE IN AS LAPPED CONDITION

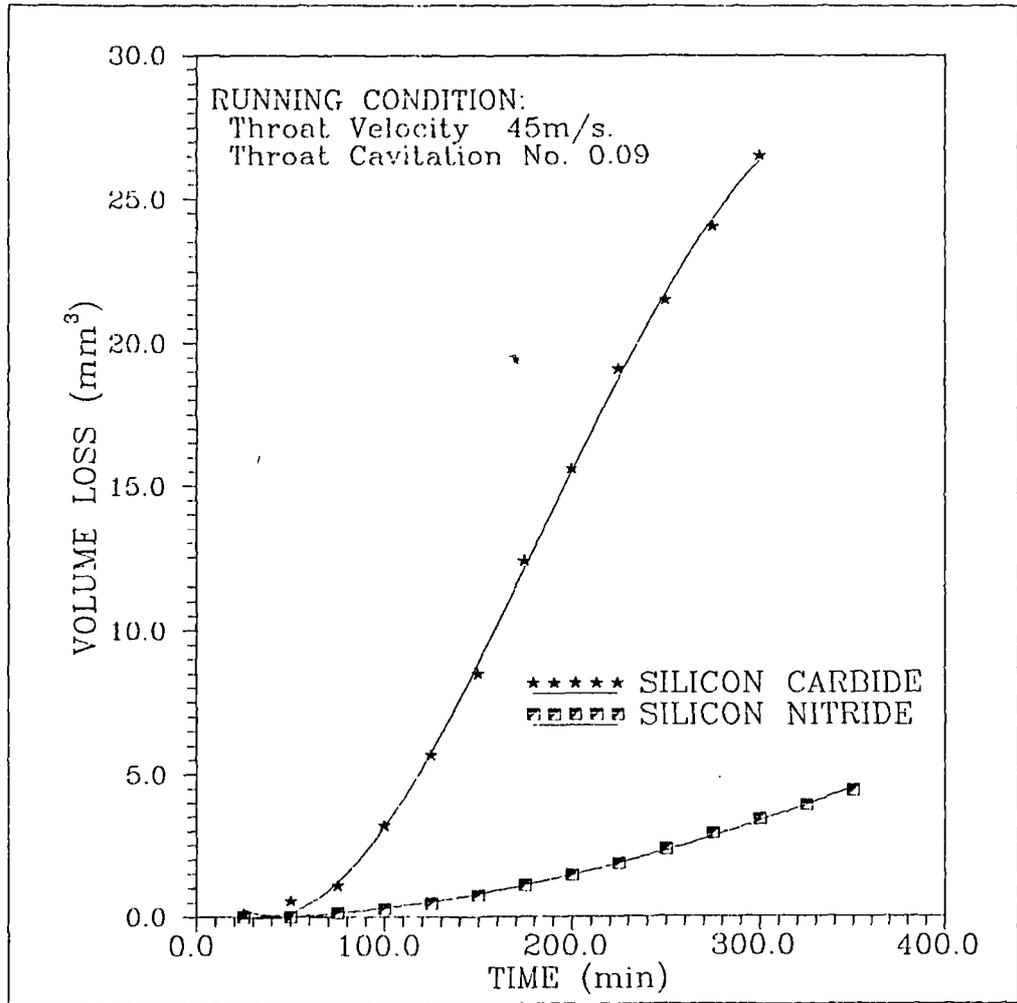
Fig.68 COMPARISON BETWEEN SILICON CARBIDE AND SILICON NITRIDE IN THE AS GROUND CONDITION

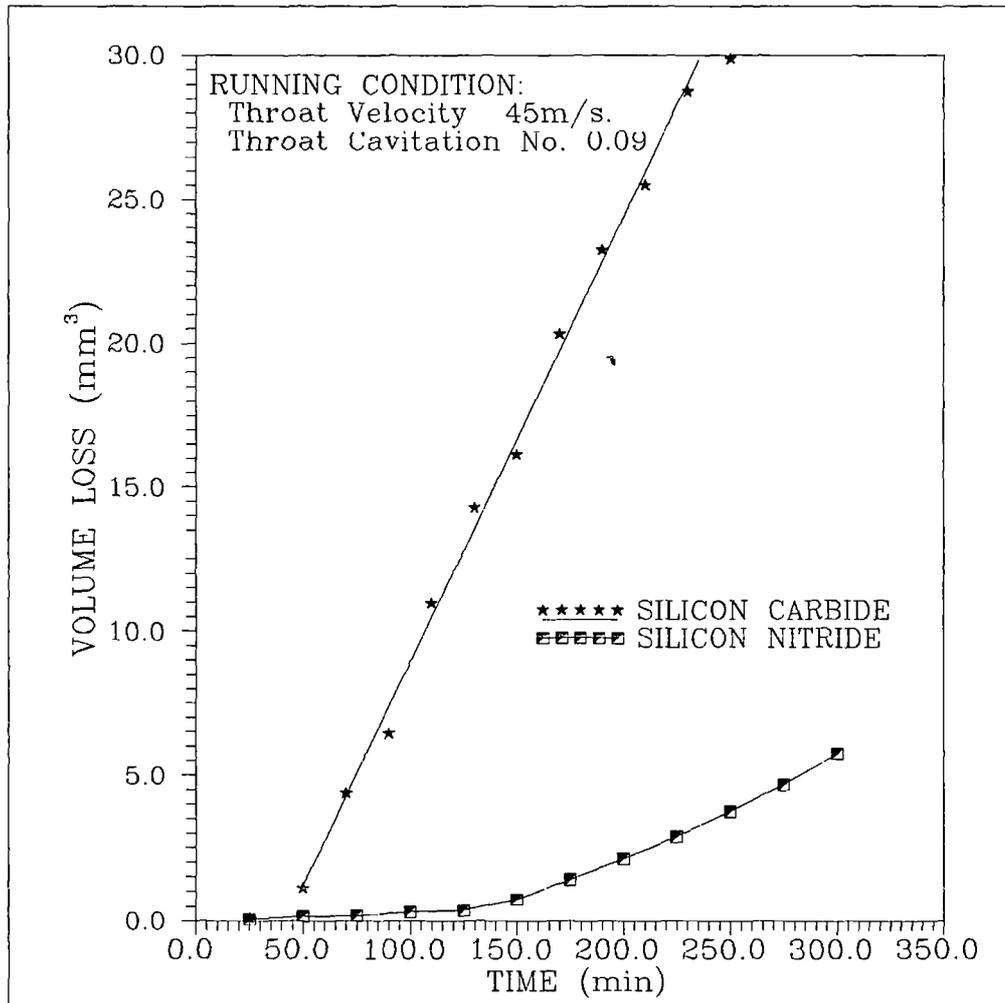
Fig.69 COMPARISON BETWEEN SILICON CARBIDE AND SILICON NITRIDE IN THE AS LAPPED CONDITION

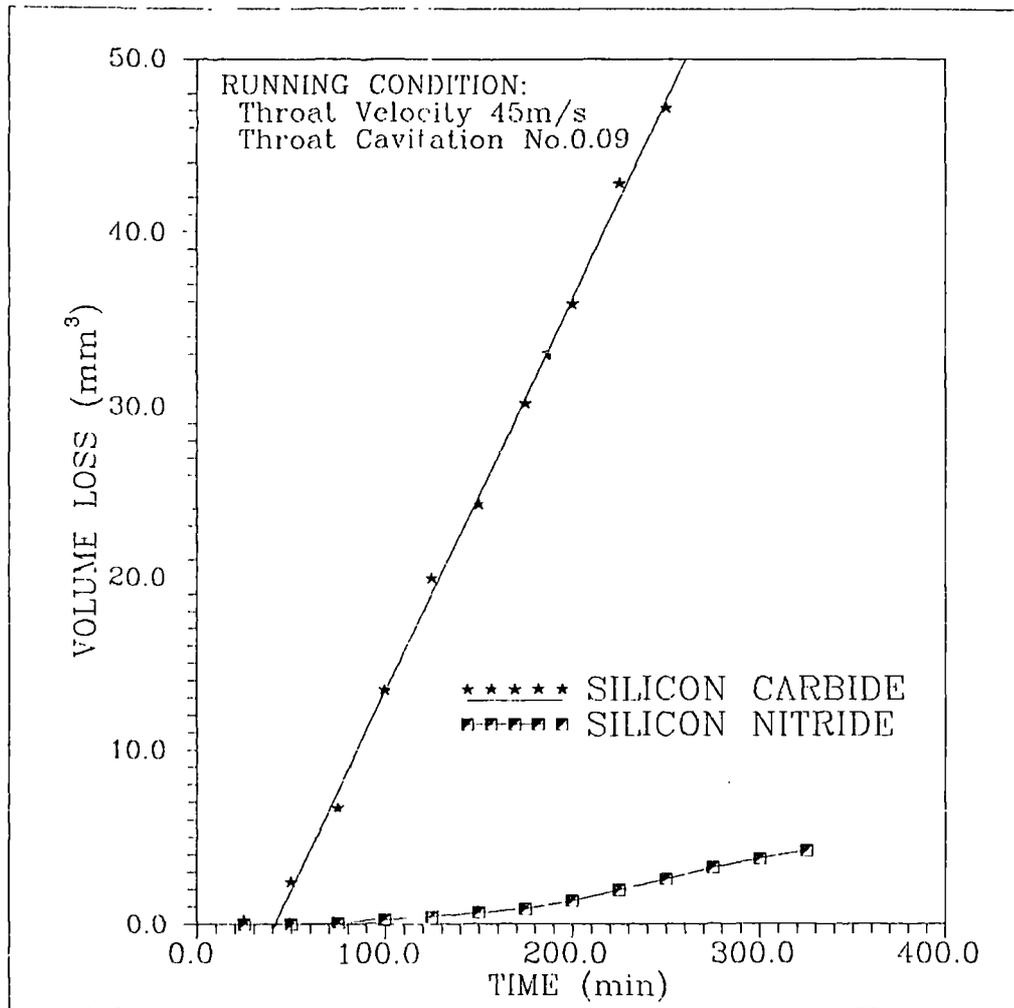
Fig.70 COMPARISON BETWEEN SILICON CARBIDE AND SILICON NITRIDE IN THE AS FIRED CONDITION

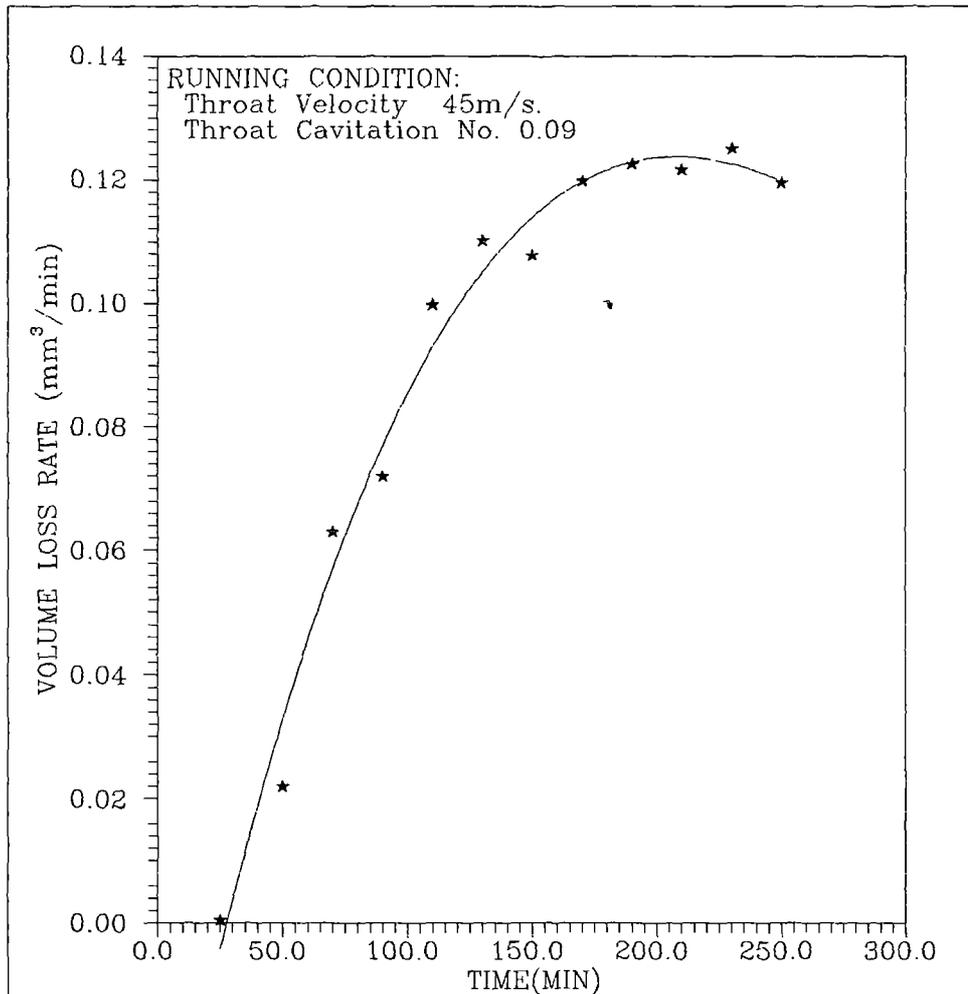
Fig.71 GRAPH OF EROSION RATE AGAINST TIME FOR SILICON CARBIDE AS LAPPED.
