# **CAVITATION EROSION OF ENGINEERING MATERIALS**

**THESIS PRESENTED FOR THE  
DEGREE OF DOCTOR OF  
PHILOSOPHY**

**DEPARTMENT OF MECHANICAL  
ENGINEERING AND AERONAUTICS  
THE CITY UNIVERSITY  
LONDON**

**AUGUST 1993**

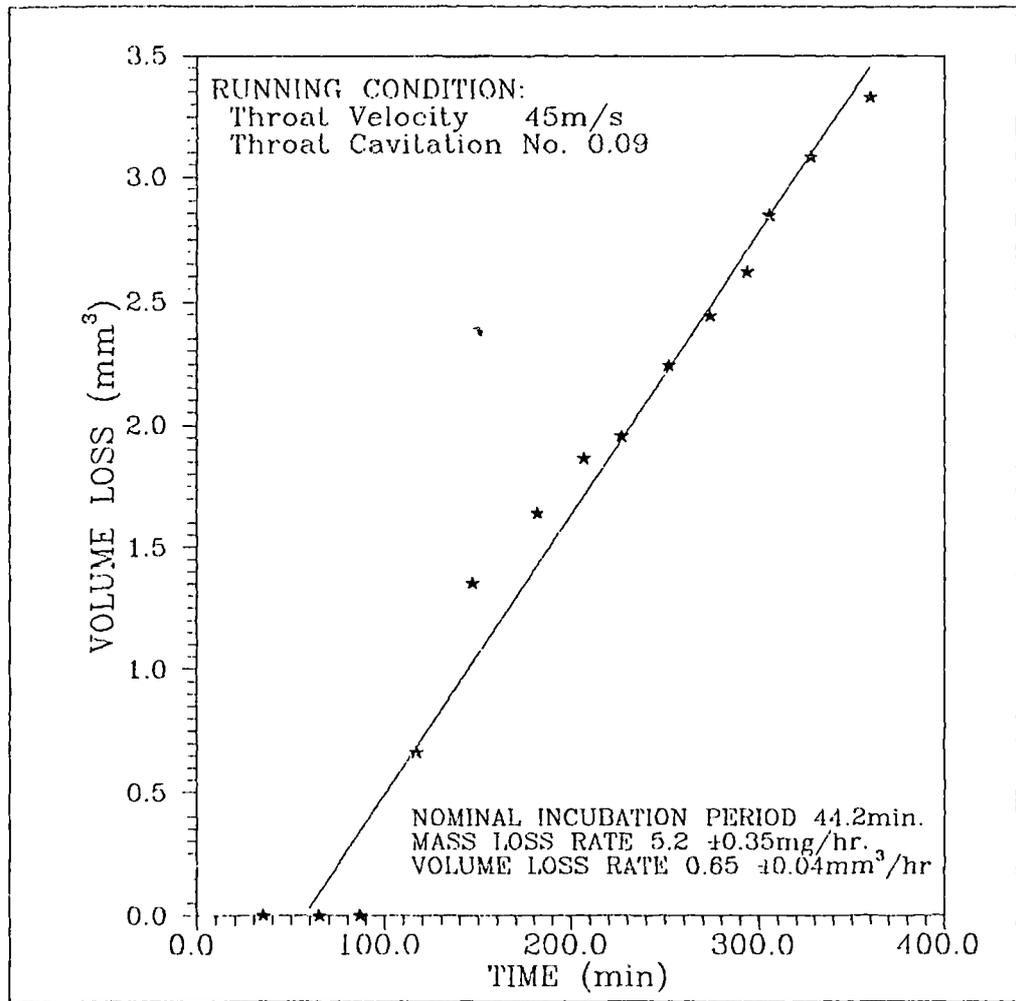
Fig.92 CUMULATIVE VOLUME LOSS AGAINST TIME FOR CAST STAINLESS STEEL

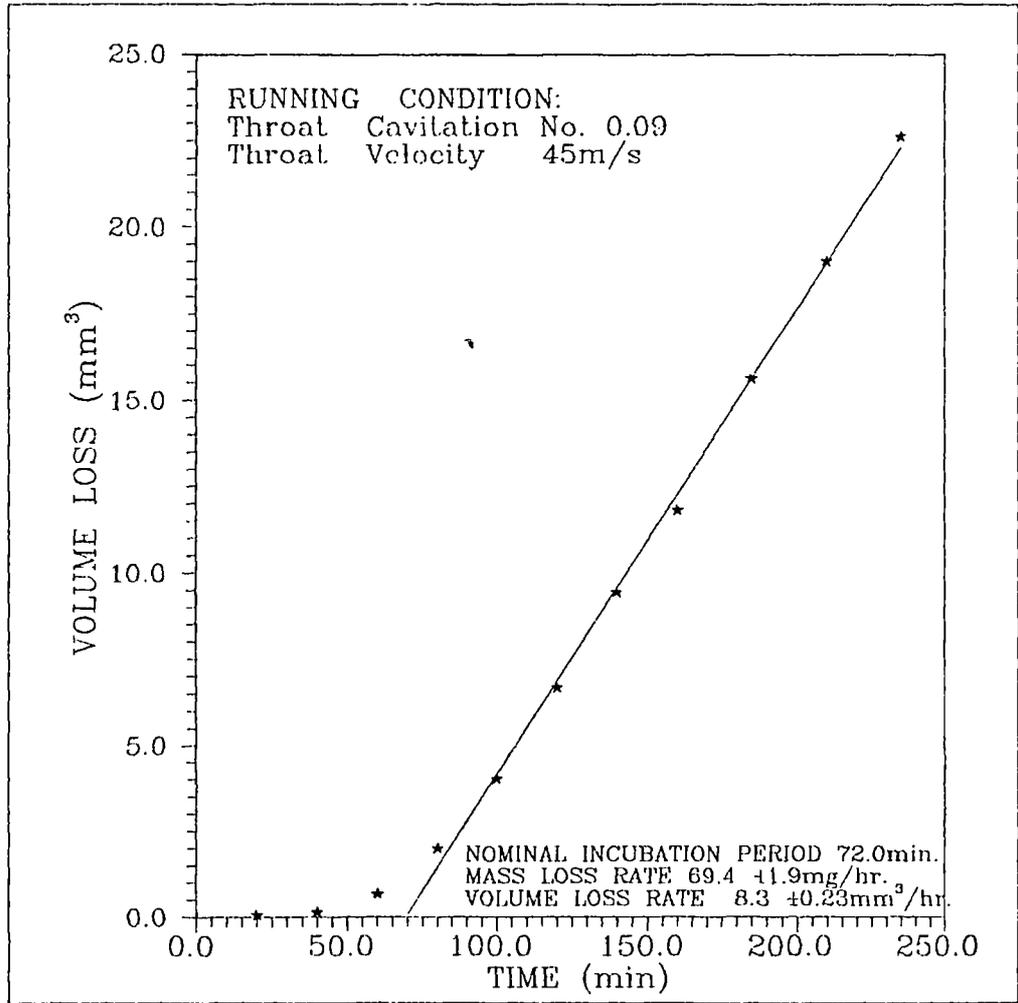
Fig.93 CUMULATIVE VOLUME LOSS AGAINST TIME FOR BRASS (M63)

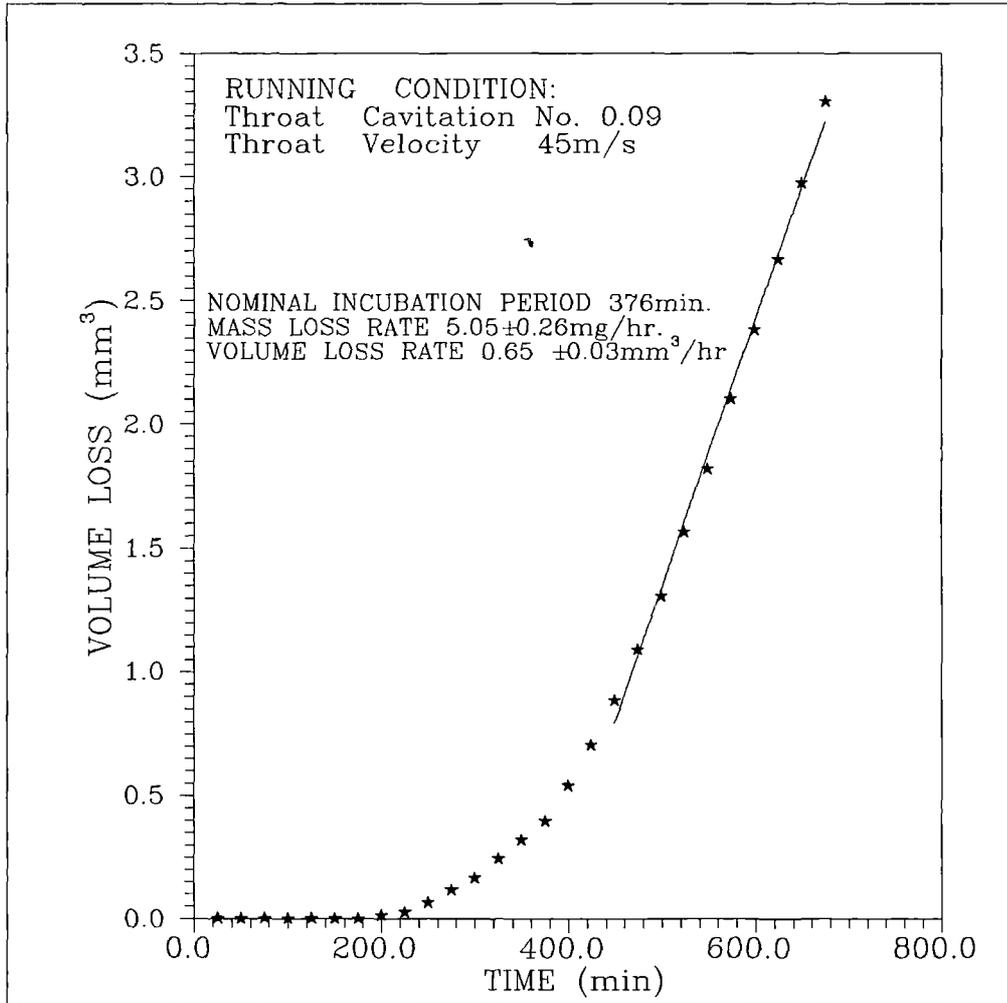
Fig.96 CUMULATIVE VOLUME LOSS AGAINST TIME FOR NITRIDED STEEL

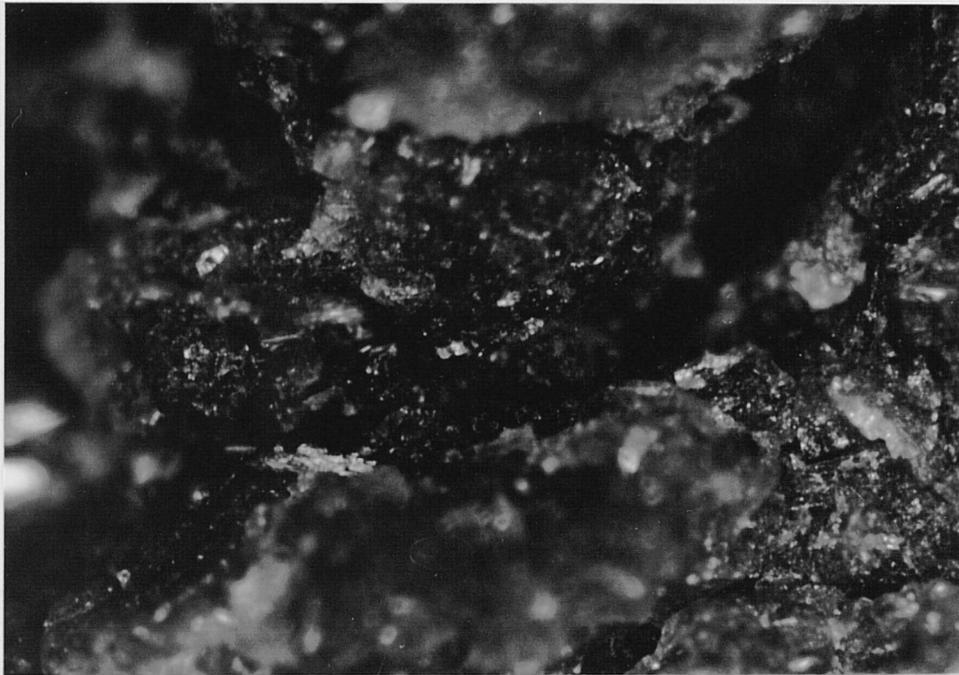
**FIG.102a** OPTICAL MICROGRAPH OF PERPENDICULAR CRACK IN  
EPOXY RESIN

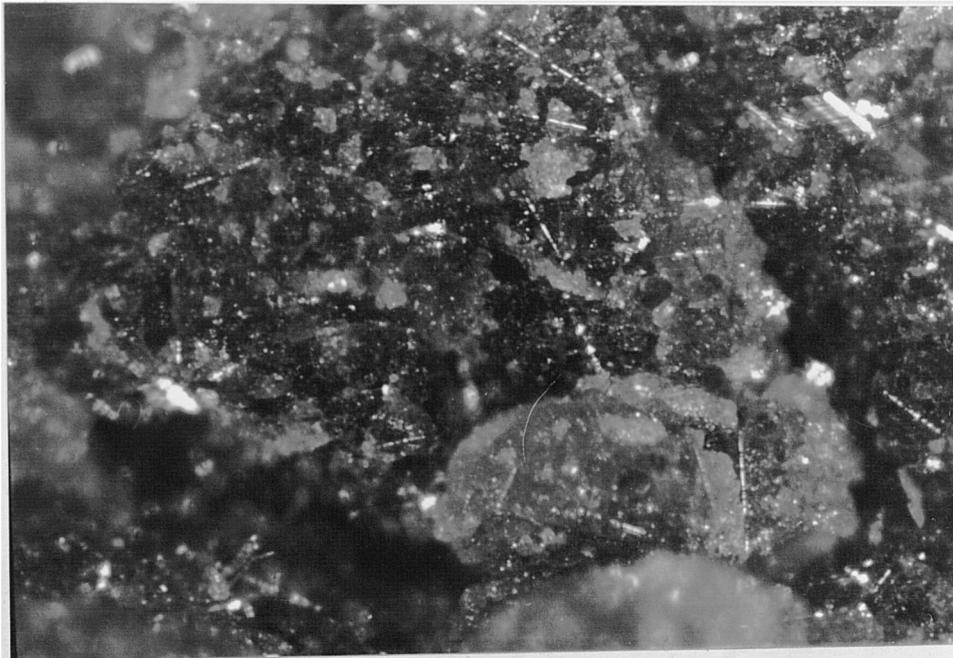
**FIG.102b** OPTICAL MICROGRAPH OF GRAIN DISINTEGRATION IN  
EPOXY RESIN

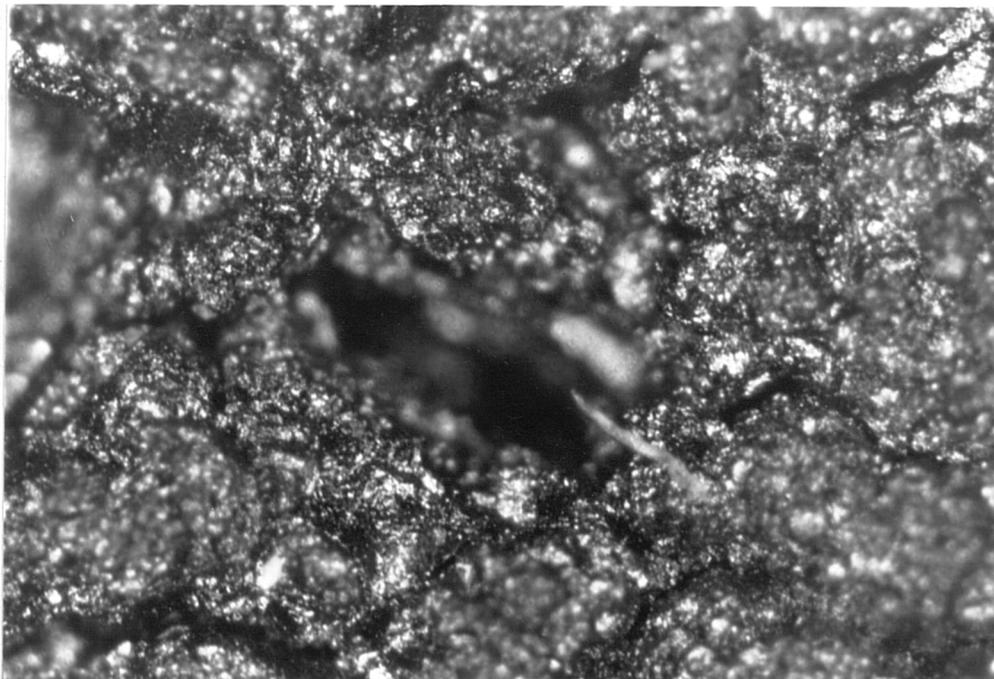
**FIG.104d** OPTICAL MICROGRAPH OF MATERIAL REMOVAL BY MICRO-CRACKS INTERSECTION IN SILICON CARBIDE

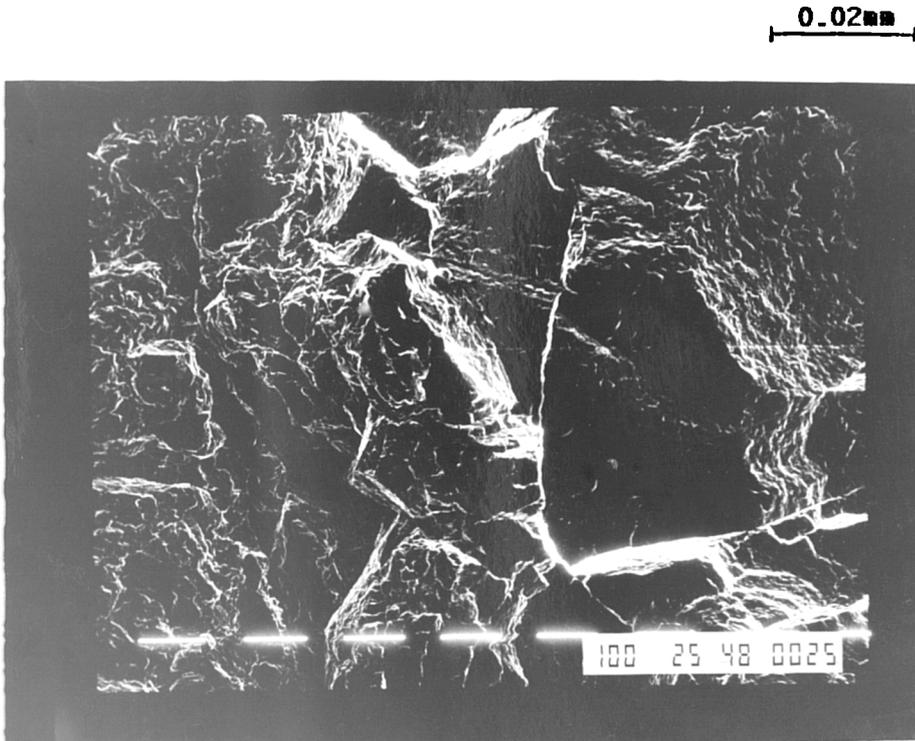
**FIG.104e** SCANNING ELECTRON MICROGRAPH OF THE PIT IN  
IN FIG.104d

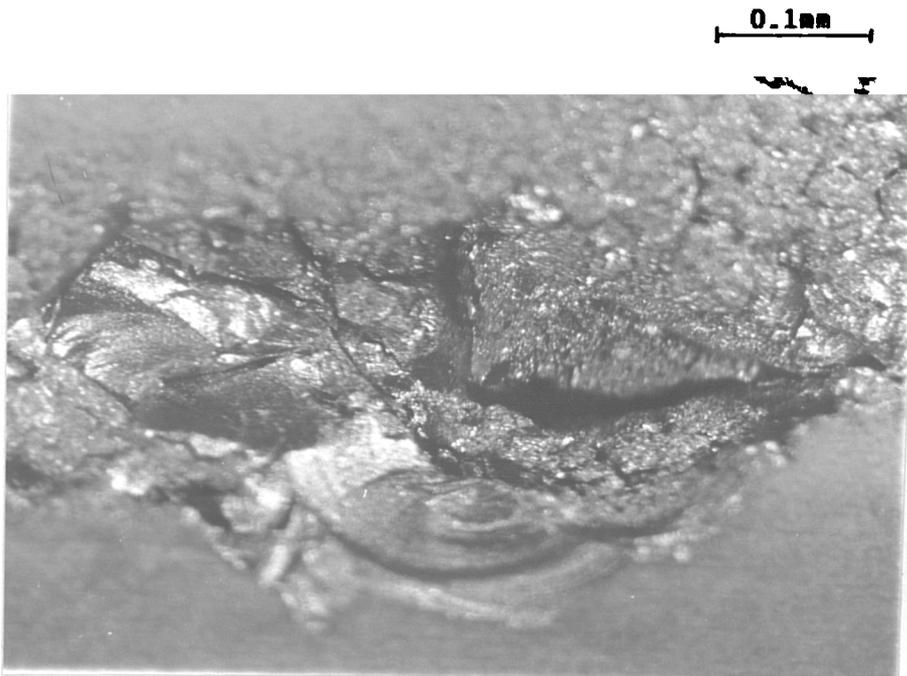
**FIG.105a** OPTICAL MICROGRAPH OF GROSS DAMAGE ON ONE  
ERODED AREA SHOWING EFFECT OF CHIPPING

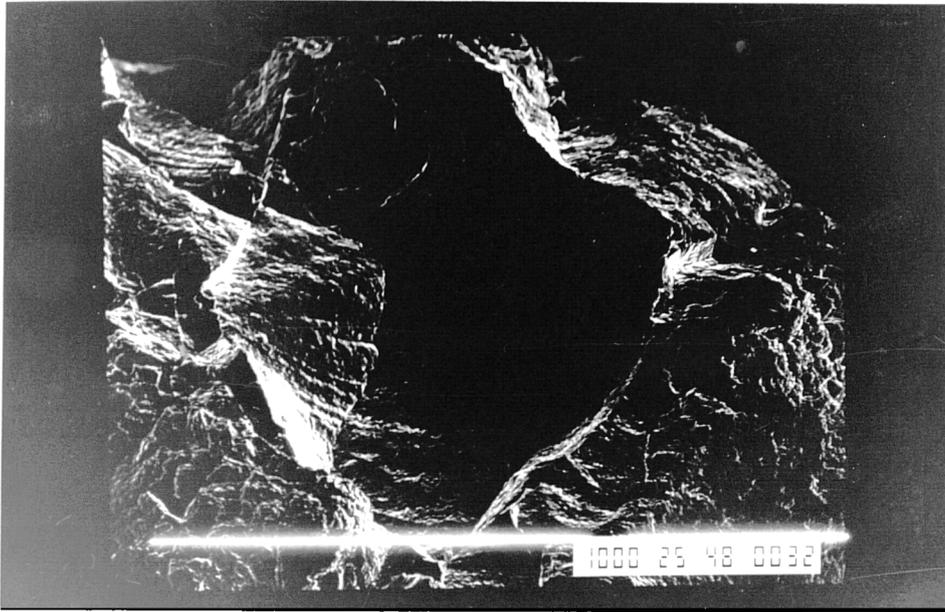
**FIG.105b** SCANNING ELECTRON MICROGRAPH OF DAMAGE INSIDE CENTRAL REGION IN FIG.105A

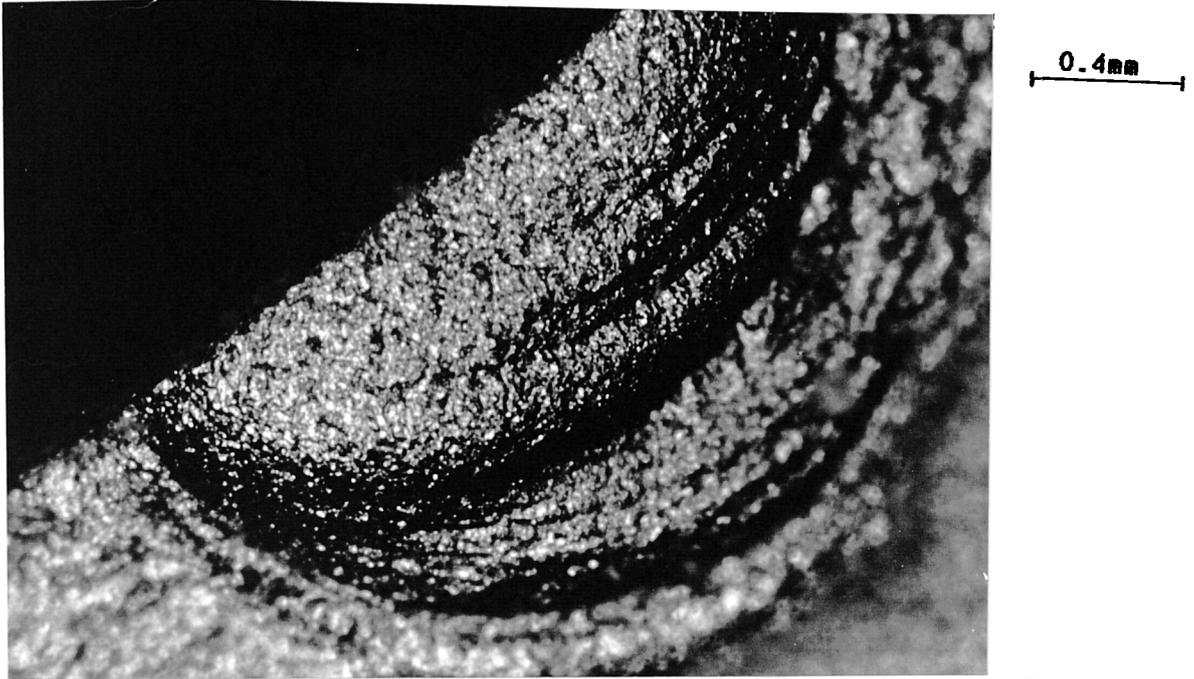
**FIG.105d** OPTICAL MICROGRAPH OF TOPOGRAPHY OF CHIPPED SURFACE OF SILICON CARBIDE

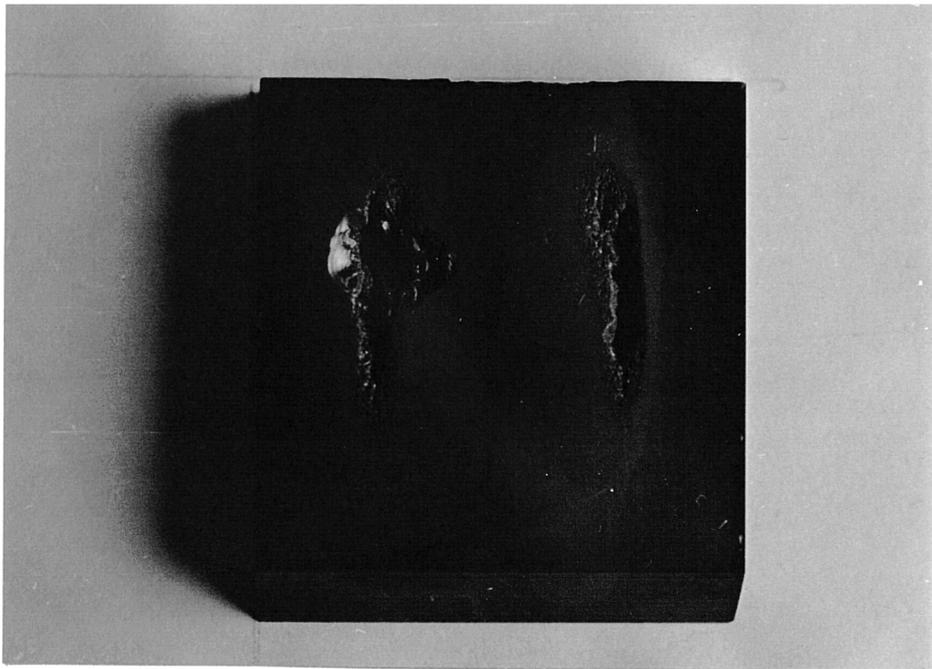
**FIG.105e** MACROSCOPIC VIEW OF GROSS DAMAGE IN SILICON CARBIDE (300 min.)

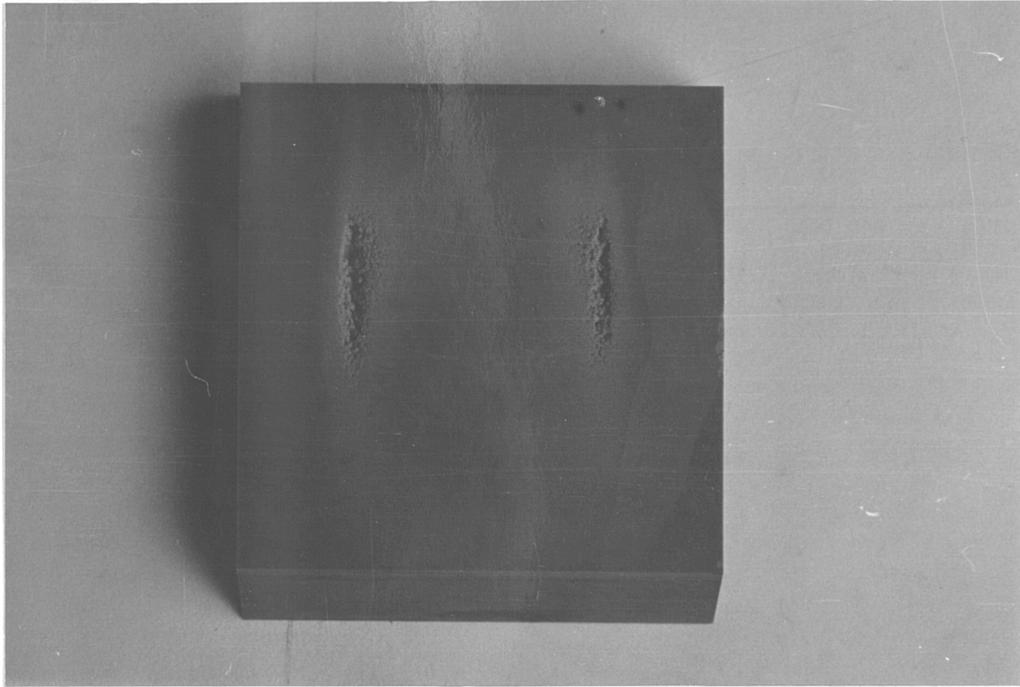
**FIG.107h**    MACROSCOPIC VIEW OF GROSS DAMAGE ON  
                 SILICON NITRIDE

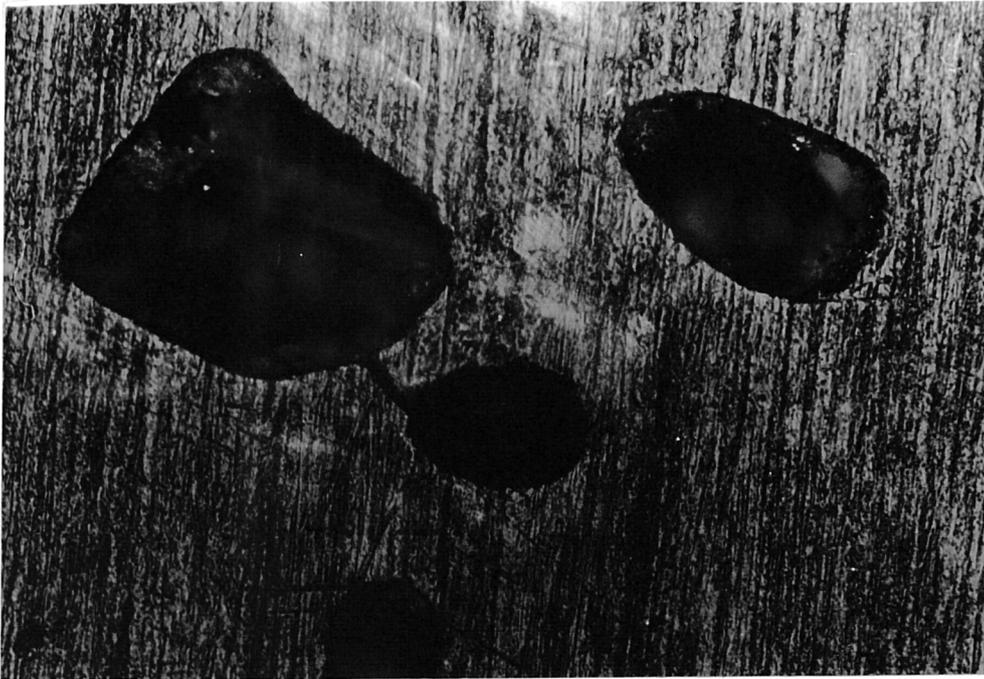
**FIG.108** OPTICAL MICROGRAPH OF SURFACE OF GRP  
SHOWING PORES DISPOSITION PRIOR TESTING

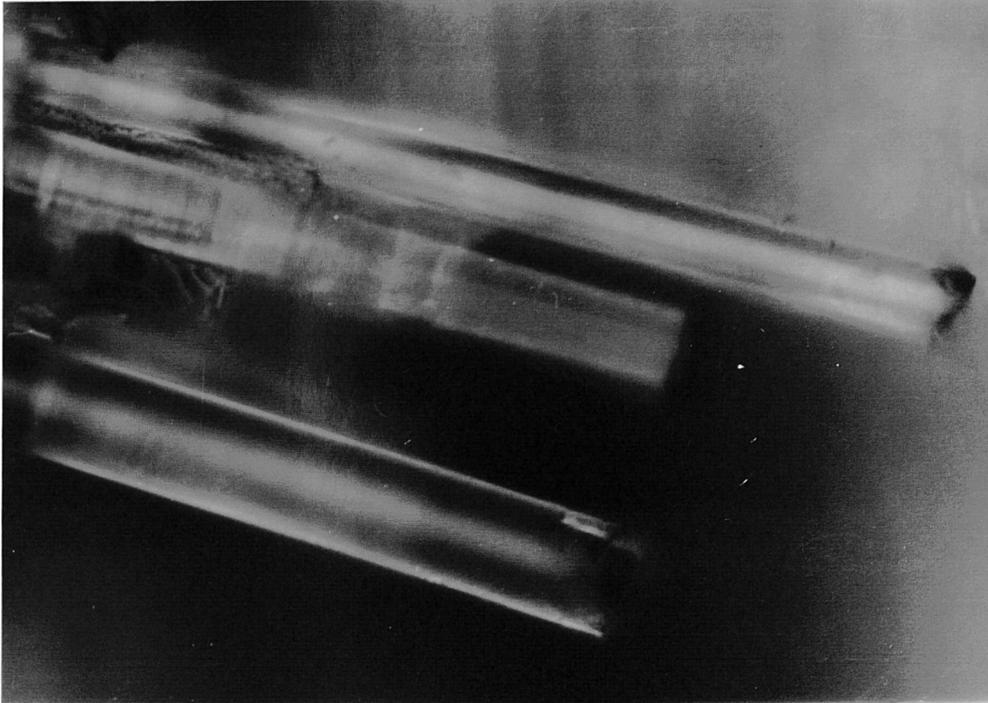
**FIG.108d** OPTICAL MICROGRAPH SHOWING THREE FRACTURED FIBRES

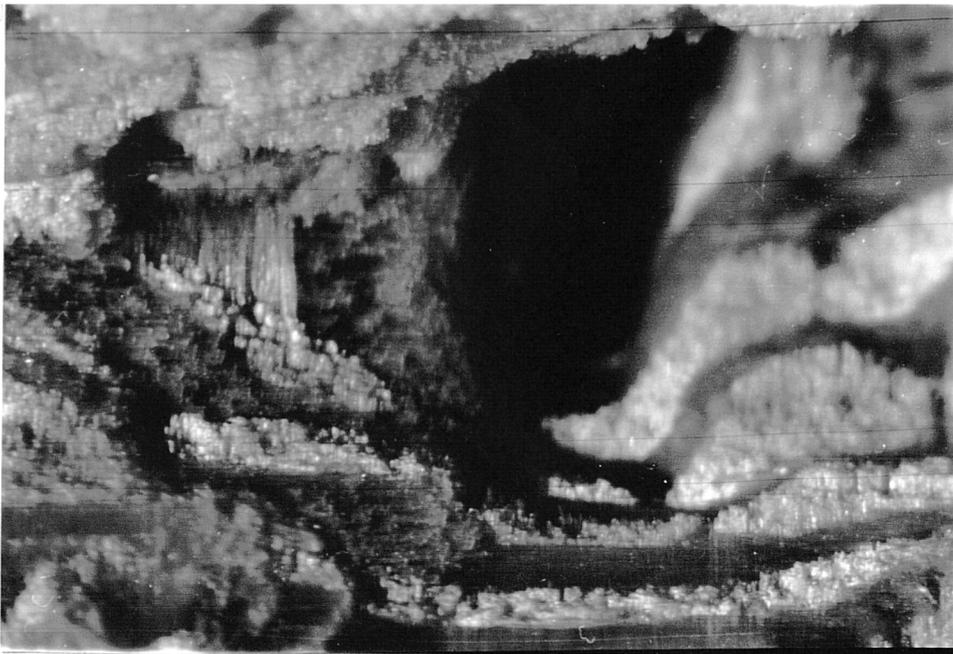
**FIG.108e** MACROSCOPIC VIEW OF DAMAGED SURFACE GRP SHOWING TUNNELING EFFECT

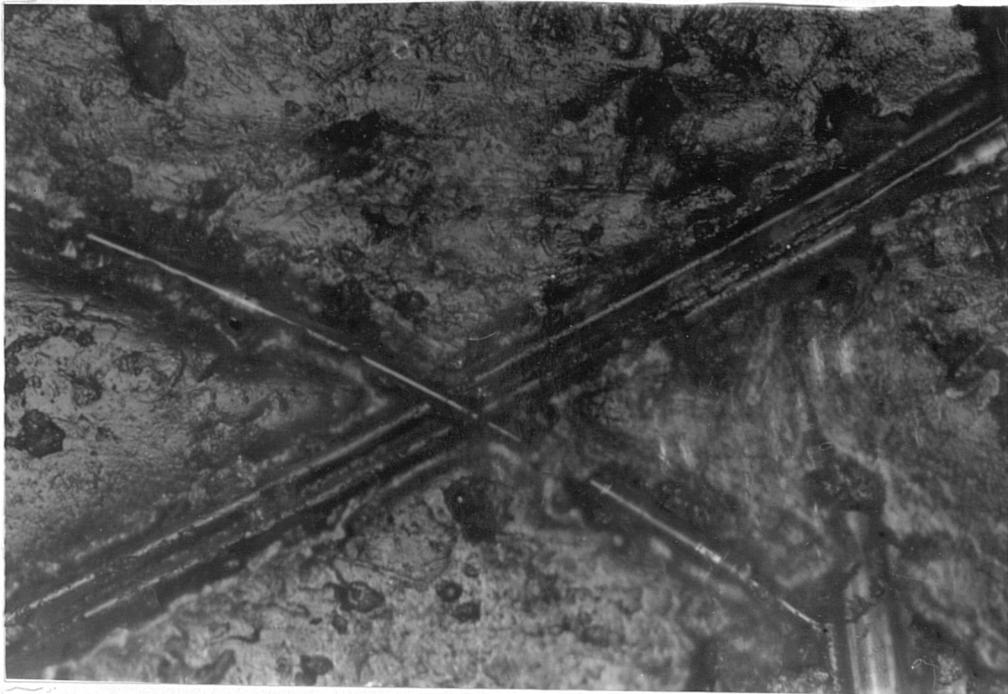
**FIG.109** OPTICAL MICROGRAPH OF FIBROC SURFACE PRIOR TO TESTING

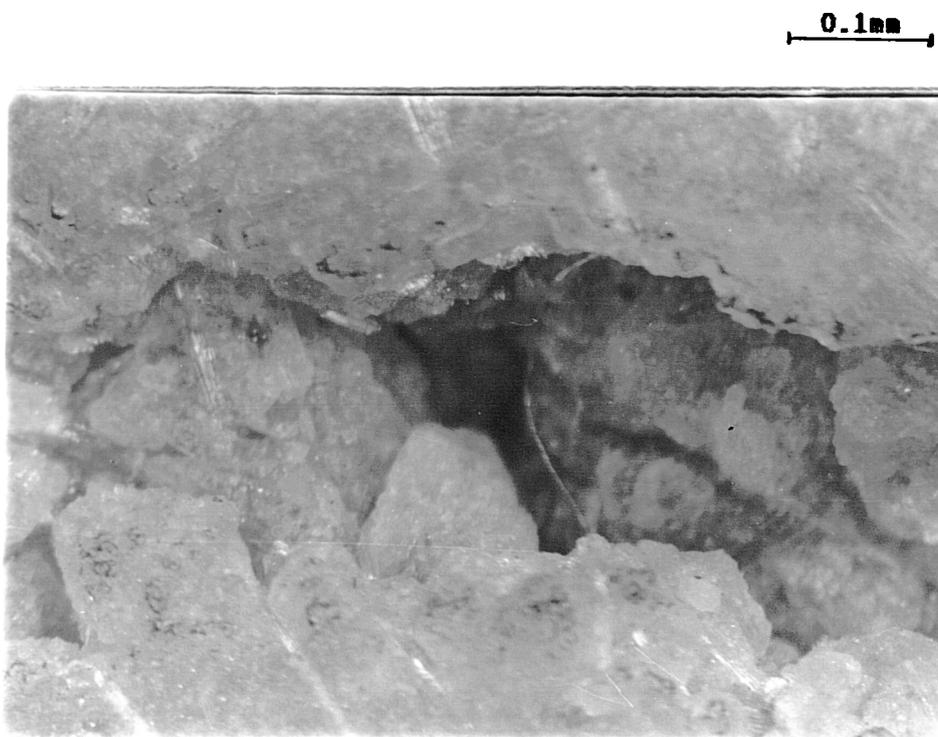
**FIG.110d** MACROSCOPIC VIEW OF GROSS DAMAGE IN FYBROC

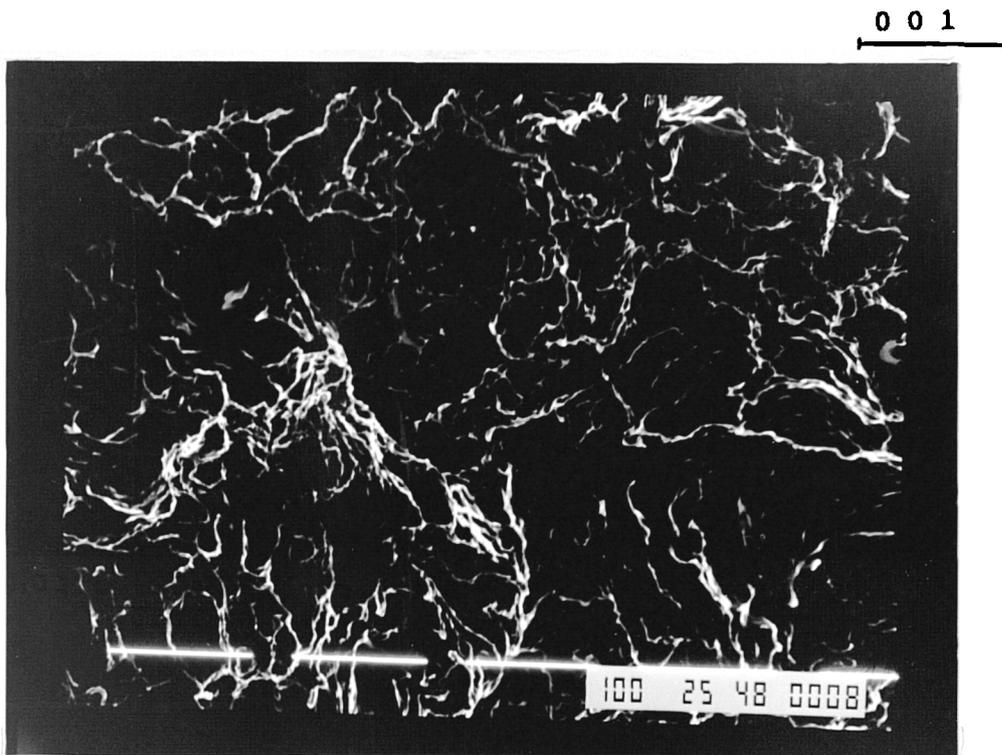
**FIG.111c** SCANNING ELECTRON MICROGRAPH OF DAMAGE IN CENTRAL ZONE AFTER TEST COMPLETION (160 min.)

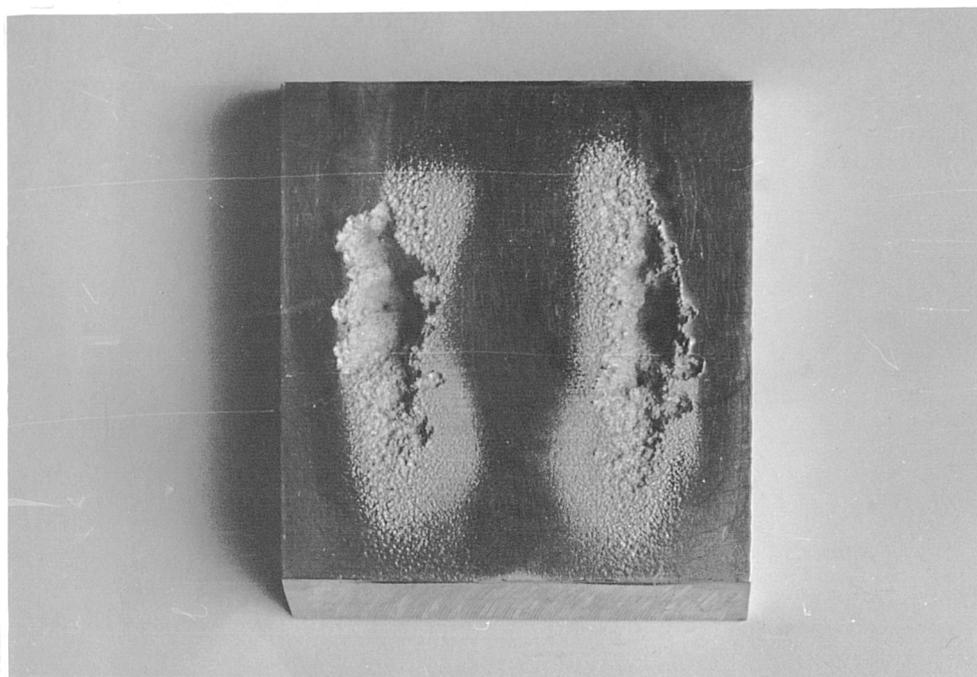
**FIG.111d** MACROSCOPIC VIEW OF GROSS DAMAGE IN ALUMINIUM ( 160 min.)

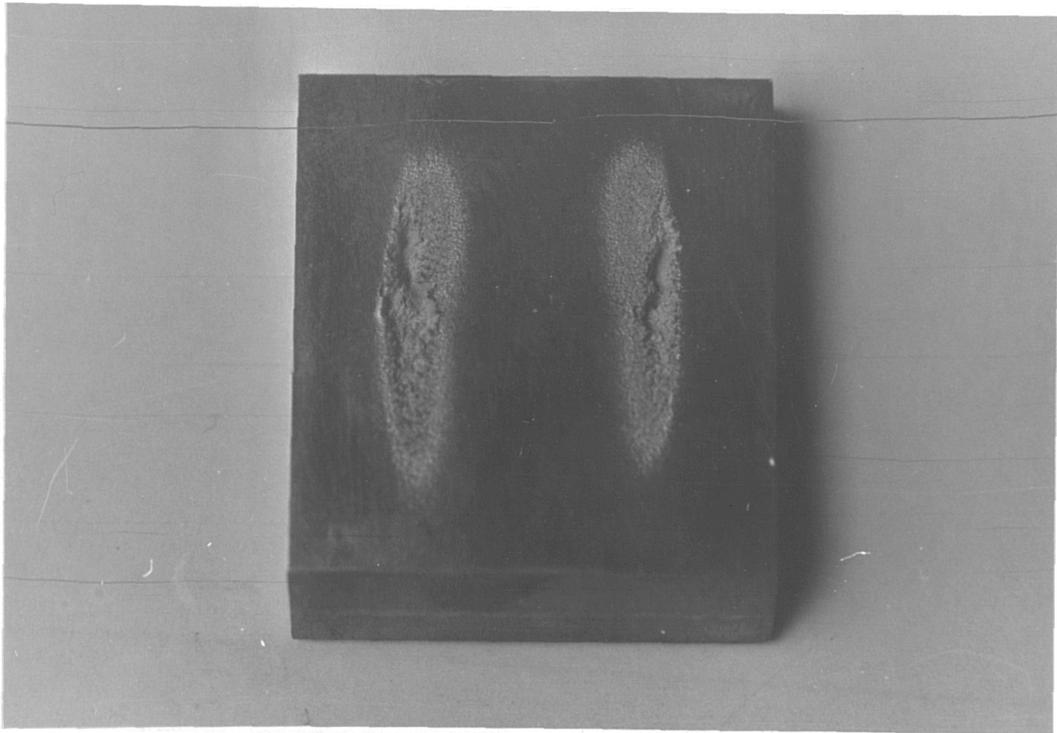
**FIG.112f** MACROSCOPIC VIEW OF GROSS DAMAGE IN  
CUPRO-NICKEL (300 min.)

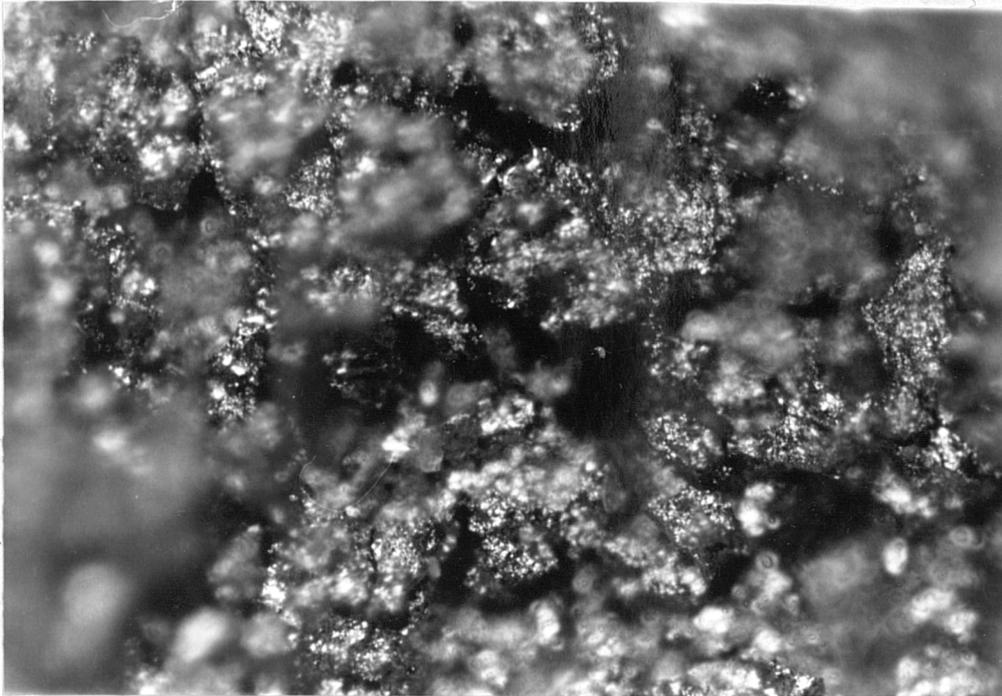
**FIG.113a** OPTICAL MICROGRAPH OF DAMAGE IN CENTRAL ZONE OF SINGLE PHASE BRASS (225 min.)

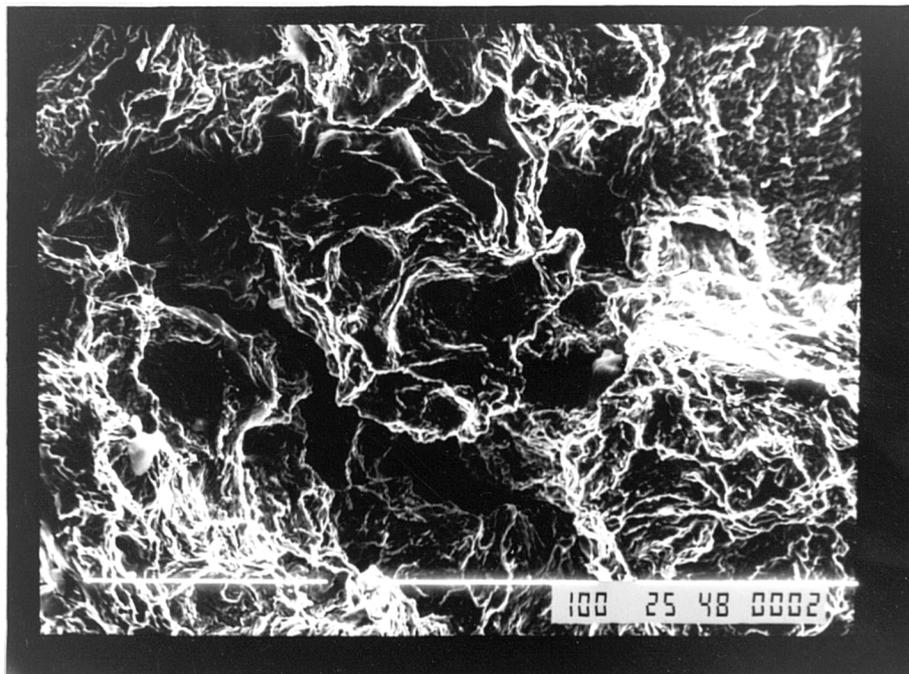
**FIG. 113b** S.E.M OF DAMAGE IN CENTRAL ZONE SINGLE PHASE BRASS

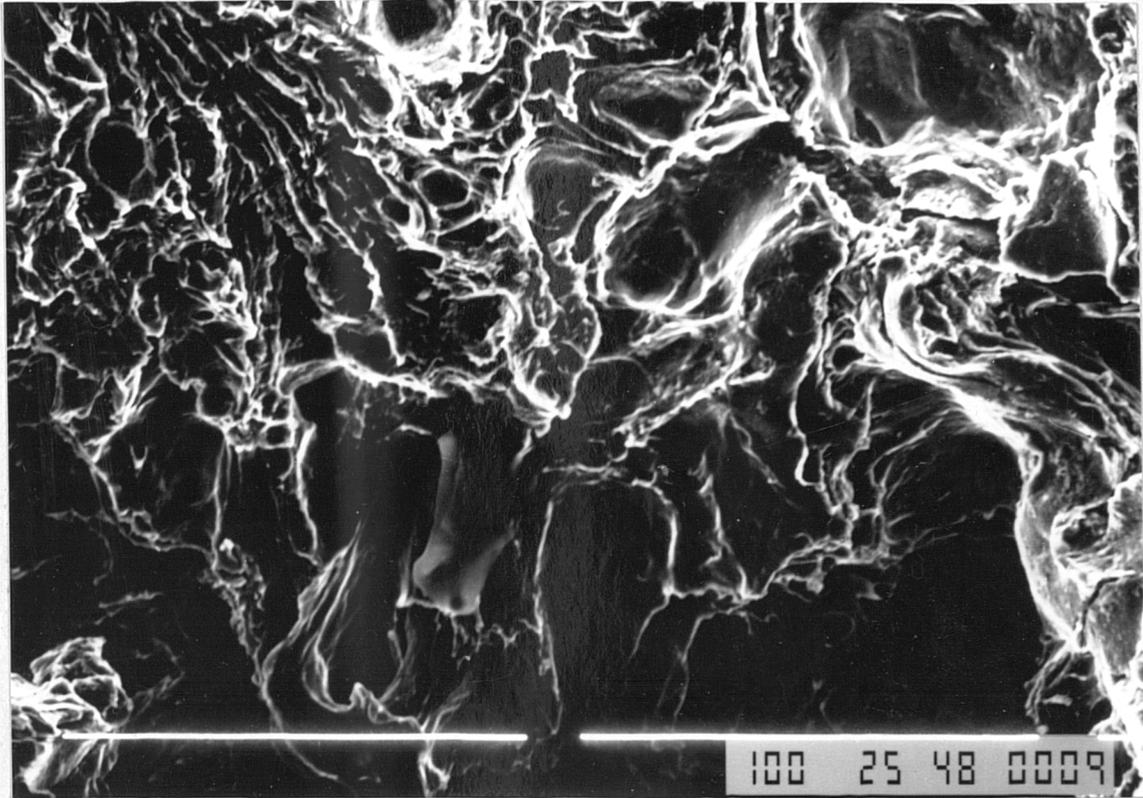
**FIG.114d** S.E.M OF DAMAGE IN CENTRAL ZONE OF ARMCO IRON (550 min.)

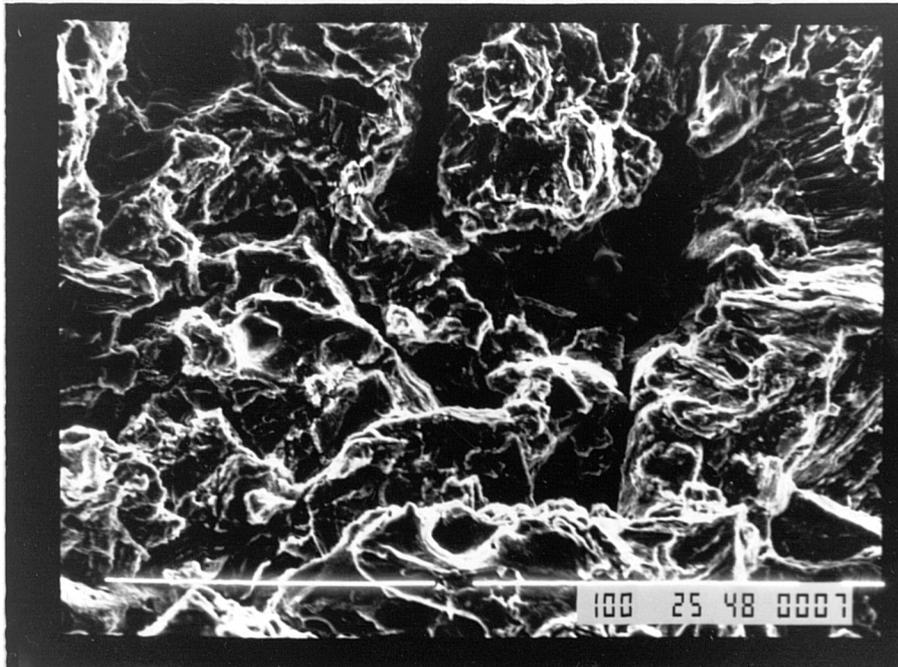
**FIG.114e** S.E.M OF DAMAGE IN CENTRAL ZONE OF ARMCO IRON (550 min.)

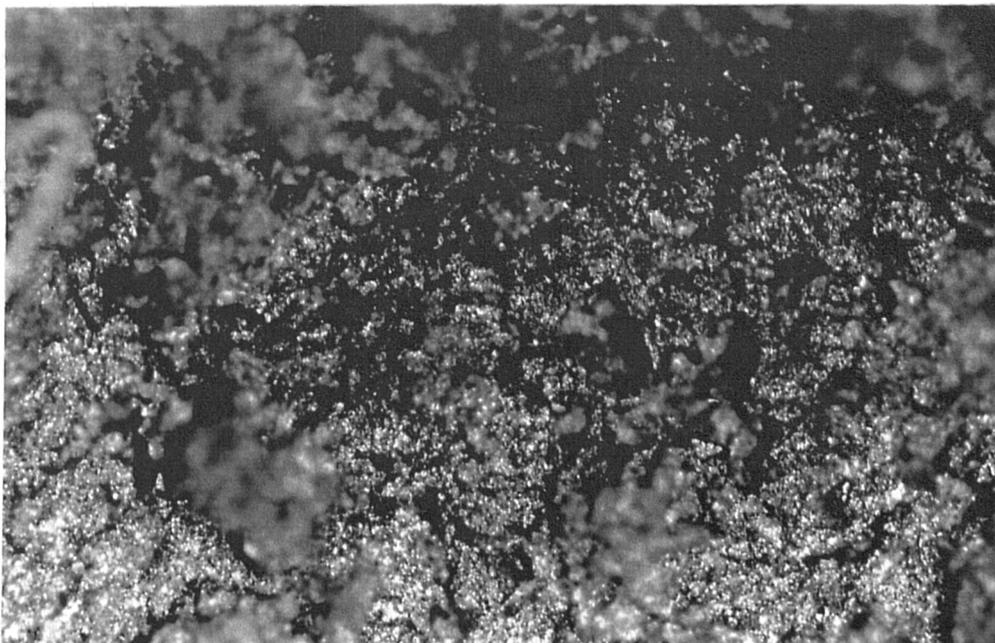
**FIG.117e** OPTICAL MICROGRAPH OF DAMAGE IN CENTRAL ZONE IN TOOL STEEL (380.min.)

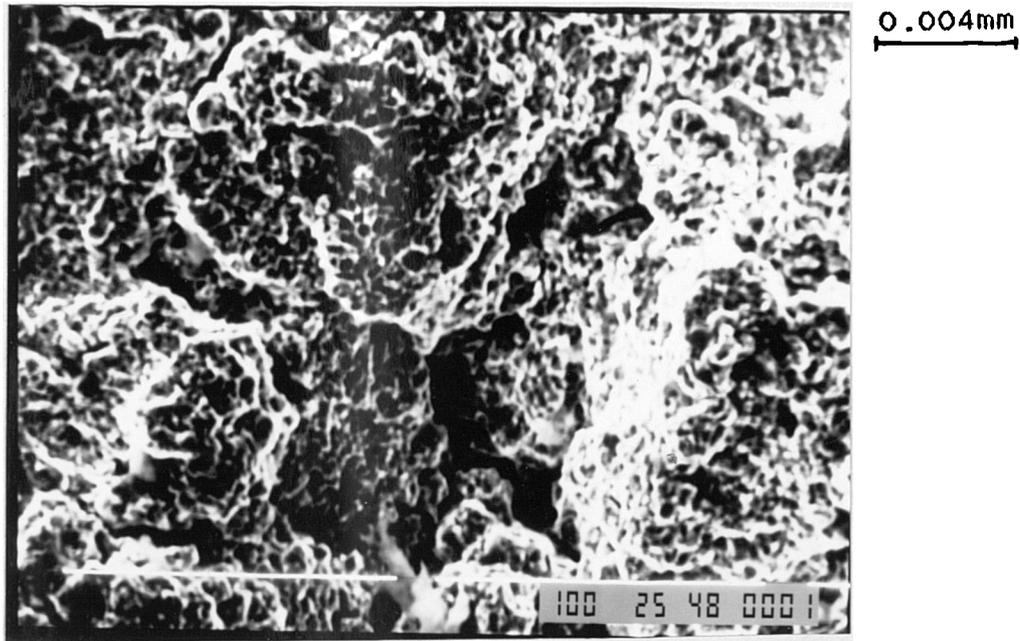
**FIG.117f** S.E.M OF DAMAGE IN CENTRAL ZONE AFTER TEST COMPLETION (500 min.)

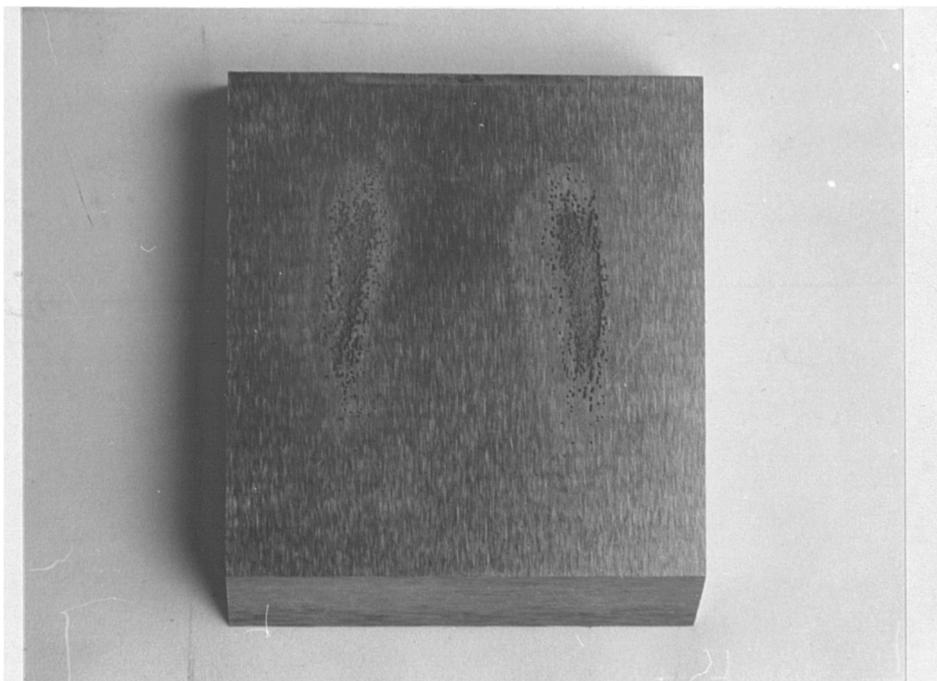
**FIG.117g** MACROSCOPIC VIEW OF GROSS DAMAGE IN TOOL STEEL

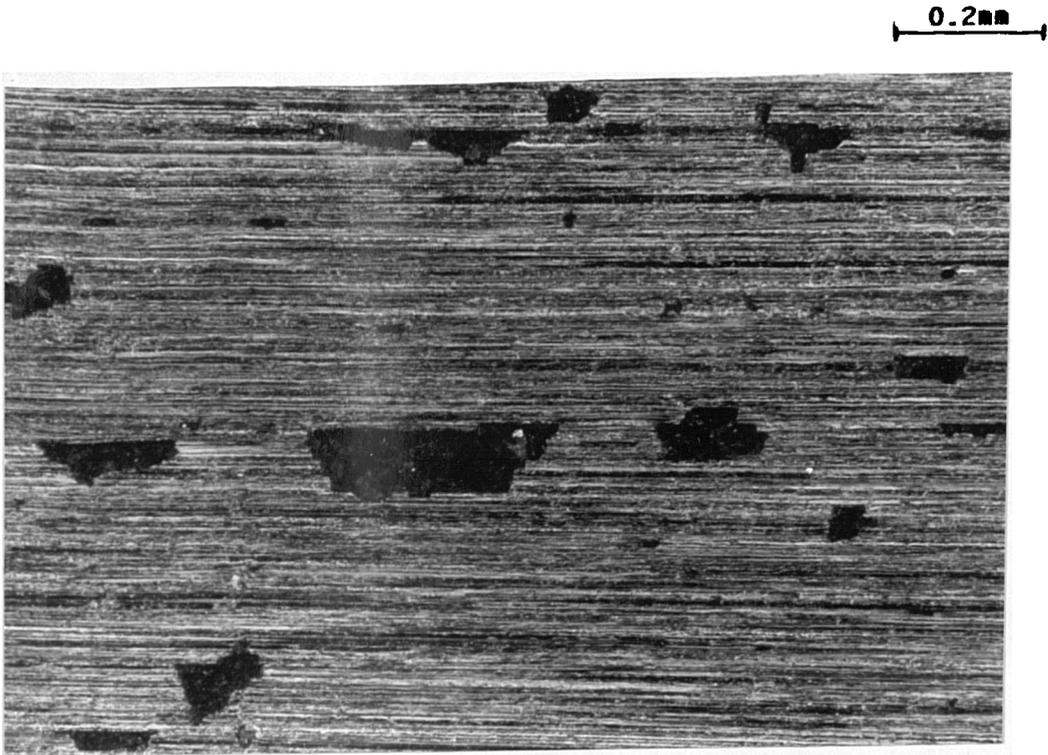
**FIG.118a** OPTICAL MICROGRAPH OF INITIAL PITTING IN NITRIDED STEEL (40 min)

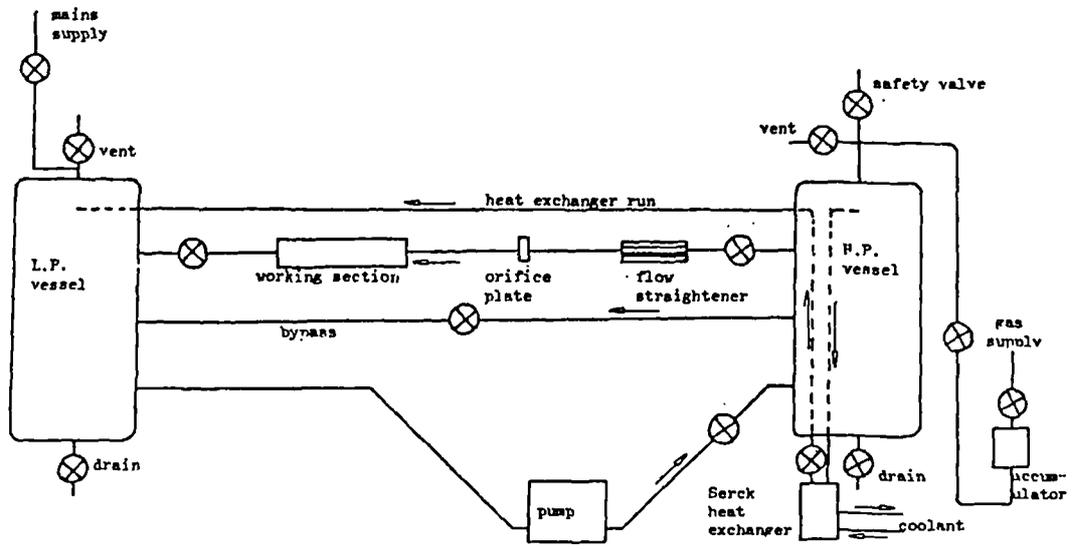
Fig.1 CAVITATION EROSION TEST FACILITY

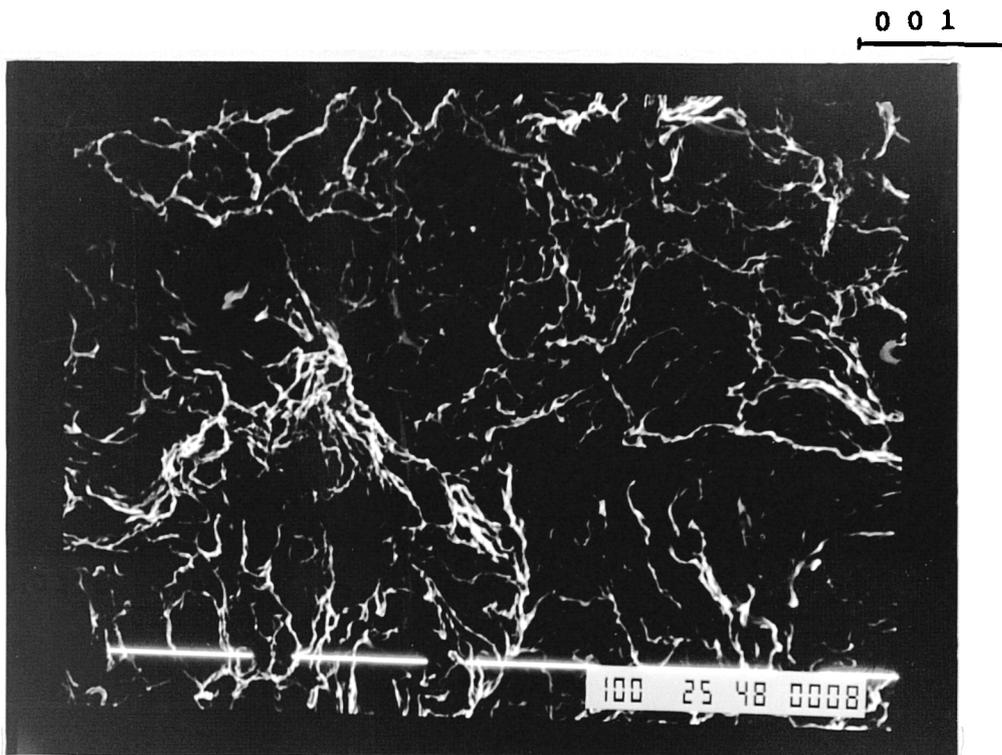
**FIG.111c** SCANNING ELECTRON MICROGRAPH OF DAMAGE IN CENTRAL ZONE AFTER TEST COMPLETION (160 min.)

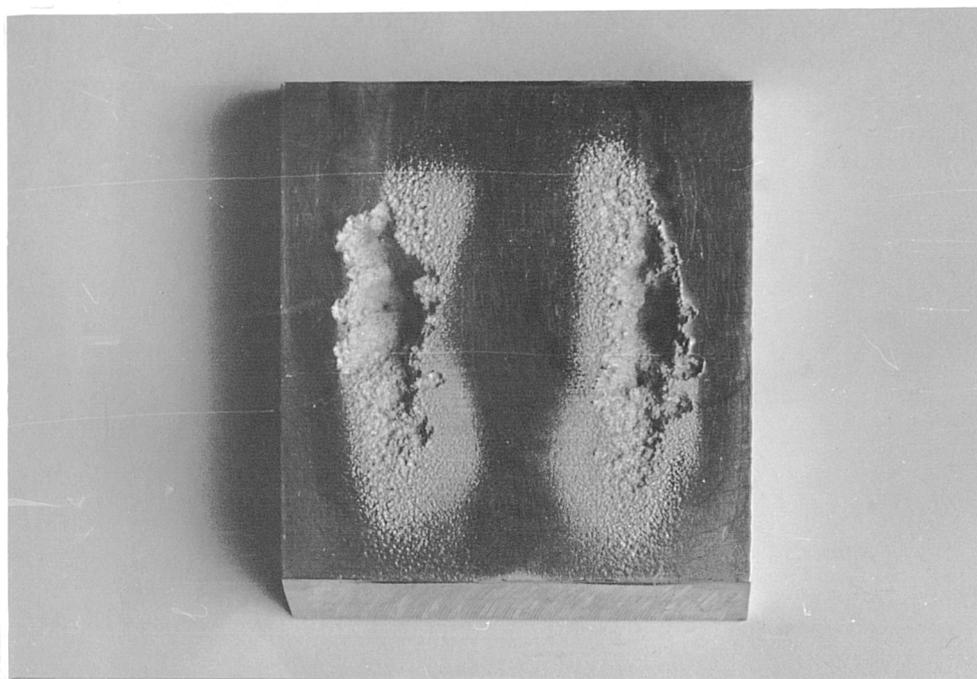
**FIG.111d** MACROSCOPIC VIEW OF GROSS DAMAGE IN ALUMINIUM ( 160 min.)
