Assessment and Retrofitting of an Existing Steel Structure subjected to Wind-Induced Failure Analysis

C. Maraveas^{1,2*} and K.D. Tsavdaridis³

¹C. MARAVEAS & ASSOCIATES P.C. - Consulting Engineers, Greece

Abstract

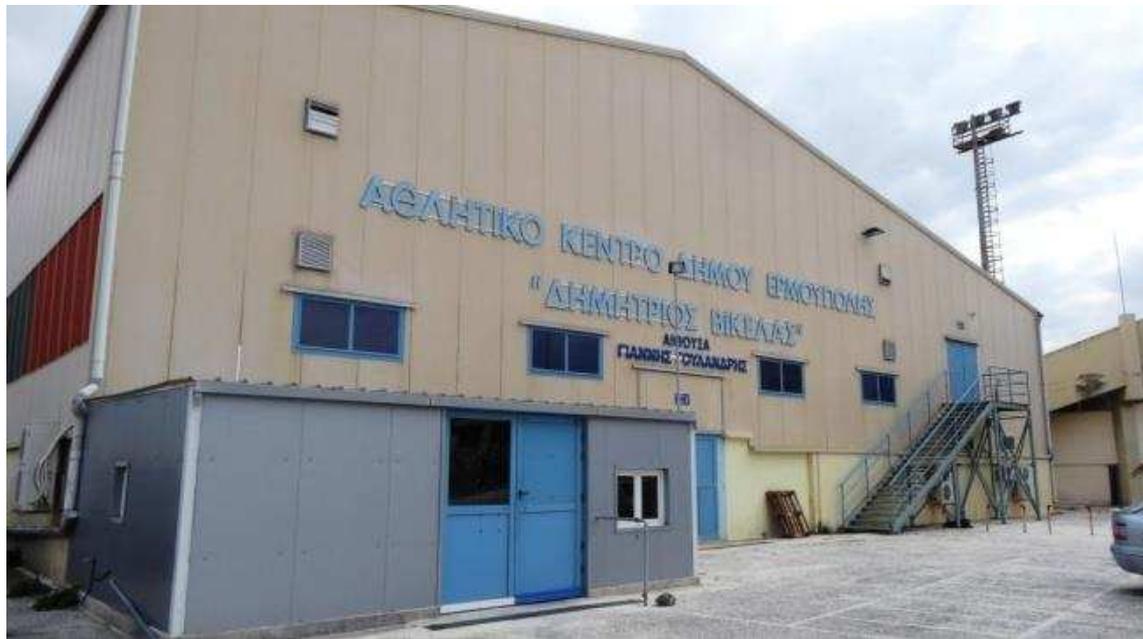
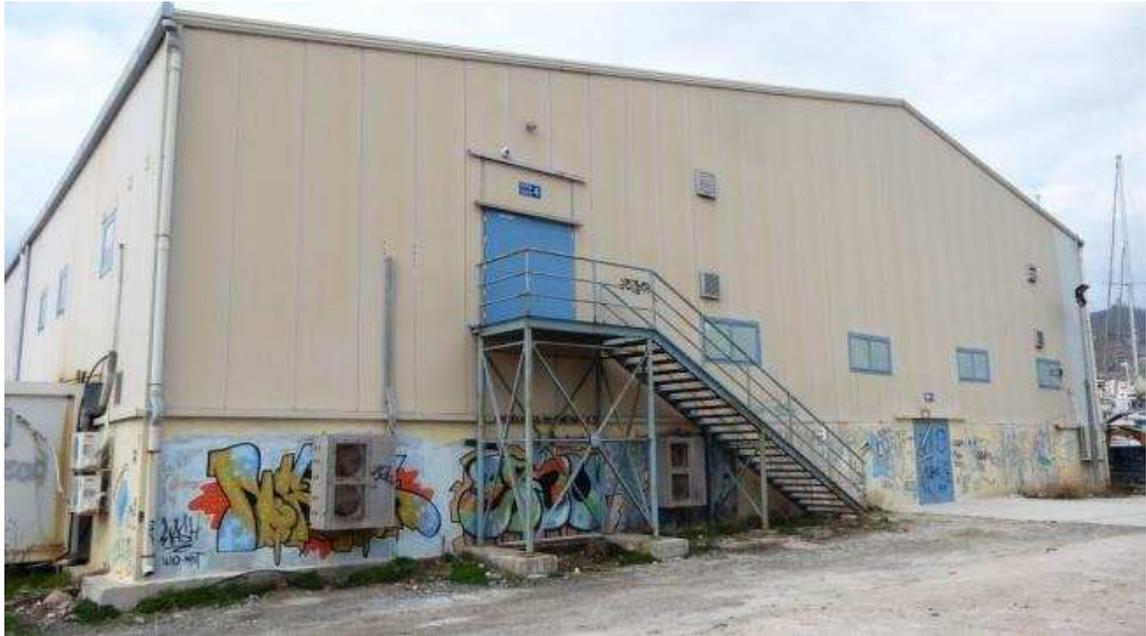
Fig. 1. Views of the a) west and b) east sides of the building.

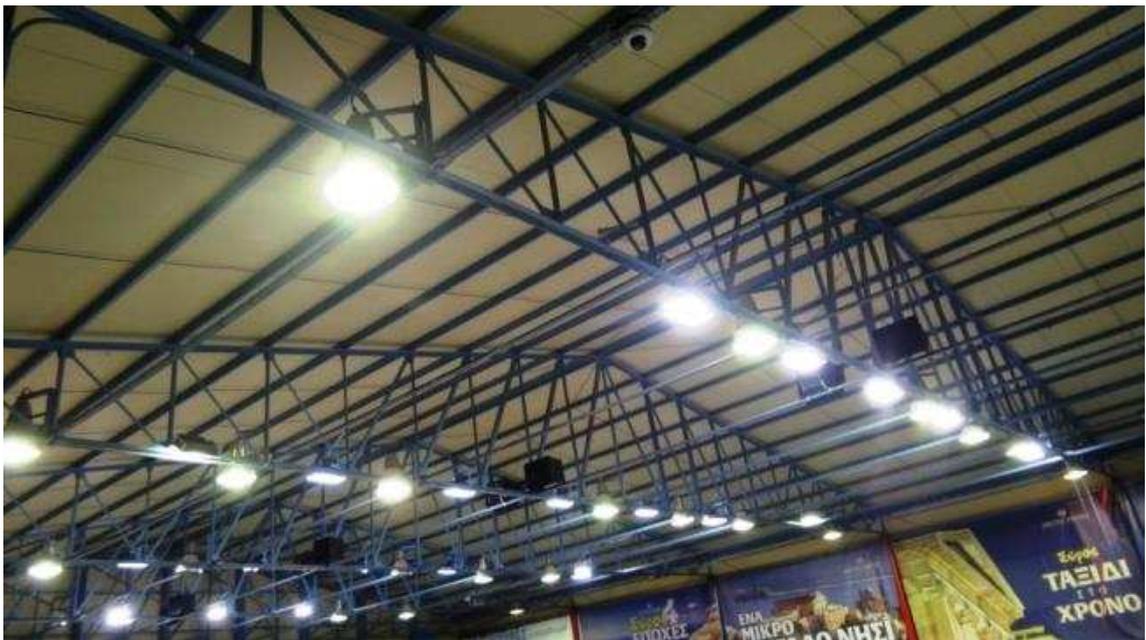
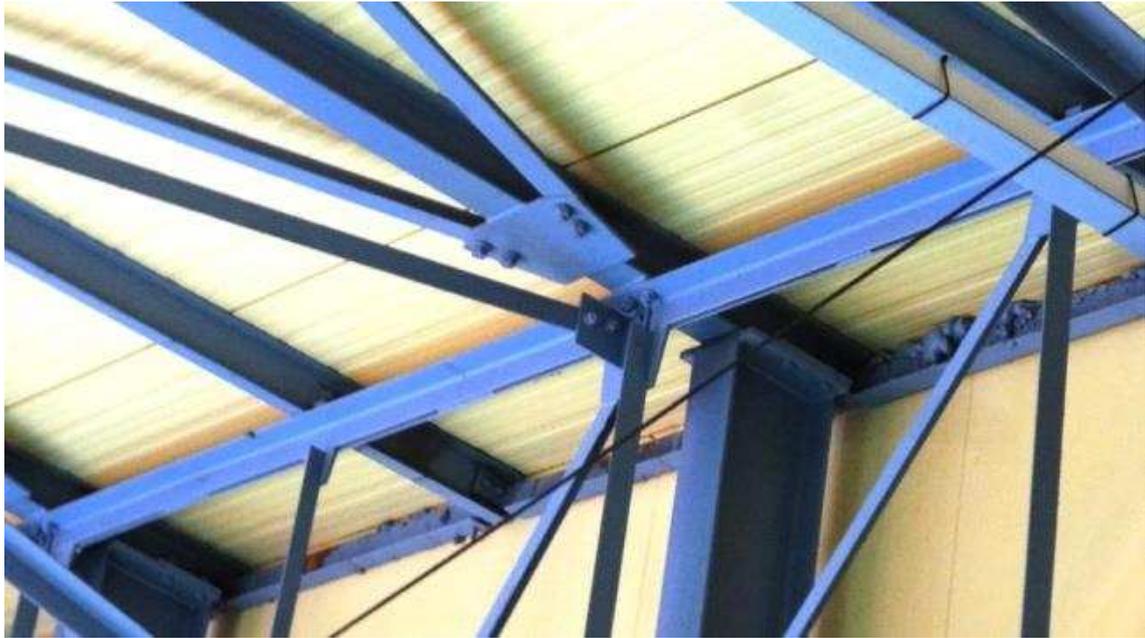
Fig. 2. a) Overall view and b) structural details of the steel lattice roof.

- f) Strengthening the cross-sections of the main chords of the lattice roof using thin-walled hollow sections. Strengthening of specific truss members by adding second angle sections [Sections 2-2 and 3-3 in Fig. 17 and details in Fig. 18(b)].

A detailed schedule of strengthening of the truss chords (point “F” of the strengthening proposals) is attached in Fig. 18(b). The new hollow sections will be properly welded under the existing angle members since the purlins and the web members used for the upper and lower chords of the truss, respectively, preclude any other recommendation. Finally, it is

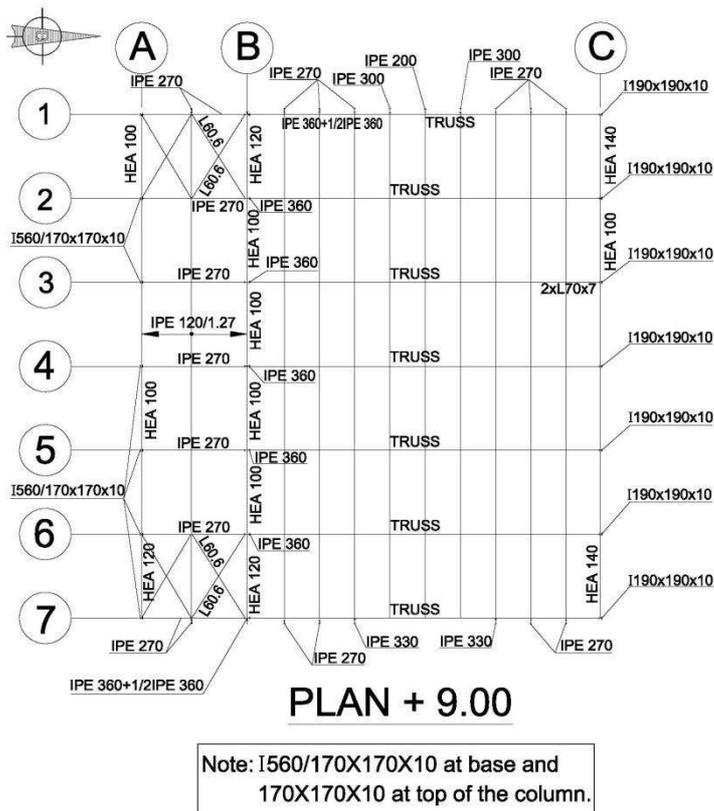
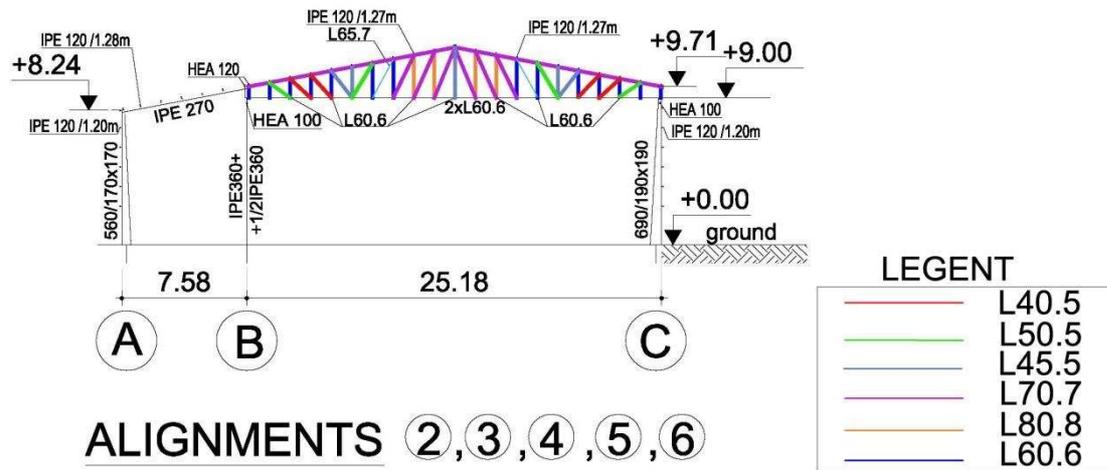
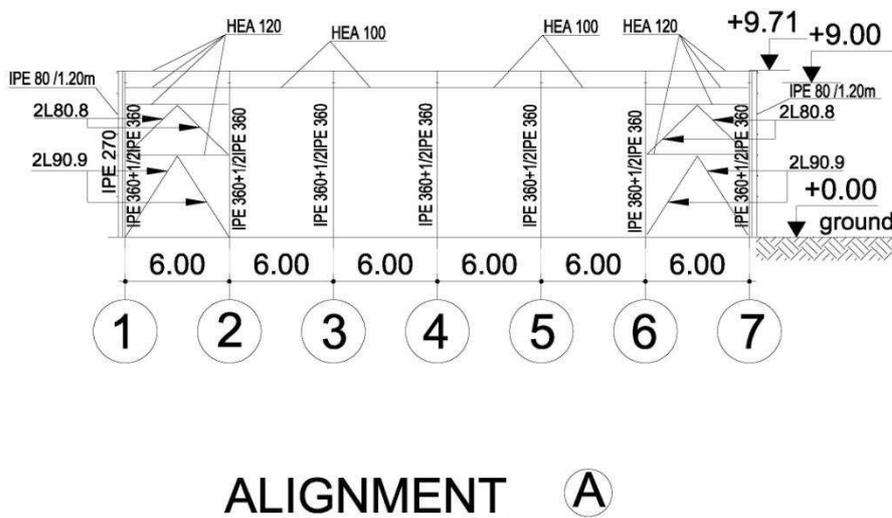
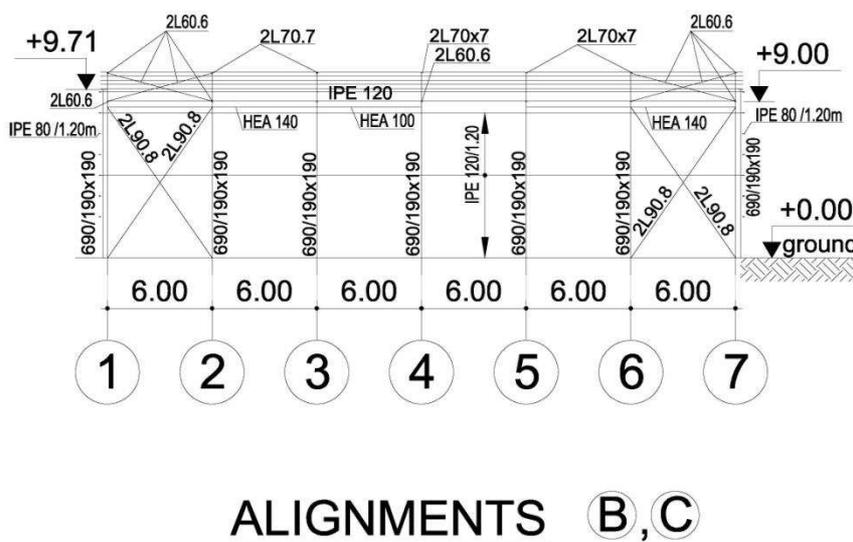
Fig. 3. Drawings of the studied steel structure (a) plan at level +9.00, (b) roof plan, (c) alignments 1 and 7, (d) alignments 2 to 6, (e) alignments A, and (f) alignment B and C

Vertical and horizontal bracings from the double angle sections are located at the end openings of the longest direction of the structure. Insignificant secondary H-type beams are located between the columns of the frames while the trusses are connected in the longitudinal direction through I-type purlins and L-sections at the top and bottom chords, respectively. Gable columns with sections ranging from IPE200 to IPE330 are used to support the large areas at the east and west sides of the building. S235 structural steel is used for all existing steel members.

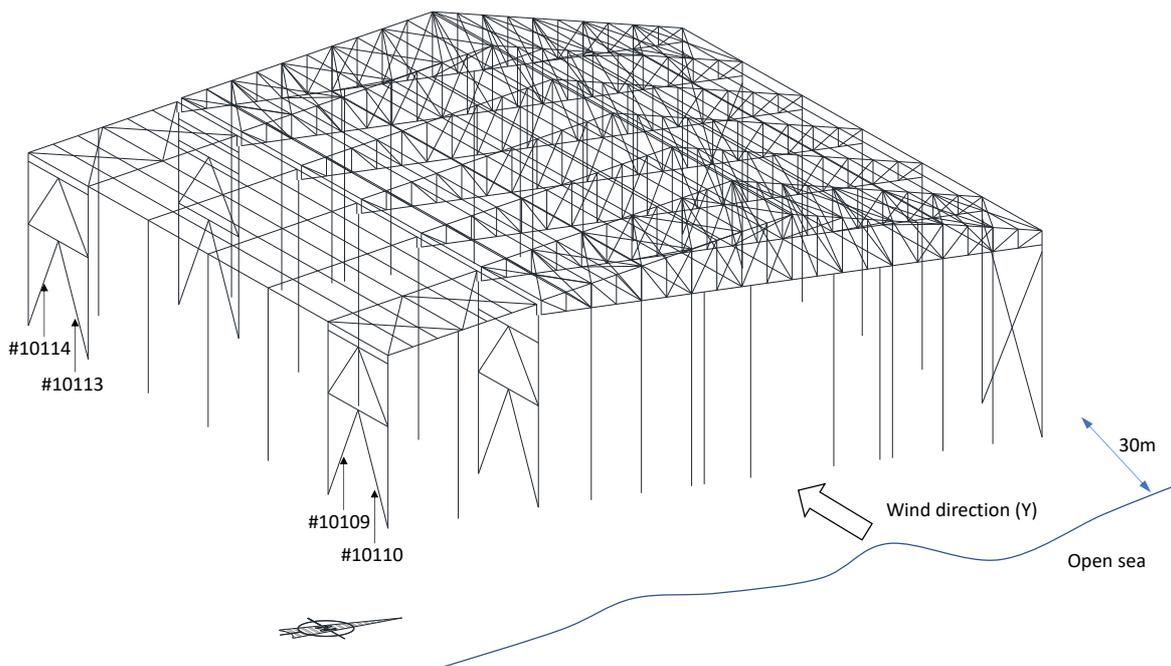
The wind load in the longitudinal direction is simulated only for the Y-axis since major building damage has been observed in this direction in particular. The vertical component of the wind load is not considered in the present study. In Fig. 11, the 3D view of the existing simulated structure is shown as well as the element numbering for 4 selected bracings.

Fig. 11. The overall configuration of the existing structure.

An interesting clue appears to significantly affect the structural response with regard to excessive second-order deformation of the south-west lower bracing [member no. 10114 presented in Fig. 4(a)]. The stiffness and vertical load capacity of the damaged member are obtained from FE buckling analyses using Abaqus [20]. The results are presented in section 2.3.2.

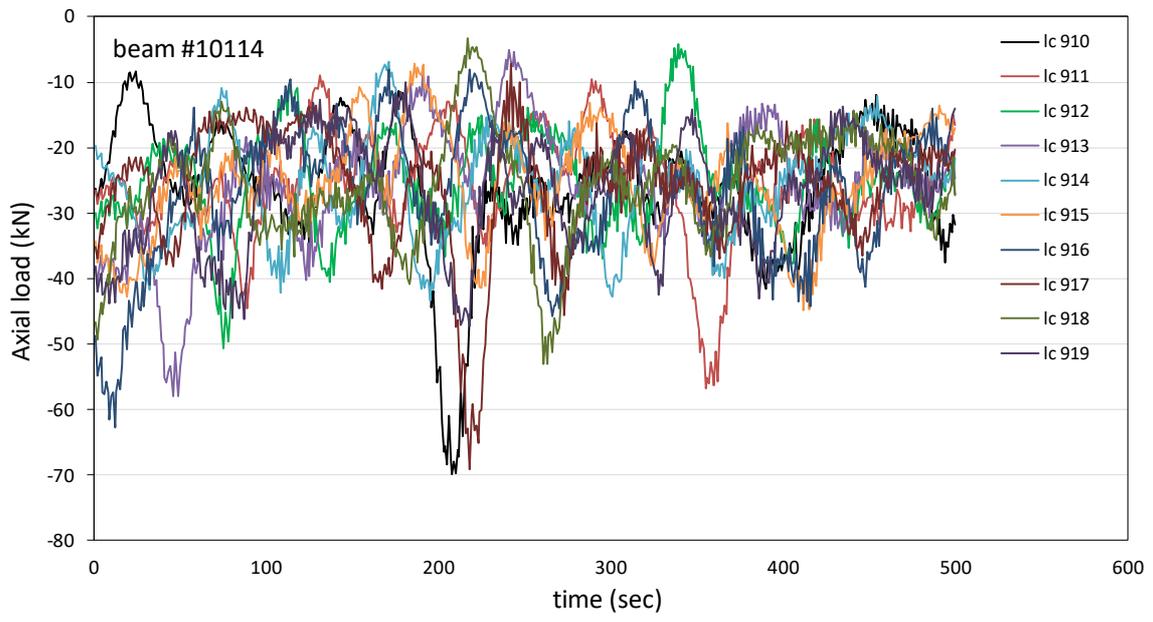
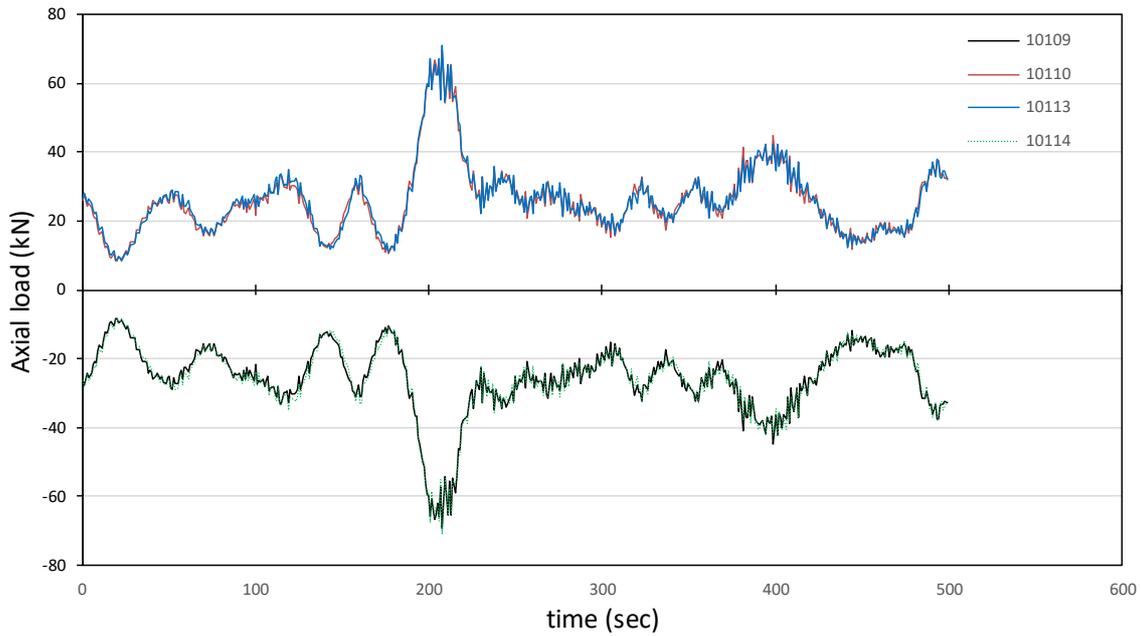
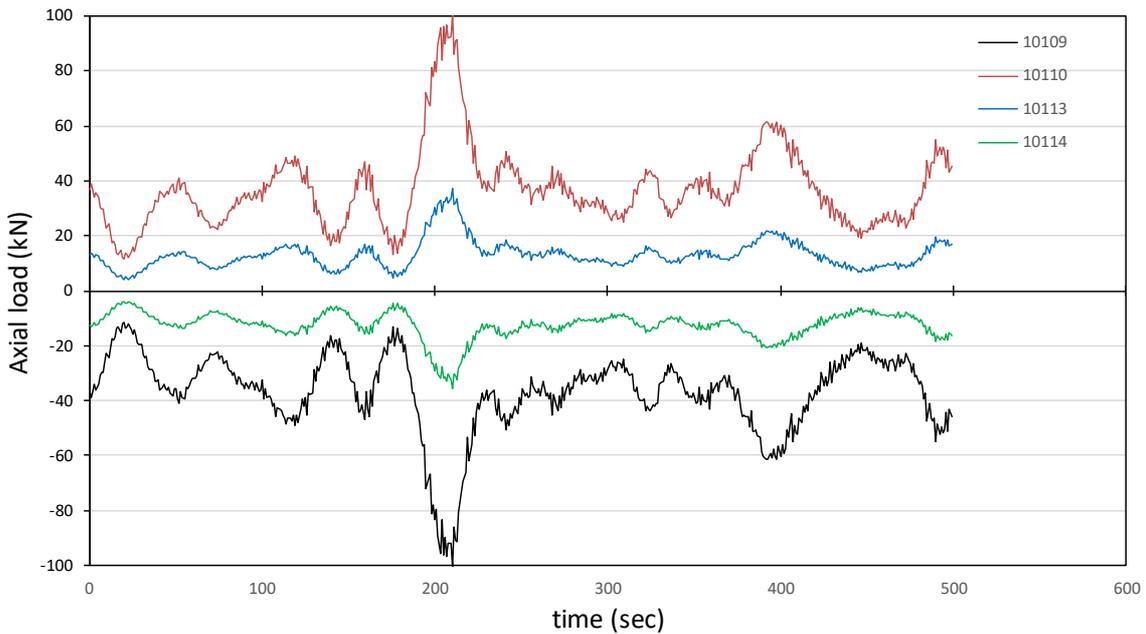
The results of the time-history dynamic analyses for the selected beam elements in terms of axial force are presented in Figs. 12(b) and 12(c). Figure 12(a) shows the axial forces developed on element 10114 (failed element) during the time history analyses performed for the 10 different wind spectras. The two figures (12(b) and 12(c)) respectively address conditions that exclude and include geometrical imperfection from the buckled L-section. The latter case can be referred to as the "imperfect" one. A thickness reduction of 1.0 mm due to corrosion is also included in this case. One can clearly observe relief of the damaged and tensile (member no. 10113) members. In contrast, the east pair of bracings displays additional axial force, which reveals a more unfavourable design status (member nos. 10109, 10110). The axial forces are differentiated by approximately $\pm 45\%$.

Fig. 12. Axial load histories for Λ -type vertical bracings with a) axial force developed on element 10114 for 10 different wind spectras and b) perfect structure axial loads of bracing elements 10109, 10110, 10113 and 10114 for the most unfavourable time history and c) imperfect structure axial loads of bracing elements 10109, 10110, 10113 and 10114 for the most unfavourable time history.

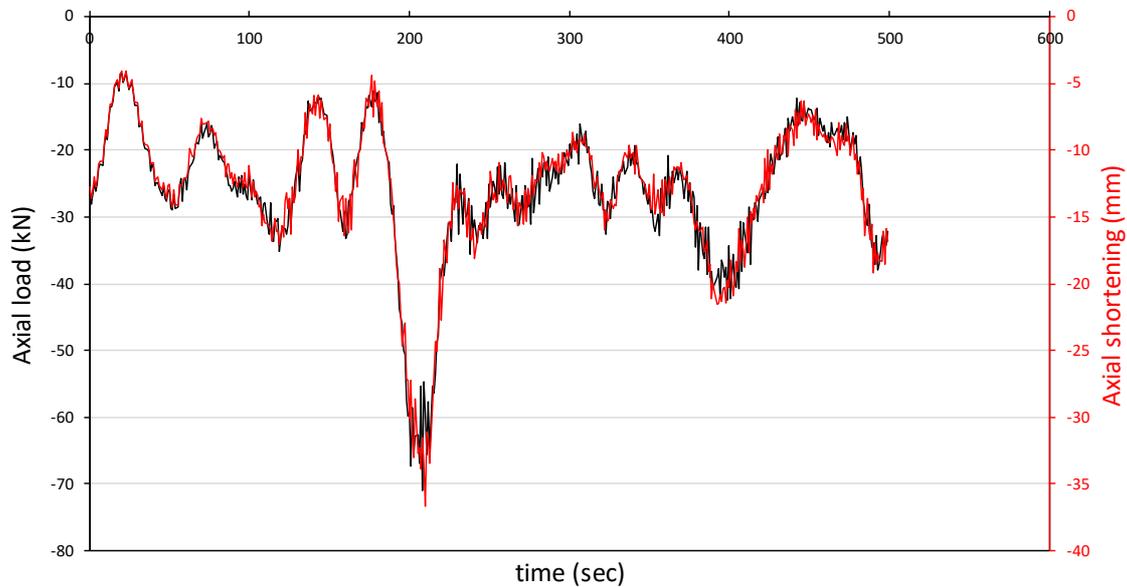
The axial force and dynamic histories as well as the axial displacement history determined via the dynamic analysis, are shown in Fig. 13. The maximum recorded load is 71.0 kN, which corresponds to axial shortening of 31.6 mm. The shortening itself ranges

from 4.0 to 36.7 mm. Considering only the axial load produces a surprising outcome since the maximum developed compressive force does not exceed the buckling capacity of the corroded bracing. However, a design engineer should cautiously consider the most critical qualities, which are the motives for a displacement-based analysis.

Fig. 13. Axial load and displacement response of element no. 10114.

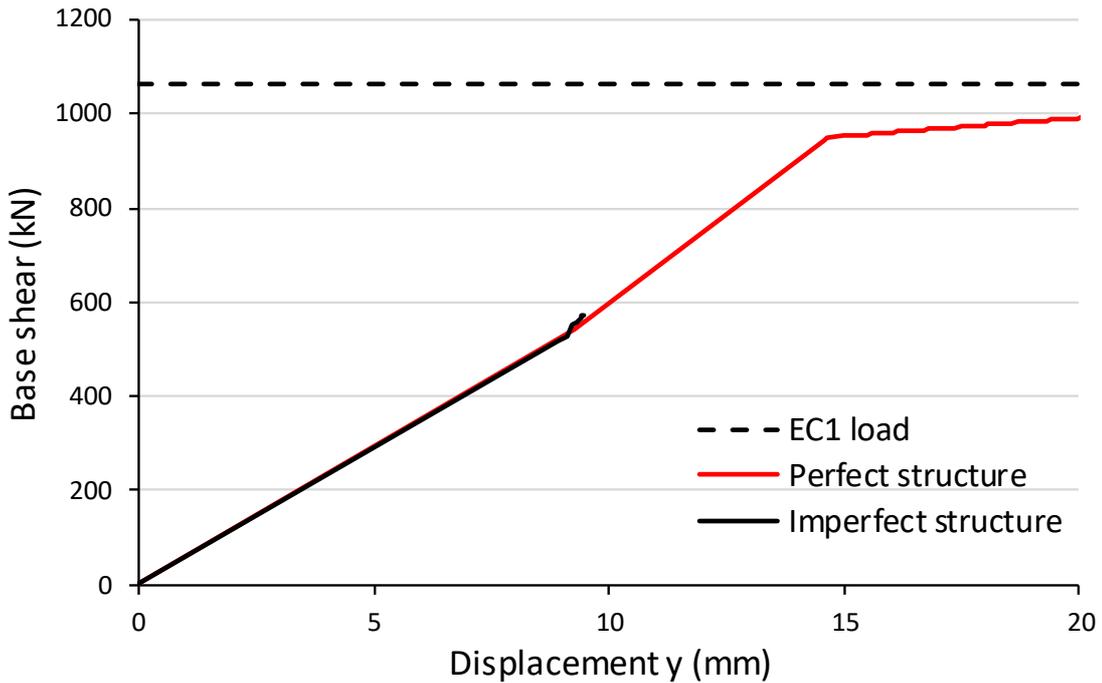
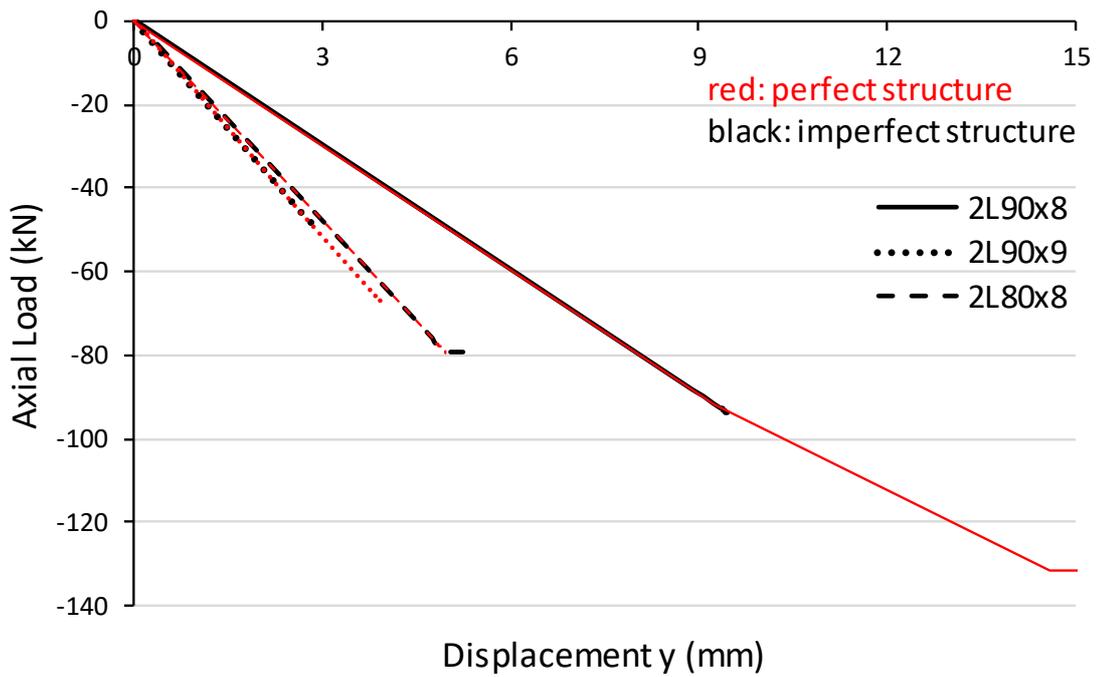
The vertical load capacity curves are shown in Fig. 15(a) capture the total response of the structure, while the dashed line defines the minimum requirement that the structure should have met. After considering imperfections, i.e., excessive deformation of the damaged bracing, the bearing capacity is only 58% of the perfect sample. Nevertheless, the latter vertical load capacity does not satisfy the Eurocode requirement in terms of the total base shear force. Furthermore, the axial load-displacement curves of the major vertical bracings are compared in Fig. 15(b), while the selected imperfection is neglected during pushover analysis. The double equal angle cross-sections L90x8, L80x8, and L90x9 correspond to the existing bracings of the north, south, and Section 1-1 views, respectively.

Fig. 15. Comparison of the a) vertical load capacity curves and b) axial load-displacement paths of vertical bracings within perfect and imperfect structures.

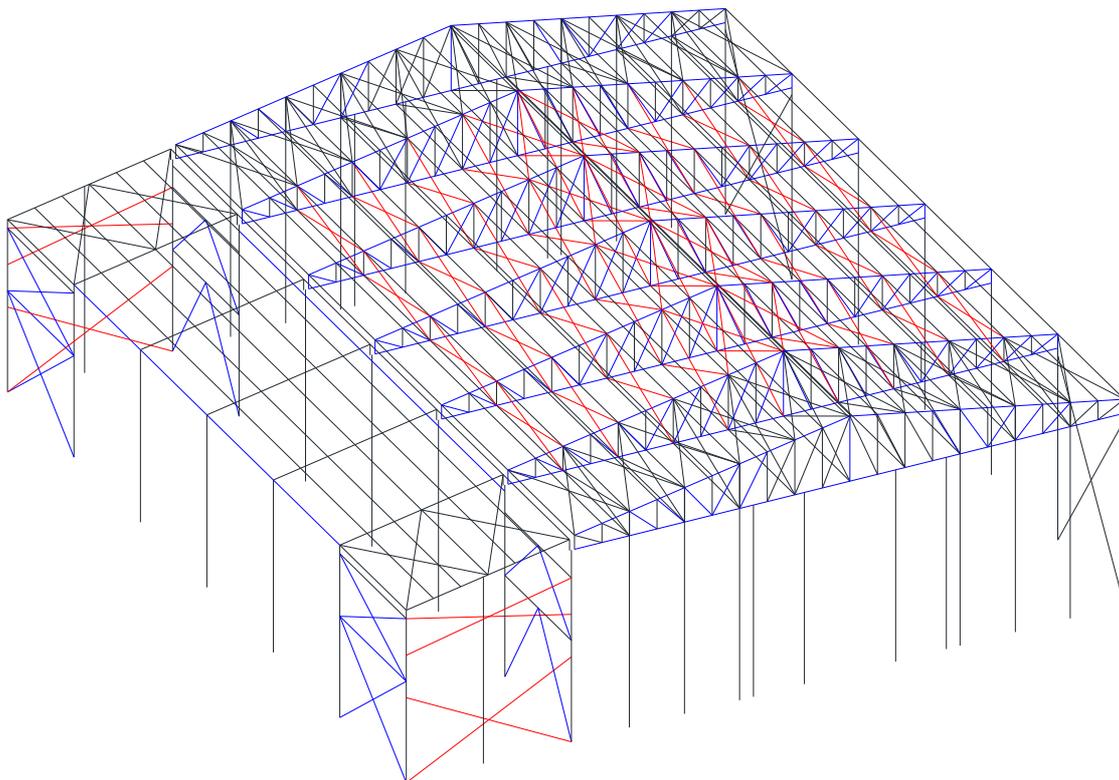
Fig. 16. Three-dimensional view of the structural modifications (blue for replacement or strengthening, red for member addition).

a) Addition of horizontal X-bracings near the roof ridge (roof plan view in Fig. 16, Fig. 17).

- c) Replacement of insufficient vertical bracings using the same or different configurations (examples from the south and north sides of the building as well as Section 1-1 can be observed in Fig. 16, Fig. 17).

- d) Replacement of distorted members such as H-type connecting beams in Section 1-1 of Fig. 16, Fig. 17.
- e) Replacement of vertical elements at the end of the IPE360 column (Fig. 17), which is predicted to provide a stiffer beam-column connection.

Fig. 16 shows the type and extent of interventions recommended for the main steel structure. Replacement and strengthening of the truss roof are illustrated in blue, while red is

used to indicate member additions. The same conventional symbolism has been adopted for Fig. 17. Some serviceability constraints (e.g., equipment, etc.) prevent the use of a more orthodox and appropriate X-bracing configuration in the east and west views (outer red vertical bracings in Fig. 16).

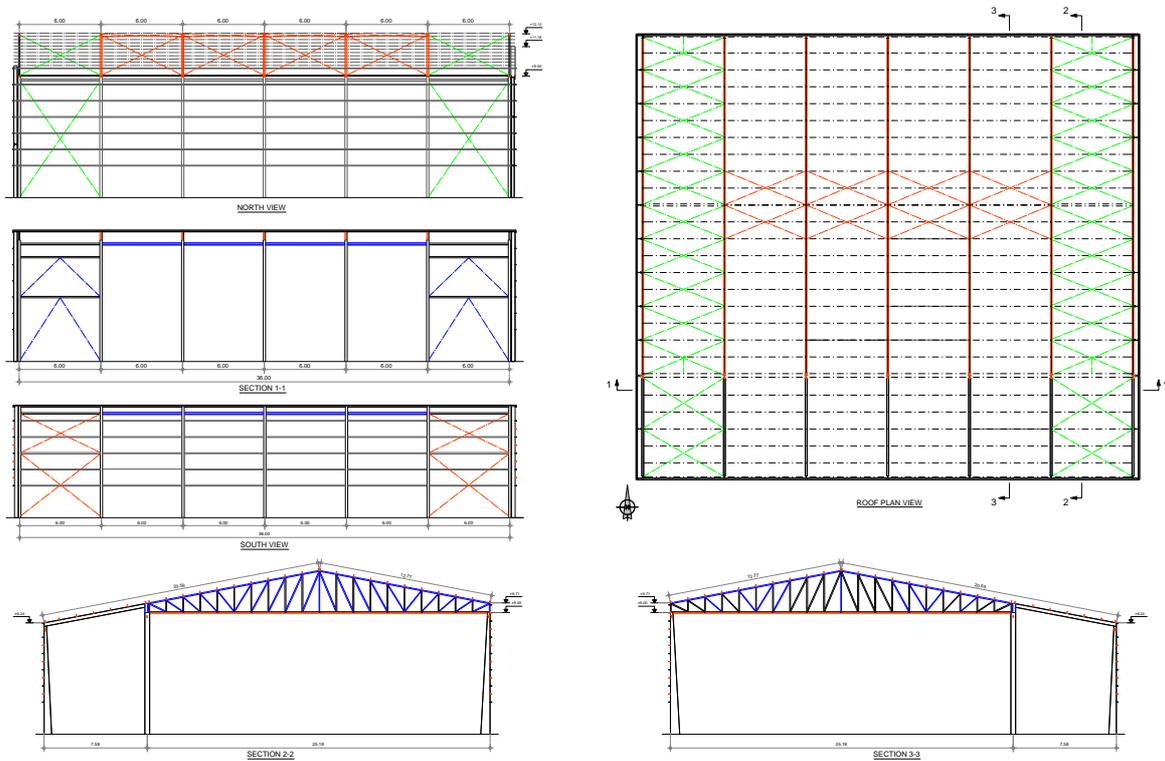
Fig. 17. Schematic view of the strengthened structure (green for existing bracings, red for proposed modifications, and blue for strengthening).

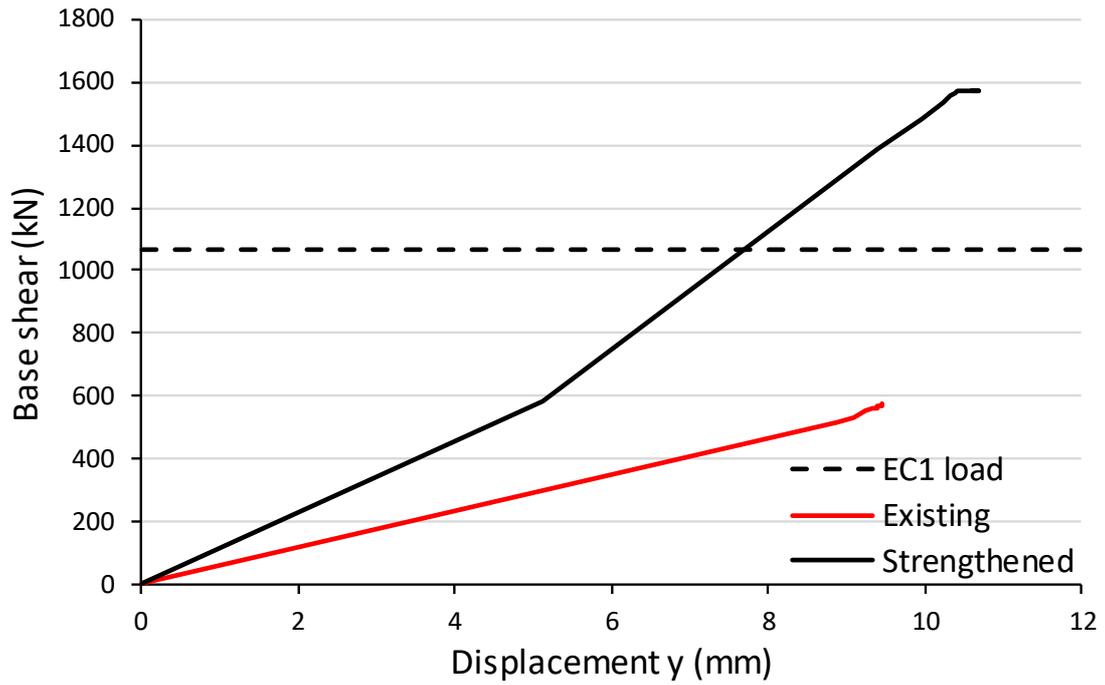
For the sake of completeness, the vertical load capacity curve of the proposed modified structure was established and compared to that of the existing structure. The procedure presented in Section 2.3.1, is repeated in Sofistik using the enhanced properties of the new and strengthened members. Fig. 21 depicts the new curve that indicates a total base shear force enlargement from 571 kN to 1571 kN.

Fig. 21. Comparison of the vertical load capacity curves of the existing and strengthened structures.

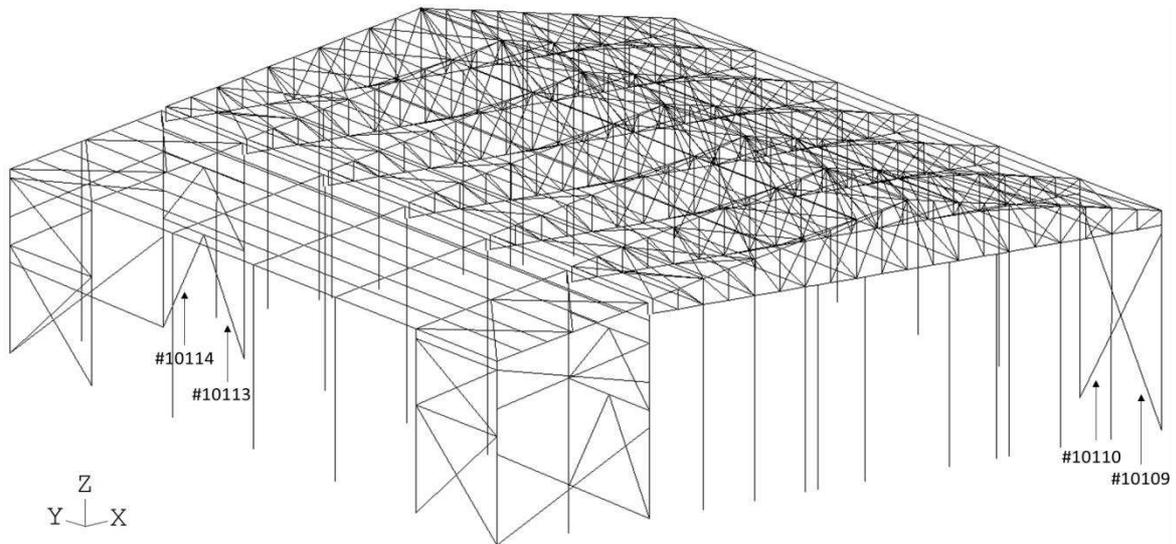
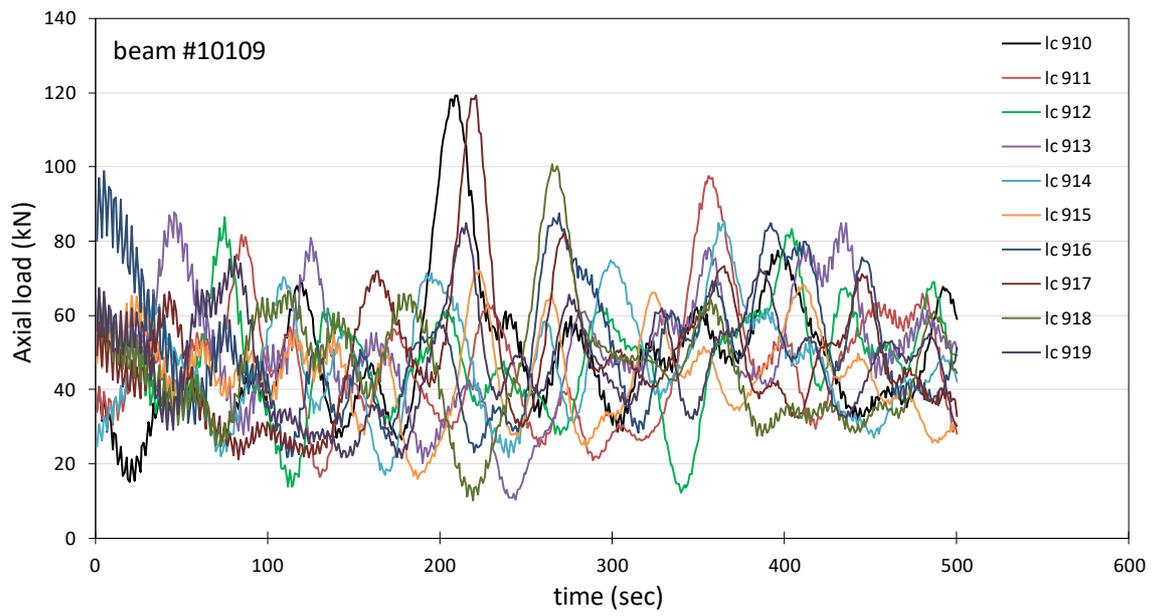
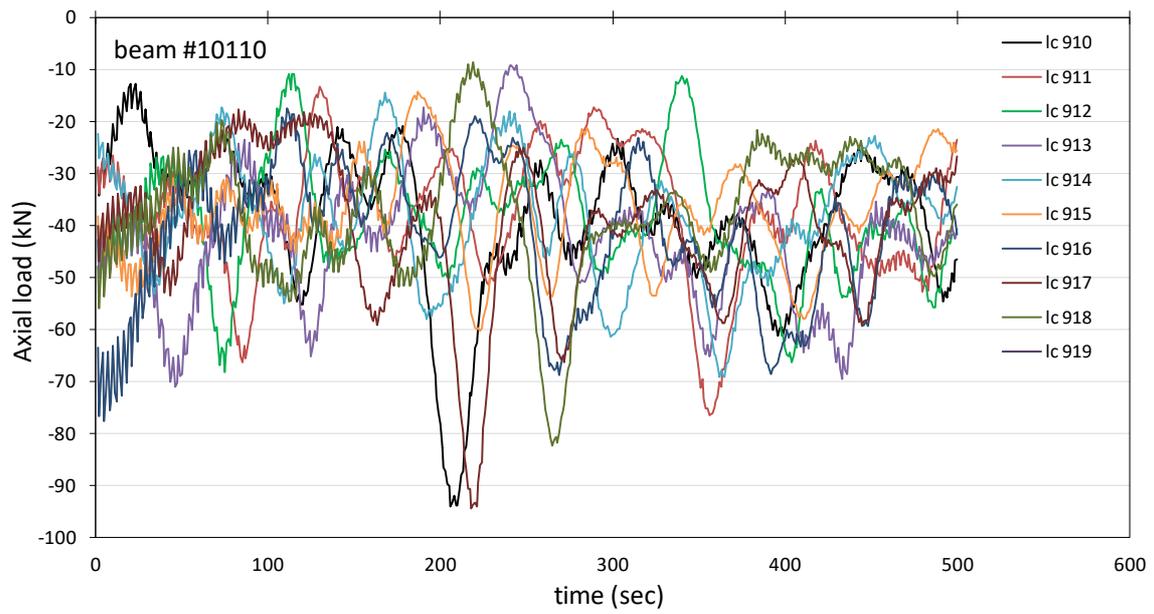
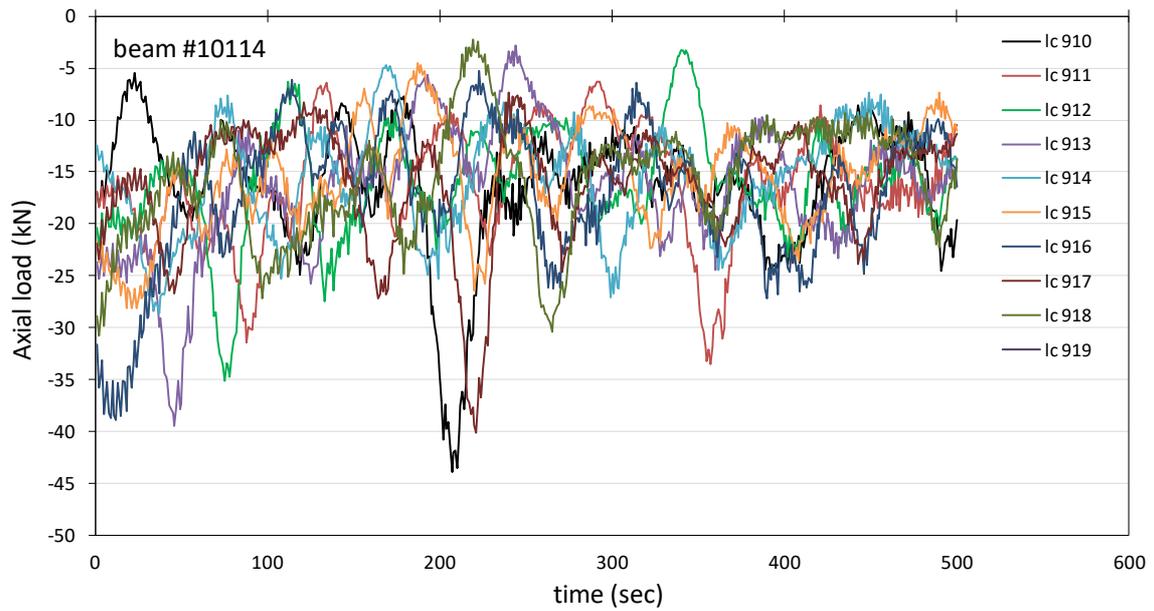
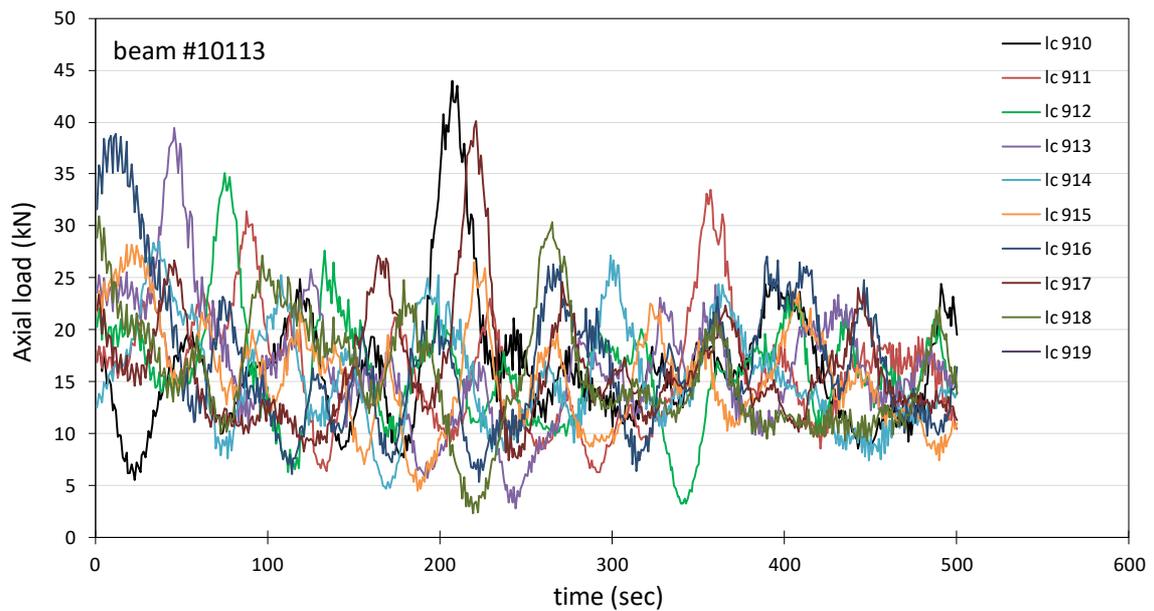
Furthermore, Fig. 22 shows the axial force histories of bracing elements for the 10 different wind histories. In order to ensure that the analysis parameters are providing safe results, a sensitivity analysis for the coherence factor was performed and showed that the used coherence factor was appropriate (Fig. 23).

Fig. 22. (a) Strengthened structure numerical model with a number of bracing elements analysed, (b) axial force history of element 10109 for 10 wind time history analyses, (c) same for element 10110 (d) same for element 10114 and (e) for element 10113.
